# **Selected Published Incidents Involving Cold Storage Facilities**

**One-Stop Data Shop  
Fire Analysis and Research Division  
National Fire Protection Association**

**March 2011**

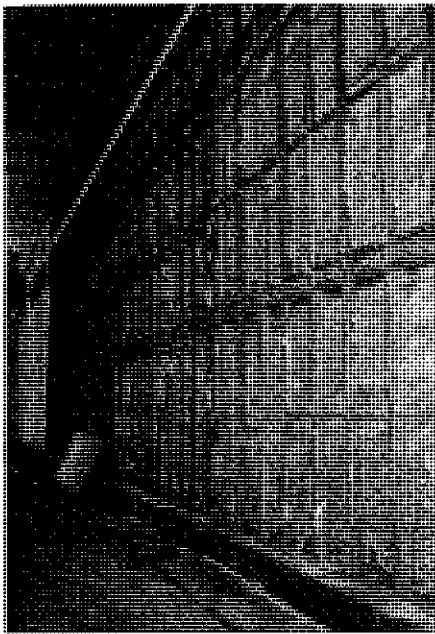
**Typical wall construction: Exterior metal sheathing with sprayed-on plastic foam and wood-frame-supported, fiberglass-covered plywood walls.**

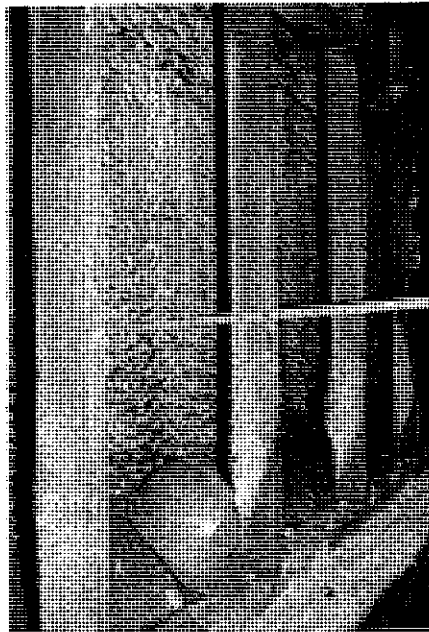
**A view of combustible concealed space between the wood-framed interior surface and the plastic foam insulation.**

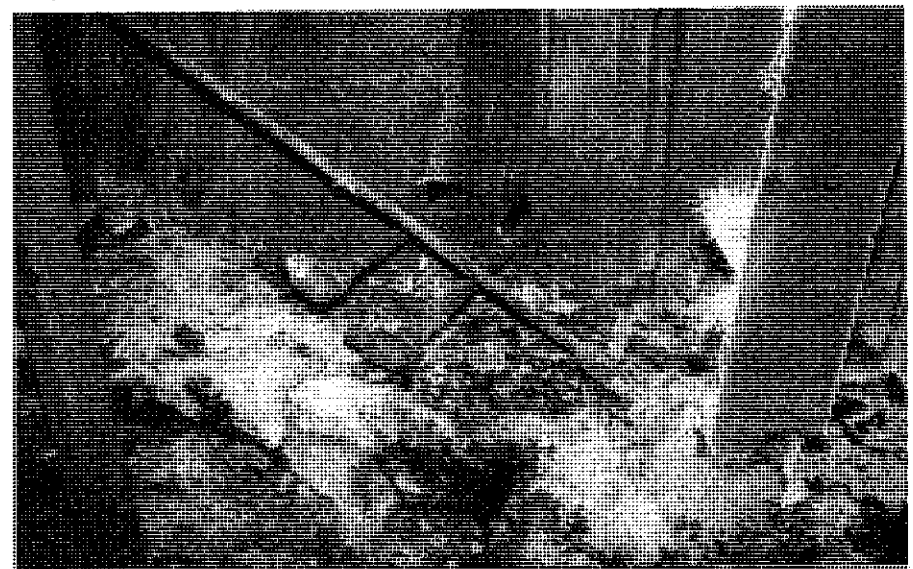
**Welders working on these elbows accidentally ignited combustible materials inside the wall at this location.**

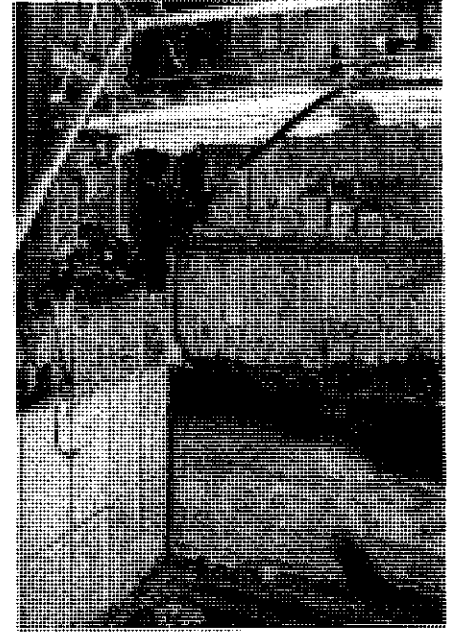
**Walls in the corner of the cooler, near the mechanical room. Wallboard and plywood covered the wall at left.**

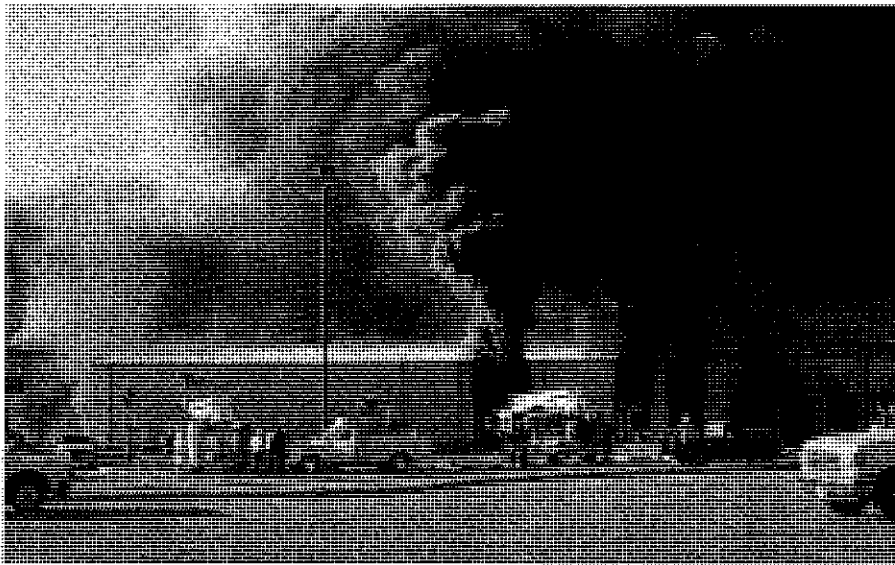
### Dense smoke that billows from doors at the front of the Dole plant impeded fire fighters' entrance and suppression activities.

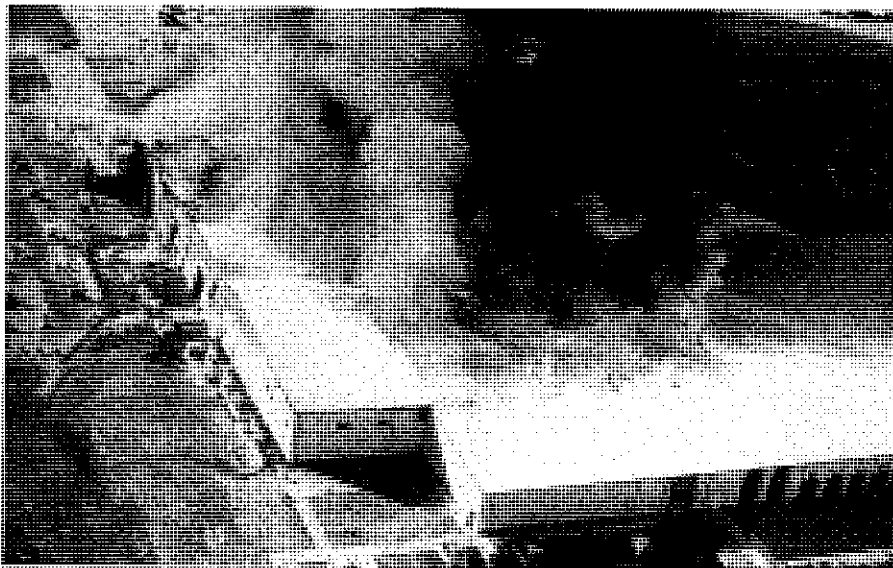
**Aerial view of the Dole plant. Exposure to severe fire conditions caused portions of the roof to collapse, allowing fire and smoke to vent freely.**

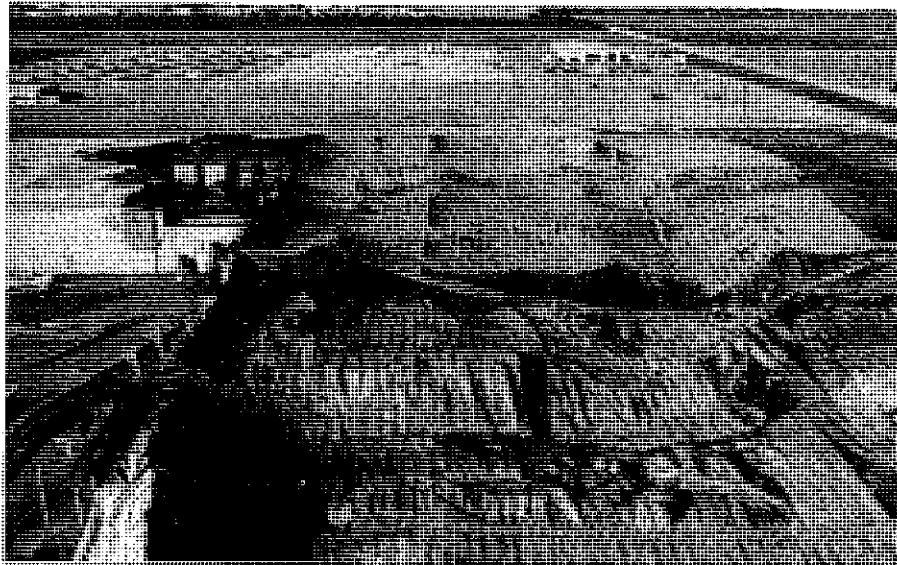
**Aerial view after the fire was extinguished. The roof above the addition and most of the roof above the salad plant collapsed.**

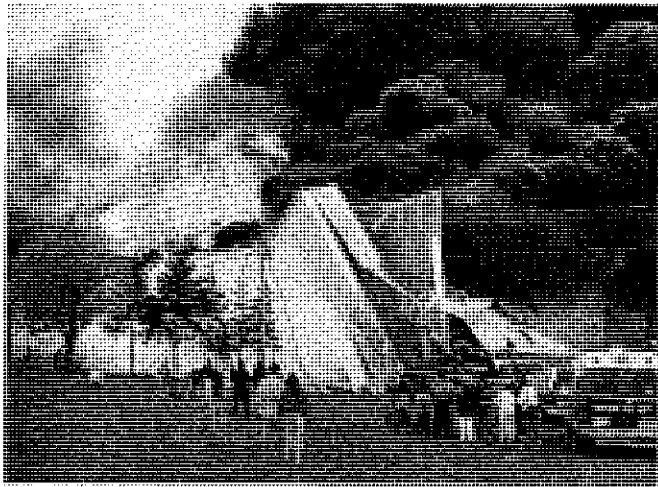
The foam insulation contained in Freezer 8's walls, partitions, and roof generated heavy black smoke as it burned. This photograph was taken from the northeast corner of Freezer 8.

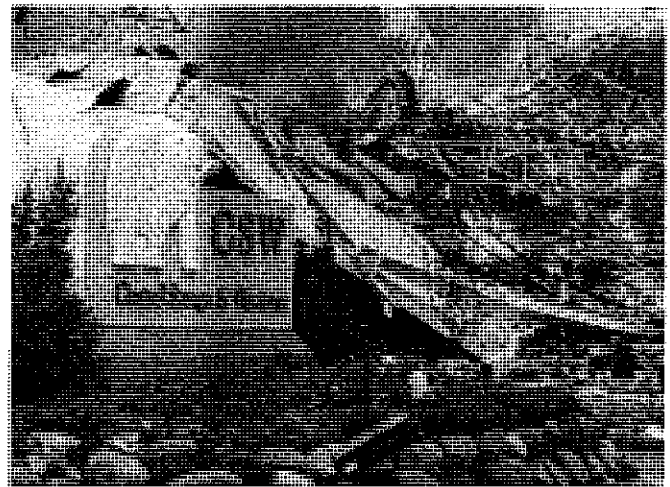
Five days after the fire had started, deep-seated fires still burned in the rubble. They were extinguished as heavy equipment uncovered them.

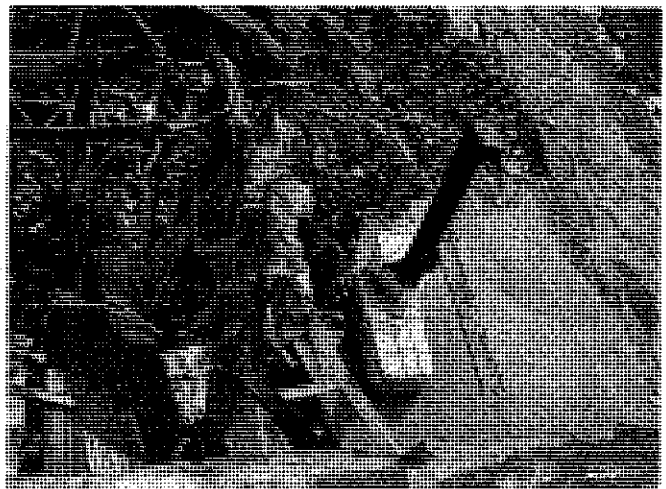
**Investigators suspect that this forklift truck was near the point of fire origin, and they are studying it to determine whether it was involved in the fire's ignition.**

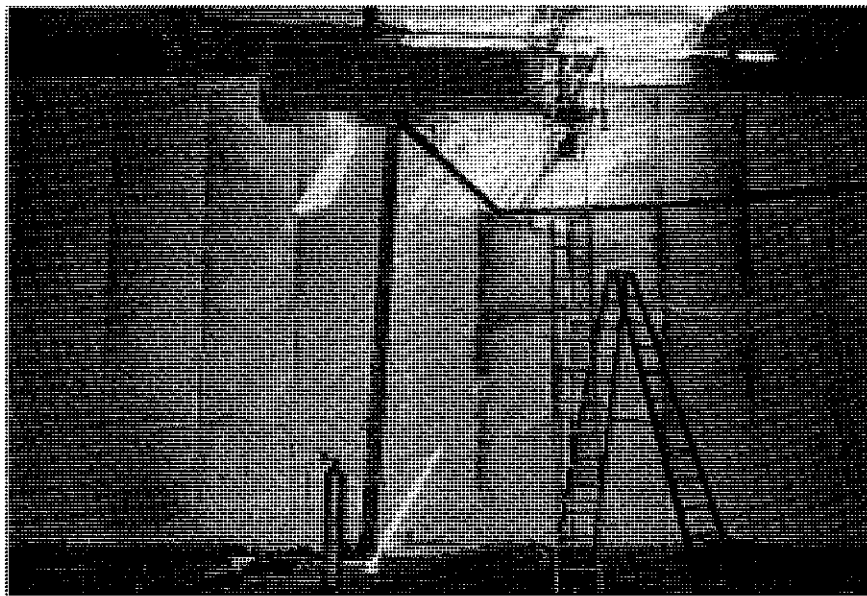
Workers were trying to replace a leaking valve to this evaporator unit when the concentration of ammonia drove them from the room. Below the unit is the carbon dioxide tank workers used to try to reduce the amount of the gas in the area before they were forced out.

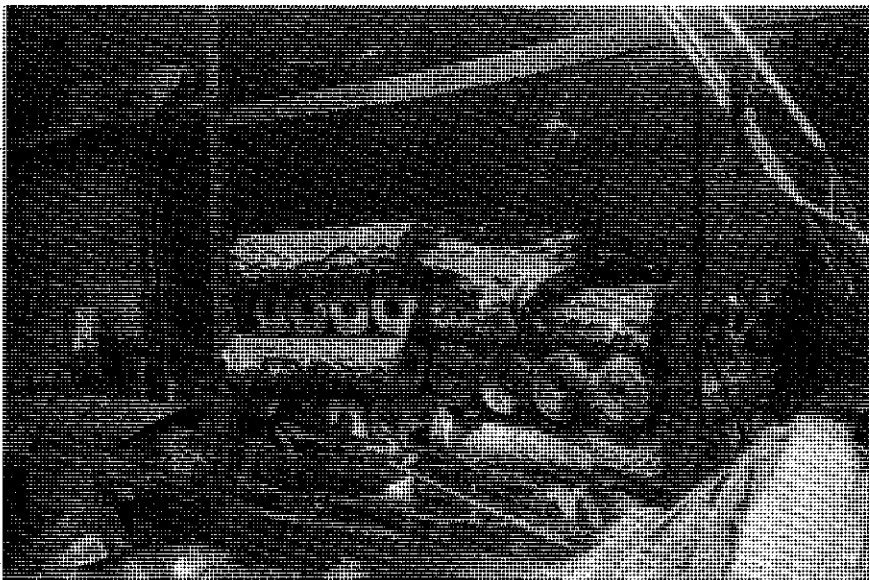
Combustibles stored in an area adjacent to the room of origin ignited soon after the explosion.

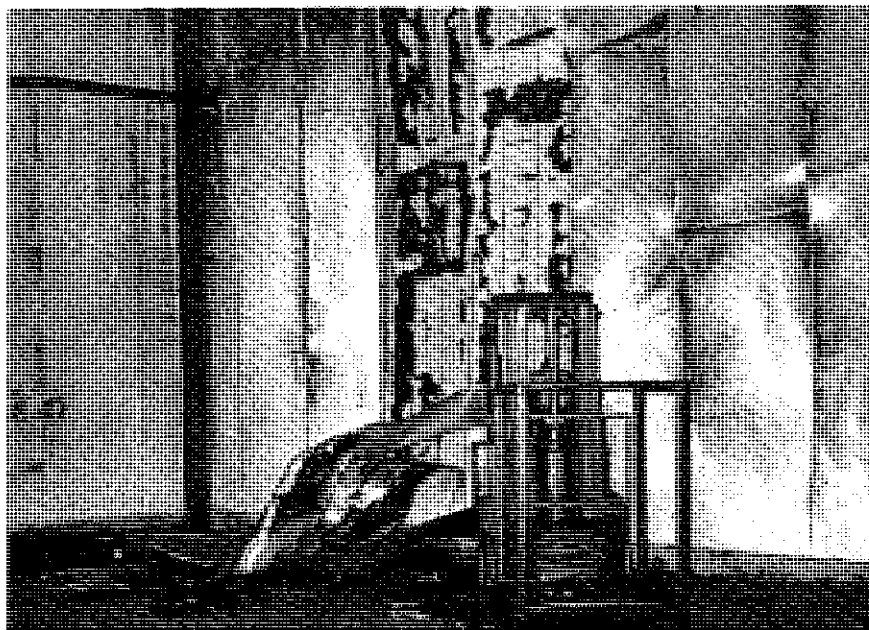
The electric forklift truck fire fighters were using to replace the valve slid into one of the walls, and an explosion resulted.
