# **Aircraft Accidents that Caused Major Changes to Emergency Response Equipment and Procedures**

**Mark T. Conroy**

**Senior Fire Protection Engineer  
National Fire Protection Association, USA**

**The International Forum on Emergency and Risk Management  
Singapore Aviation Academy  
10-12 January, 2005**

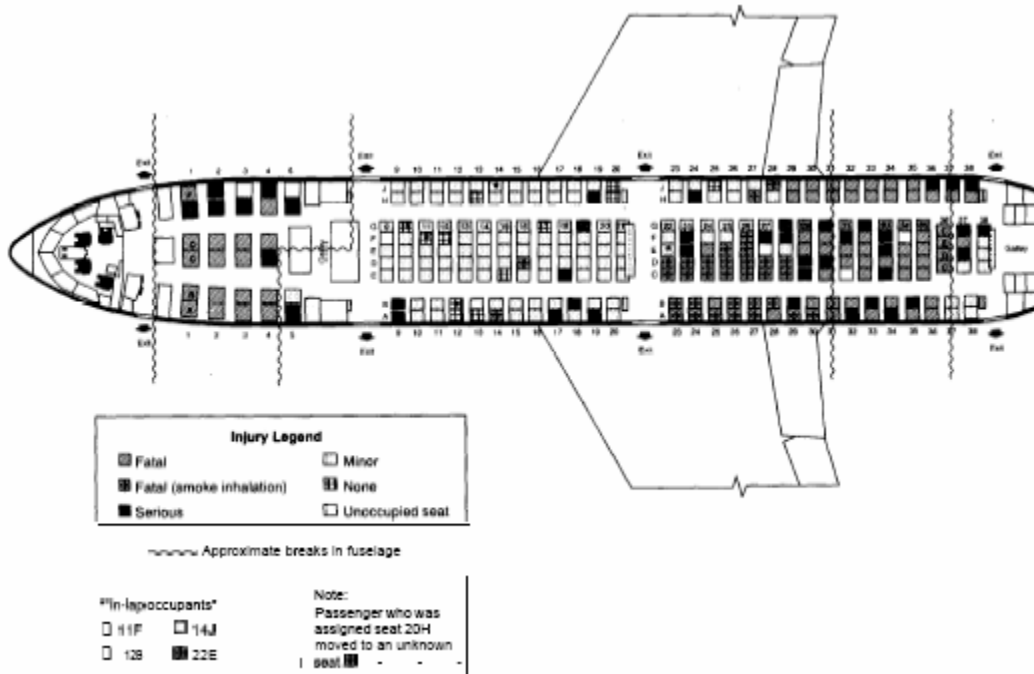
Figure 1 Aircraft Configuration and Occupant Injuries, Flight 232  
 (Copied from NTSB Accident Investigation Report)

Of the 296 people onboard, 111 died and 185 survived (see Figure 1). Of the 185, forty-seven were seriously injured, 125 had minor injuries, and 13 reported no injuries. Passenger seating was provided in 38 rows in this configuration of a DC-10. The setup was typical with the first class section taking up rows 1-8 and coach seating (2/5/2 seat arrangement per row) in the remainder. The upside-down center section in the cornfield contained rows 9-30, which was where most of the surviving occupants of the aircraft were seated. It therefore made sense to focus firefighting efforts to this area. Although this portion of the aircraft was eventually destroyed by fire, the early fire suppression activities are credited with saving many lives. Thirty-three of the 35 passengers, who died from asphyxia/smoke inhalation, were in rows 22-30. The egress path was to the front of the wreckage and these 35 people were seated in the back. Twenty-four of them did not receive traumatic blunt force injuries and may have been overcome by the smoke before they had a chance to reach the opening in the front. Also contributing to the high survival rate was “brace-for-impact” instructions given by the flight attendants.

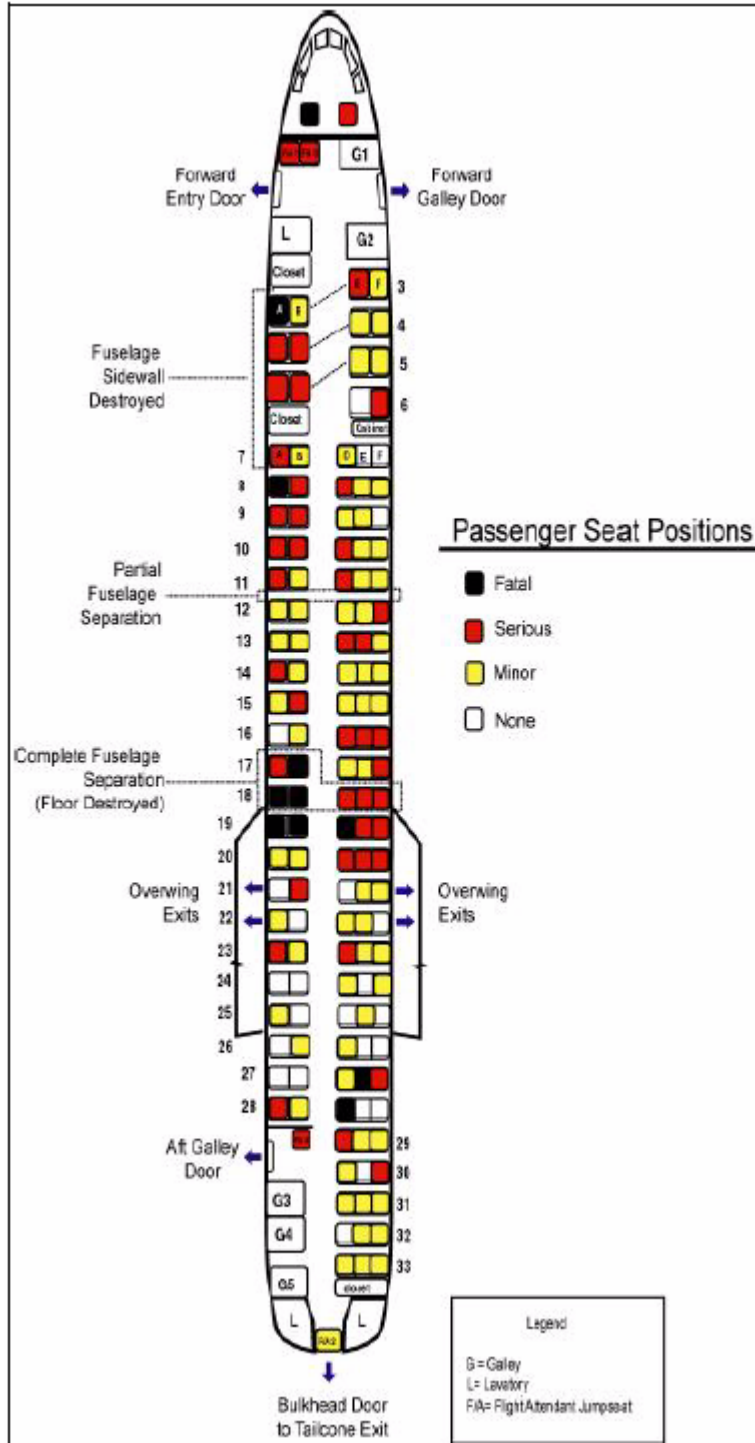
Figure 2 Aircraft Configuration and Occupant Injuries, Flight 1420  
 (Copied from NTSB Accident Investigation Report)

The Pilot was killed on impact with the ALS. There were 10 other fatalities. Passengers in 3A, 8A, 17B, 18A, and 18B died of traumatic injuries. Five passengers in 19A, 19B, 19D, 27E, and 28D died of asphyxia/smoke inhalation. Three of these passengers were at the opening where there fire entered the rear section of the cabin. The two other smoke inhalation fatalities were quite a ways back in the cabin and further analysis would need to be conducted to determine if age or other factors contributed to their inability to self evacuate. Figure 2 shows the relationship to the fatalities and the break points on the aircraft. Passengers in first class in 3A, 3B, 4A, 4B, 5A, and 5B were ejected from the aircraft while still strapped in their seats. Also at the center section break, passengers in 17A, 17B, 18A, 18B, 18D, 18E, and 18F were ejected from the aircraft while still strapped in their seats. Comparing those that died with those that were ejected, four of the 13 passengers ejected from the aircraft died of traumatic blunt injuries, the others that were ejected, survived.
