AUTO DEALERSHIP

Hackensack, NJ

SUMMARY INVESTIGATION REPORT

Five Fire Fighter Fatalities
Hackensack, New Jersey
July 1, 1988

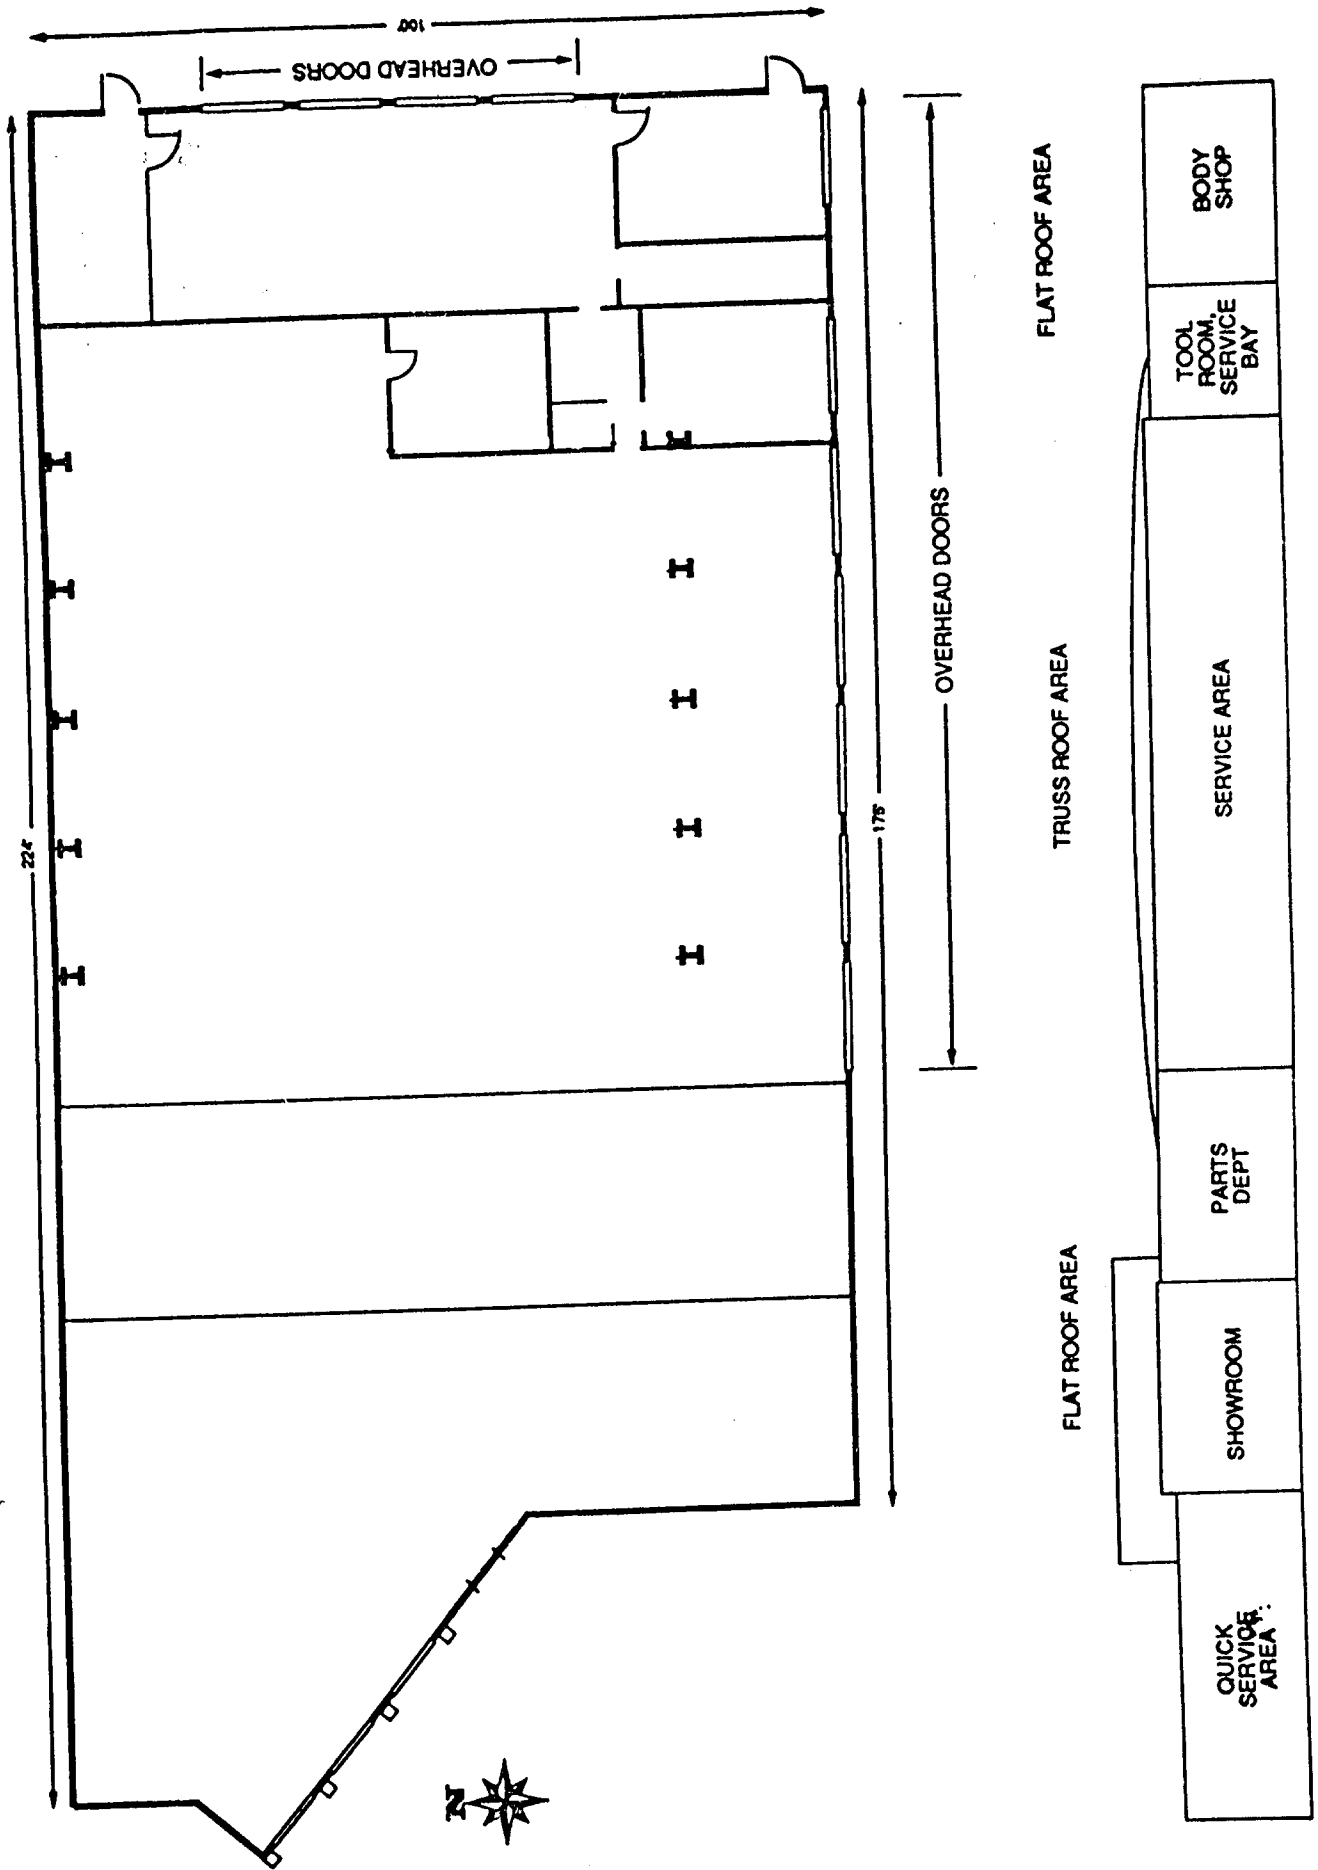
FIGURE 1: TOP VIEW AND SOUTH ELEVATION

The new car showroom and a quick service area were arranged along the front, western portion of the building, closest to River Street. New cars were also displayed on the exterior of the building between the showroom and the street. An approximately 30-foot wide service road provided access to the remaining sides of the building. The auto service area was located in the center portion of the building accessible from the north and south sides of the building. The body shop was located at the east end of the building. (See Figure 1.)

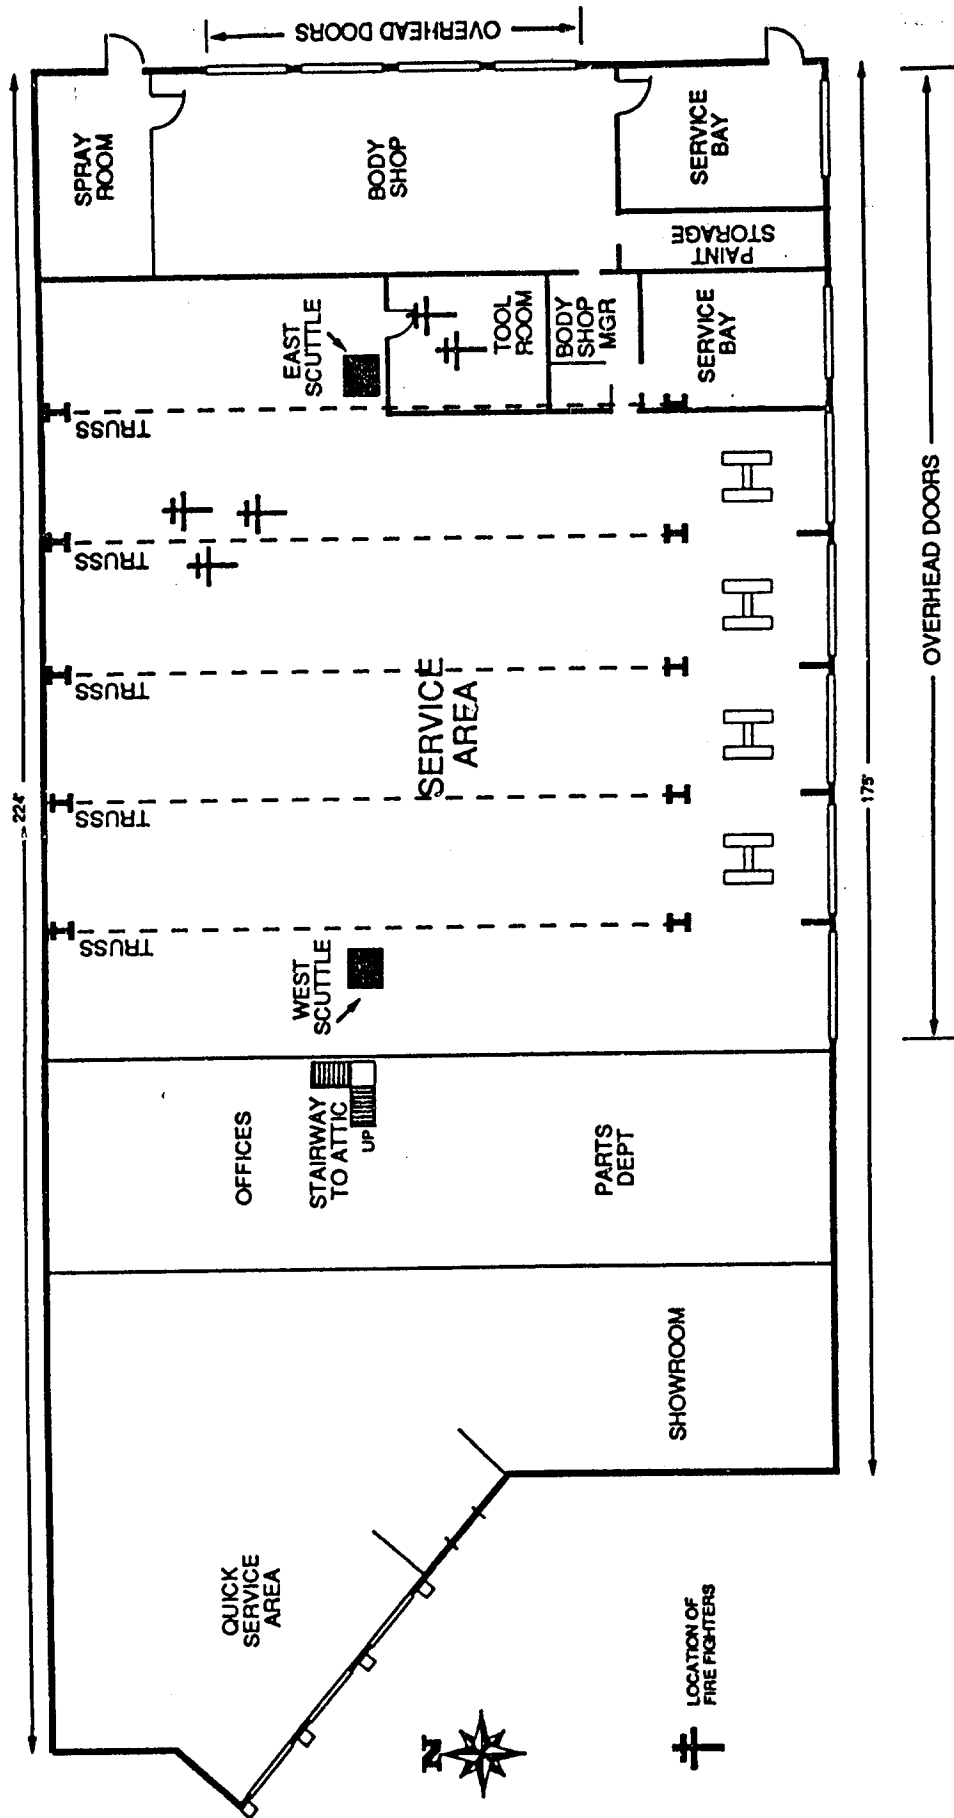
FIGURE 2: TOP VIEW DETAIL

The roof construction of the arched roof above the service area consisted of five bowstring wood trusses. A truss was located at each of the structural columns. (See Figure 2.) The trusses were spaced just over 16 feet apart, ran north to south, and spanned approximately 78 feet of the nearly 100 foot wide service area. The construction details of the bowstring truss could not be fully determined; however, it is estimated that there was a 10-foot distance from the bottom chord to the top chord at the highest peak of the truss.¹ A short metal beam was attached to the vertical column at the ceiling level, and the bottom chord of the truss was then connected to the beam with a series of bolts. The top chord reportedly was made of laminated 2-inch by 4-inch wood material, the bottom chord was made of 2-inch by 6-inch members bolted together, and web members were 2-inches by 6-inches. The connections were bolted steel plates, and all the web members are thought to have been wood. It is not known if metal components were also used as web members or tie rods, although it is common to do this.

The interior of the service area was a large, open area of approximately 10,000 square feet. At the southeast corner of the service area there were three rooms: a tool room, an office, and a storage room. The walls were constructed with masonry materials, and they ran to the underside of the finished ceiling. The east wall of the tool room was a common wall with the body shop, and it had no openings. The only opening to the tool room was an entrance door that was located along its north side. One 275-gallon storage tank (containing transmission oil) was positioned along the west wall of the tool room, and another storage tank (containing antifreeze) was stored in the tool room. A door opening in the east masonry wall gave access to the area between the rear of the service area and the body shop. (See Figure 2.)
