**HOTEL FIRE**  
Las Vegas, NV  
February 10, 1981

**Fire Investigation Report**

**Hotel Fire  
Las Vegas, Nevada  
Eight Fatalities  
February 10, 1981**

**David P. Demers, P.E.,  
Consultant to  
NFPA Fire Investigations Department**

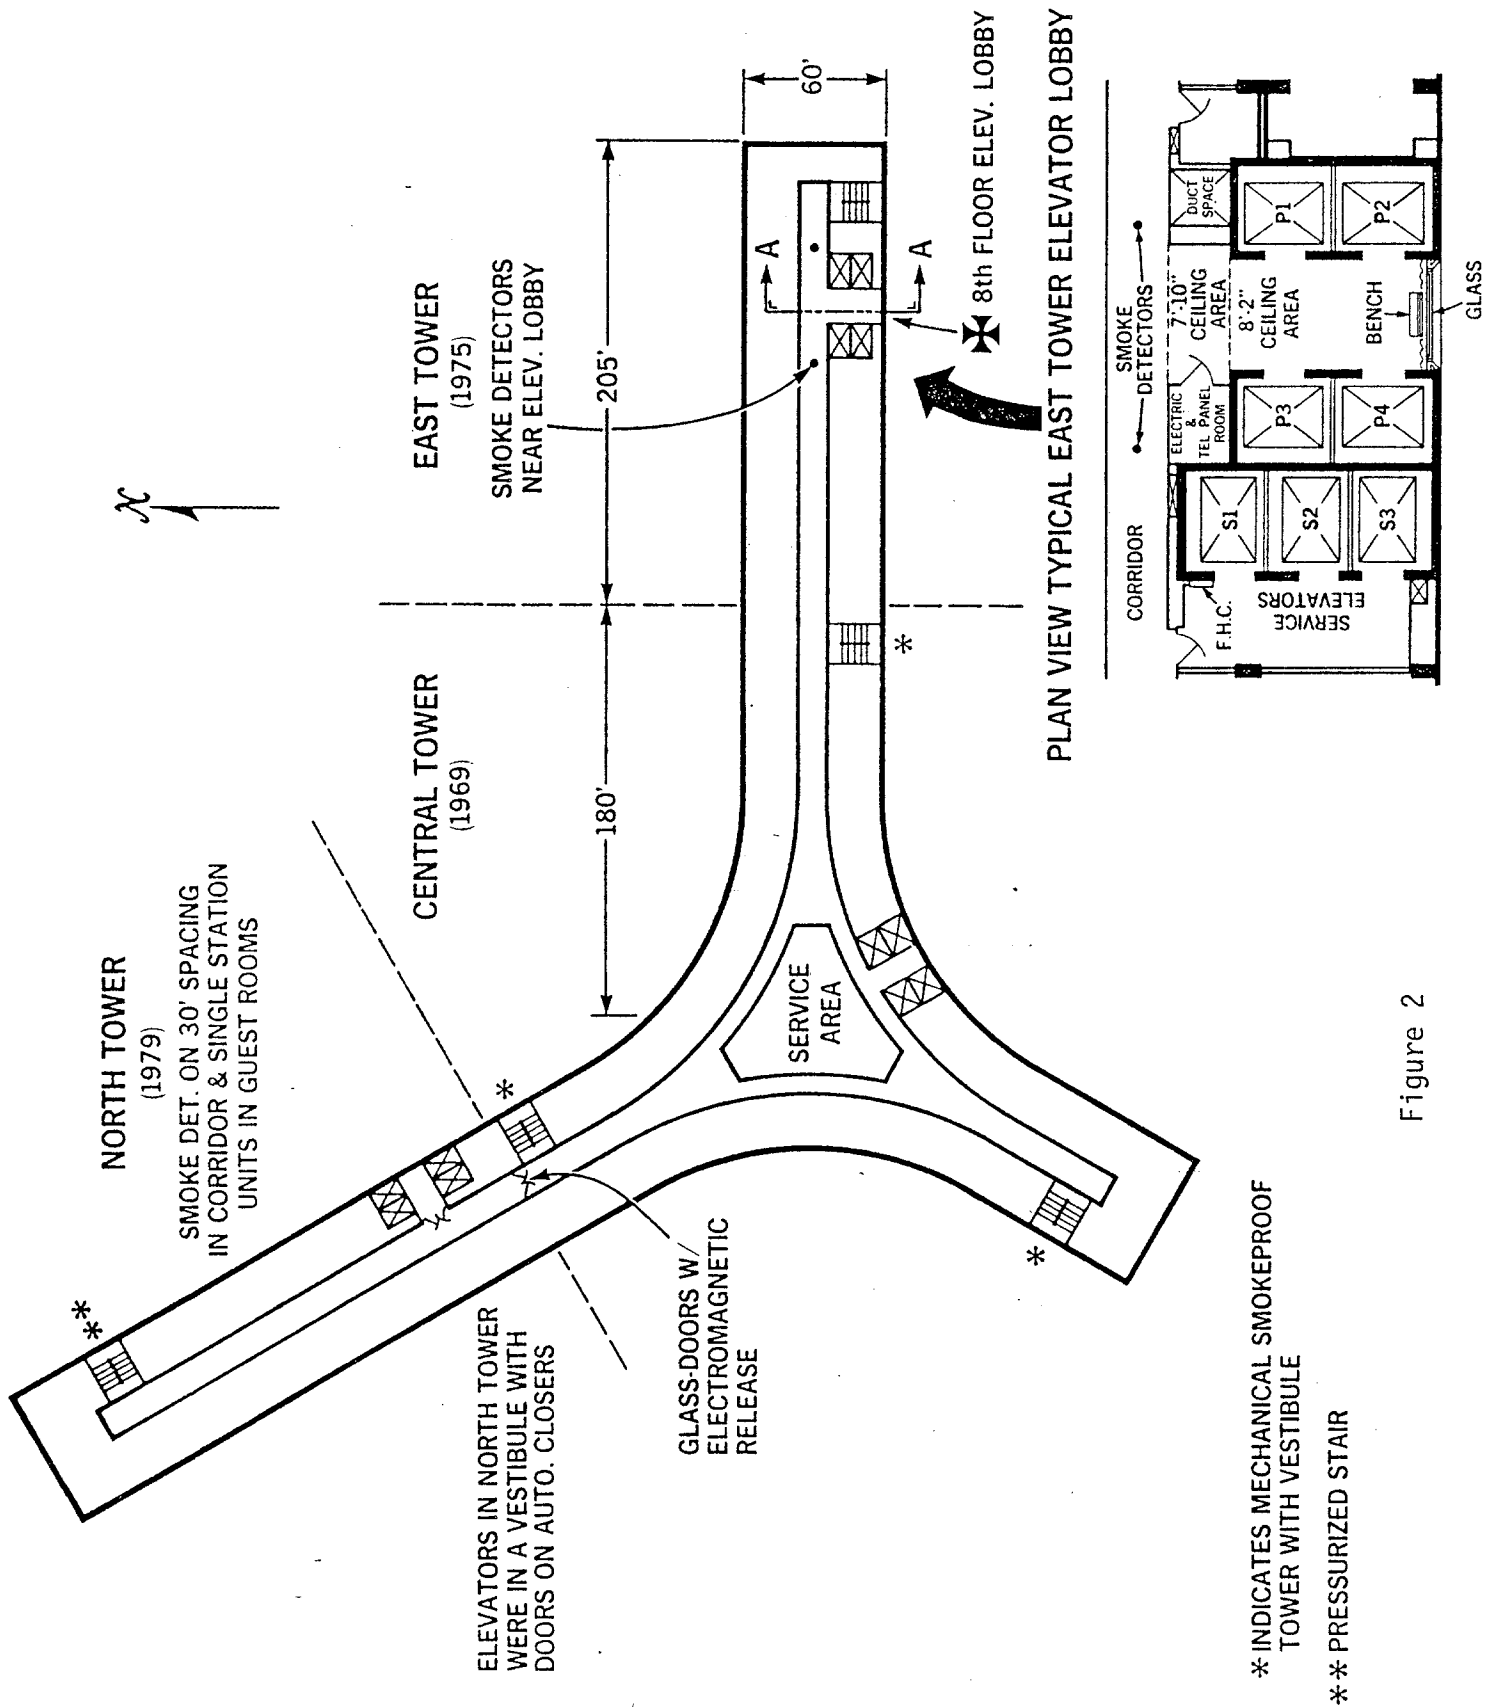
Figure 2

The 30-story building was constructed in three stages. The original Central Tower was started in 1967 and opened in July of 1969. The East Tower opened in 1975 and the North Tower opened in 1979. This resulted in different provisions for fire safety in each of the three towers due to differences in building code requirements, technology, and construction techniques (see Figures 1 and 2).
