# Fire Investigation Summary

## Cruise Ship Fire

**Miami, Florida  
July 20, 1998**

**National Fire Protection Association  
Fire Investigations Department**

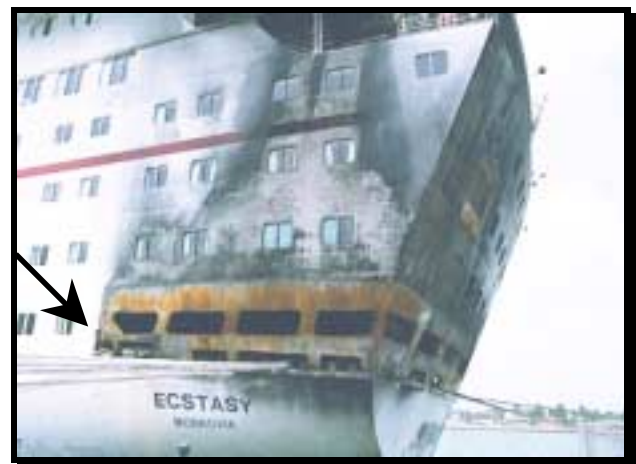
**Photo showing damage on the port side of the ship, outside the mooring deck. The arrow shows the location of the bulkhead where the fire brigade held the fire's spread. (NFPA)**
