HOSPITAL FIRE

St. Jerome, Quebec Canada

January 29, 1989

Summary Investigation Report

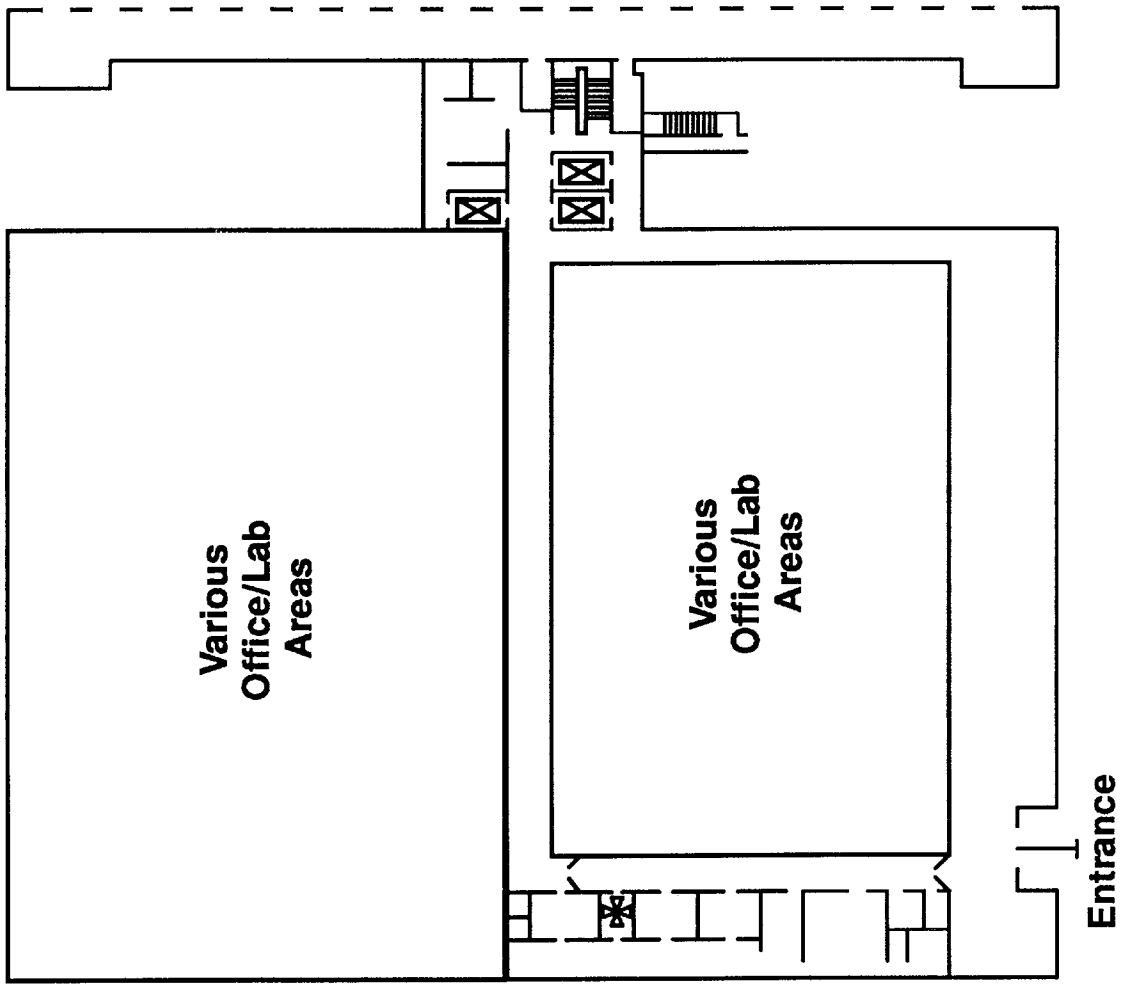
**Figure 2
Emergency Room
Floor Plan**

The fire originated in an isolation room approximately 150 feet from the emergency room entrance along the north-south corridor. Access to the 8 X 10-foot room was gained not only from the public corridor side but also from a nurses' (medical staff) area. The nurses' area was positioned parallel to the public corridor with several observation rooms sandwiched between the areas. This arrangement enabled the medical staff to move along a rear corridor and into treatment rooms for care. The medical area contained medical treatment materials and supplies stored in wooden cabinets or placed on counter space.

Fire damage to the emergency room area was extensive. The fire consumed most of the combustibles in the room of origin and spread to several adjacent observation rooms, also causing extensive damage. Since the doors to the room of fire origin were open, the medical area and the exit corridor also were severely damaged. The north-south corridor had extensive damage along its entire length, as did approximately half of the east-west corridor. Closed smoke doors at the north end on the north-south corridor were effective in preventing fire spread in this direction. Combustibles in the corridor area (mostly mattresses on stretchers totally

Smoke spread in the emergency room area followed a path similar to the fire spread. However, there was some smoke spread into adjacent functional areas, most likely around doors that were closed and by way of HVAC systems open ducts. Smoke was able to move freely through over 400 feet of the exit corridor to the elevator lobby because a smoke barrier door (adjacent to the room of origin) was blocked open. Other smoke barrier doors in the area were closed and were effective.
