**Air Canada Regional Jet Accident
Fredericton, New Brunswick
12/16/1997**

**Presented By:
Captain Brian Boucher
Air Canada**

**Presented at:
The International Forum on Emergency and Risk Management
Singapore Aviation Academy
10-12 January, 2005**

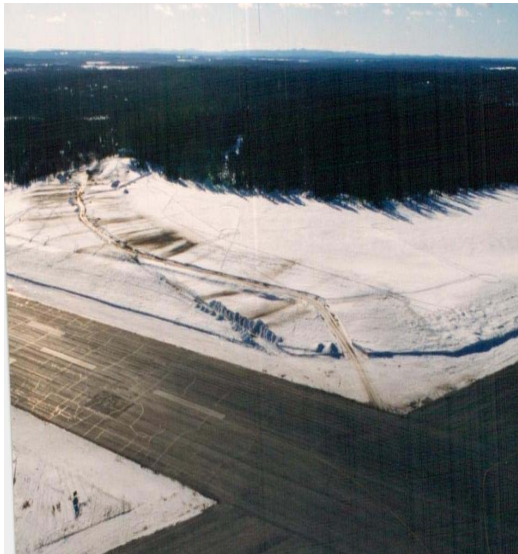
The aircraft struck the ground with its nose, shearing the nose gear off. The right wing slammed the runway with great force ripping the winglet apart. The engines were still at full power with the Captain unable to grasp the thrust lever to idle. The aircraft plowed through the snowy field until it a drainage ditch parallel to and about 70 meters from the runway. The aircraft became slightly airborne continuing in a slight right arc for another 300 meters until it hit a one meter Hemlock tree.

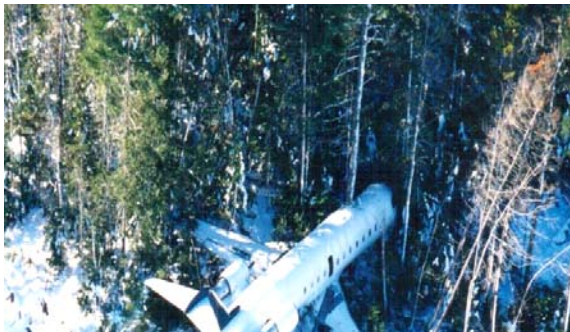
The aircraft remained generally intact with no damage to the empennage. The wings were still attached to the fuselage but there was major damage to the L1 door caused by the Hemlock tree as it entered the fuselage. As the aircraft moved forward, the tree cut through the aircraft cabin nine feet aft of the L1 door. The other damage to the aircraft was the right winglet, which detached just before the aircraft stopped moving. There was heavy damage to the Electrical compartment in the nose area.
