Fire Investigation Summary

**Residential High-Rise
North York, Ontario
January 6, 1995**

Fire Investigation Summary
North York
Residential High-Rise
North York, Ontario
January 6, 1995

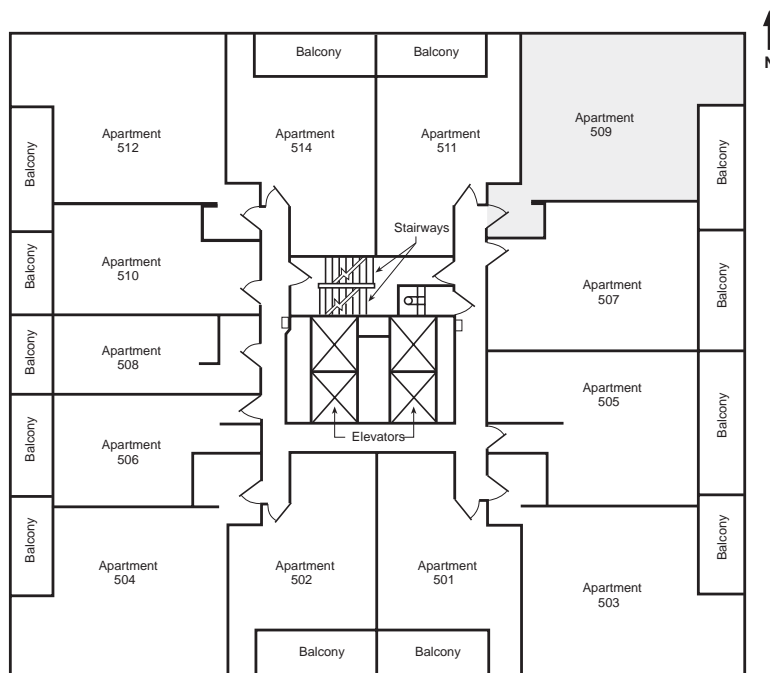
5th FLOOR ARRANGEMENT

After unsuccessfully attempting to extinguish the fire, the occupant in the apartment of fire origin left without closing the dwelling unit door to the corridor. Fire and smoke passed through the open door into the exit access corridor and made that corridor untenable for many fifth-floor residents. The residents who did not escape early in the incident stayed in their apartments until they were rescued by fire fighters. The combination of closed doors and noncombustible walls prevented untenable conditions and deaths from occurring in other fifth-floor apartments.

The door to one of the building's two exit stairways was heavily damaged by the fire, and the door to the other exit stairway was held open by a fire department hoseline used during the fire suppression operations. As a result, smoke entered both stairways. Natural stack effect moved the smoke vertically through the stairways, elevator shafts, and heating, ventilation, and air conditioning ducts. On the upper floors, the smoke passed through open doors and seeped past closed
