The Chicago School Fire

By Chester I. Babcock, Manager and Rexford Wilson, Engineer

NFPA Fire Record Department

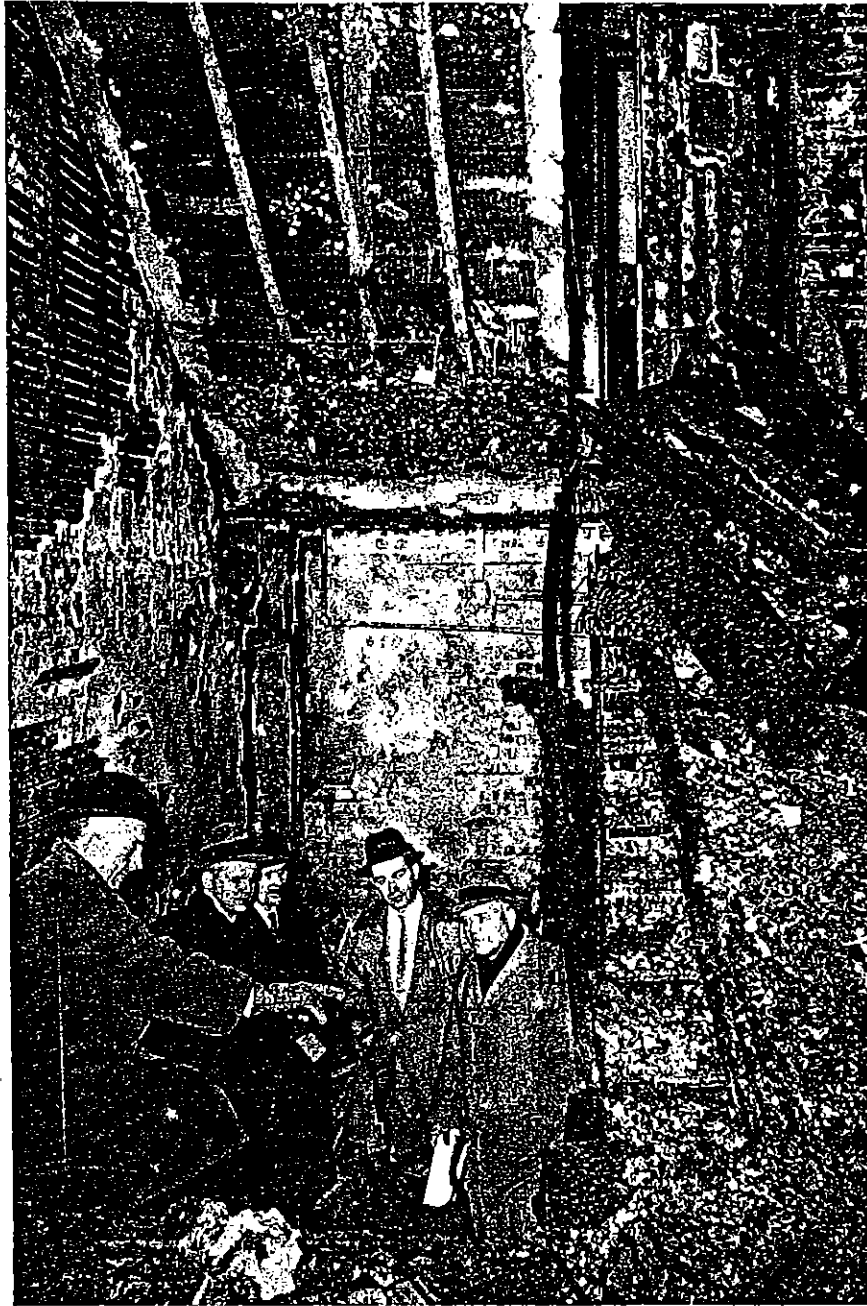
This photo was taken from the grade level landing in the rear stairwell of the north wing. The fire started at the basement level landing where the four men are standing. The window in the left background broke early in fire. Two doorways from basement level are not visible. At the first floor level the Class B fire door that kept fire and smoke out of the first story is seen standing ajar.

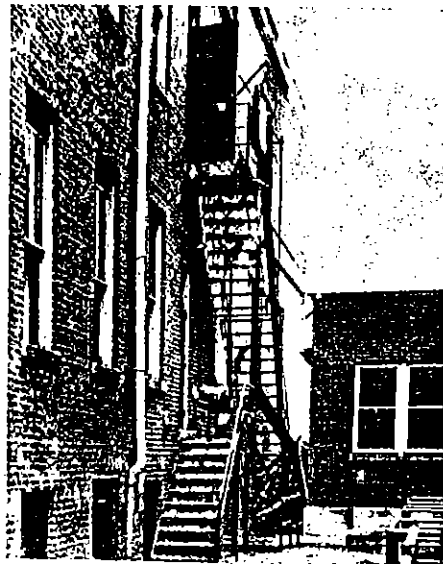
The 40 pupils and their teacher who were in Room 207 escaped down this fire escape.

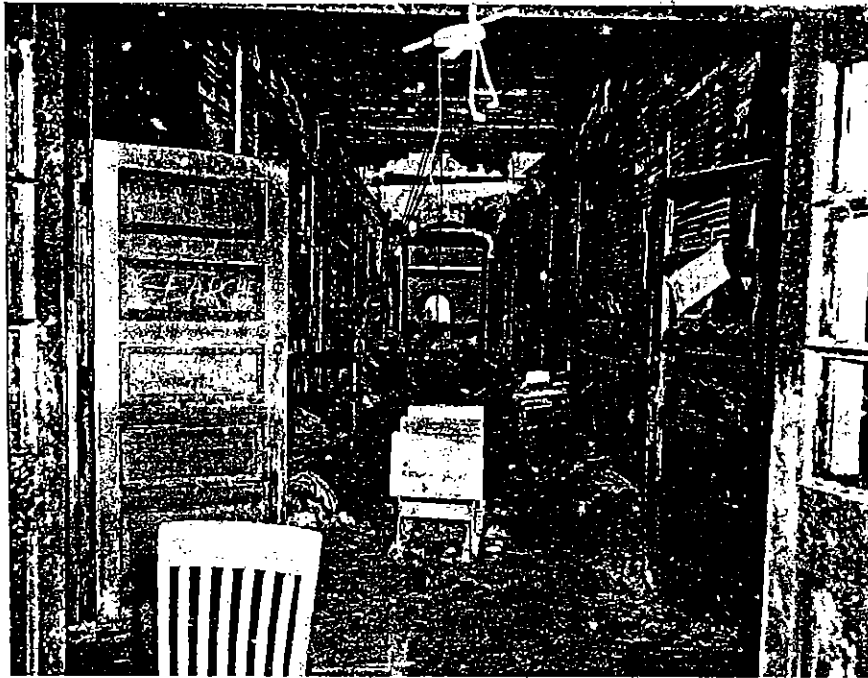
View of second story corridor of north wing, looking from front stairway landing. Fire originated in rear stairway beyond the arch in center background of photo. Door to Room 212 is at left foreground.

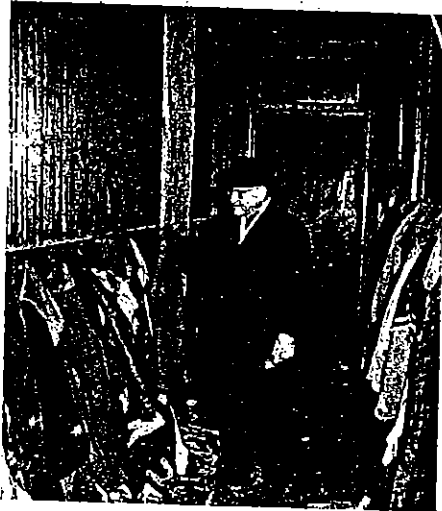
The cloakroom between Rooms 206 and 207 shows the way coats were hung in the main corridor of the north wing at the start of the fire. Note the height of the fire extinguisher to the right of the 7-ft.-high door to the fire escape.

Private fire protection consisted of soda-acid fire extinguishers, standpipe and hose systems and a manually operated building fire alarm signal system. The tops of the 2½-gallon soda-acid extinguishers were eight feet above the corridor floor (maximum recommended height 5 feet). Two standpipes in the north wing were one half inch less in diameter than the 2-inch minimum recommended for buildings of this height, and access to valves and hose racks was difficult because they were six feet above the floor.

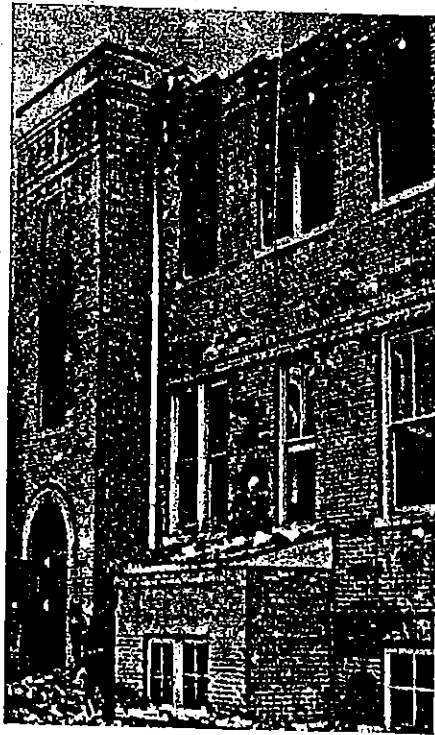
Many occupants escaped from Room 208 in the second story by jumping to the roof over a basement stairway shown just beneath first story windows. The stairway where fire started is at left.

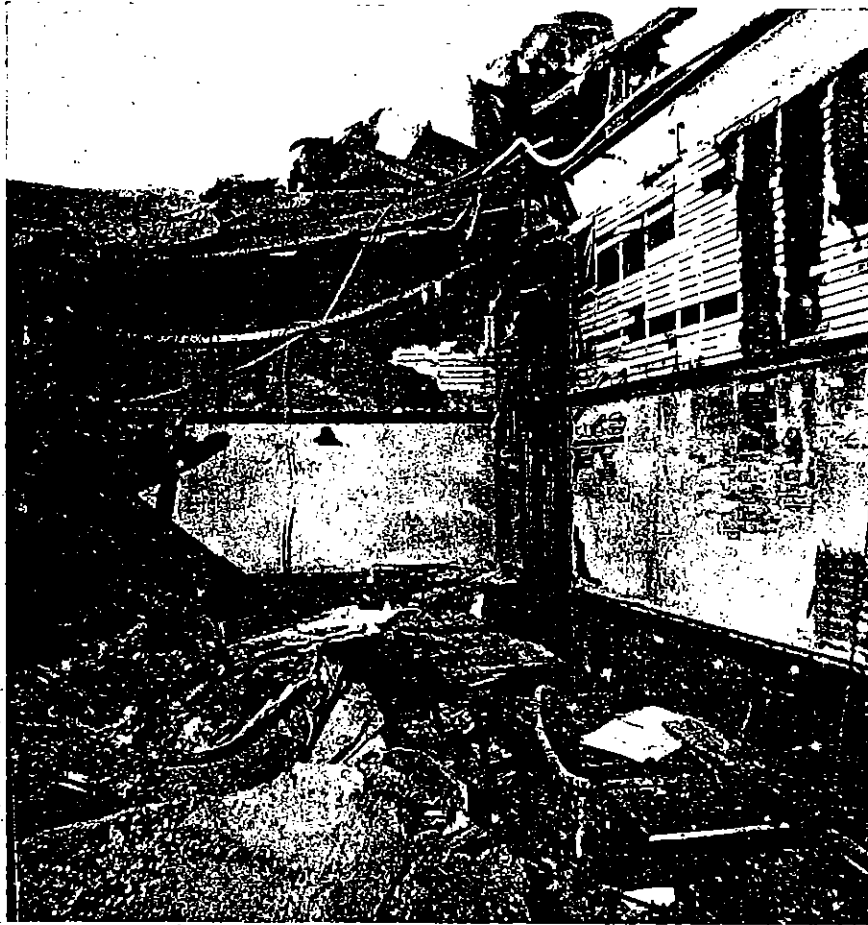
The quick-thinking teacher of Room 209, who took firm control of her class, had much to do with the fact that only one child died in this room. Note the vacant spaces on the walls that had been filled with highly combustible pressed paperboard blackboards.

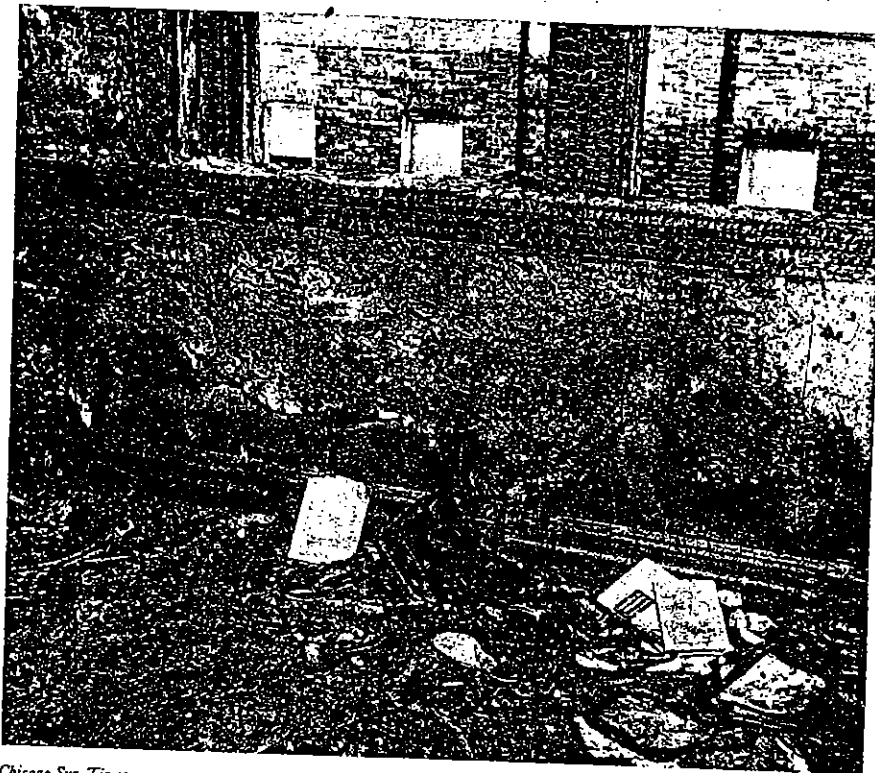
Many of the fourth graders in Room 210 died beneath these double windows. Height of windows above floor $37\frac{1}{2}$ inches.

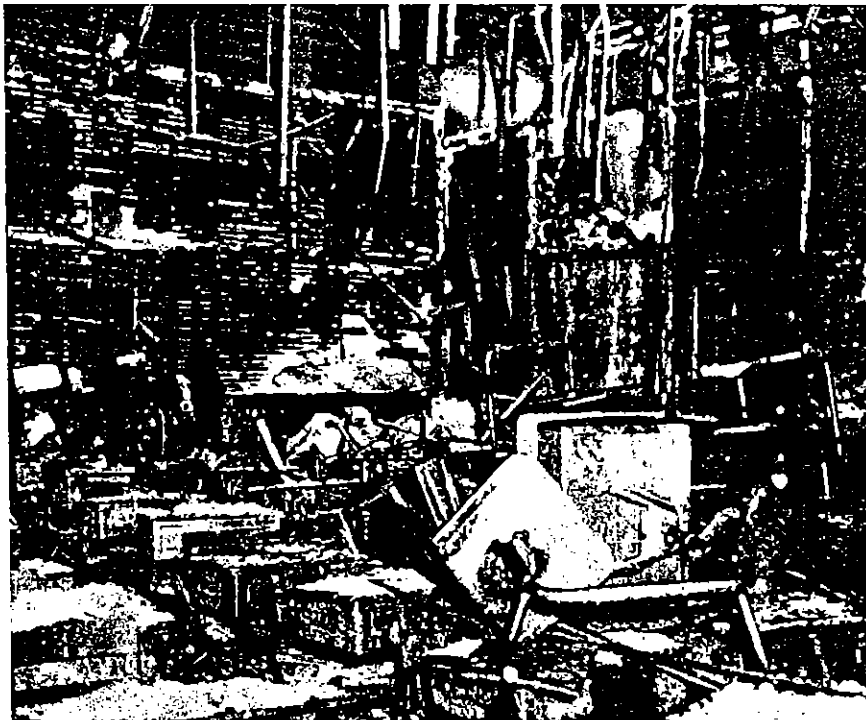
Room 211, remote from the rear stairway had a high casualty list. Note heavy fire damage. Room 212, across the hall, suffered the highest number of casualties but very little fire damage.

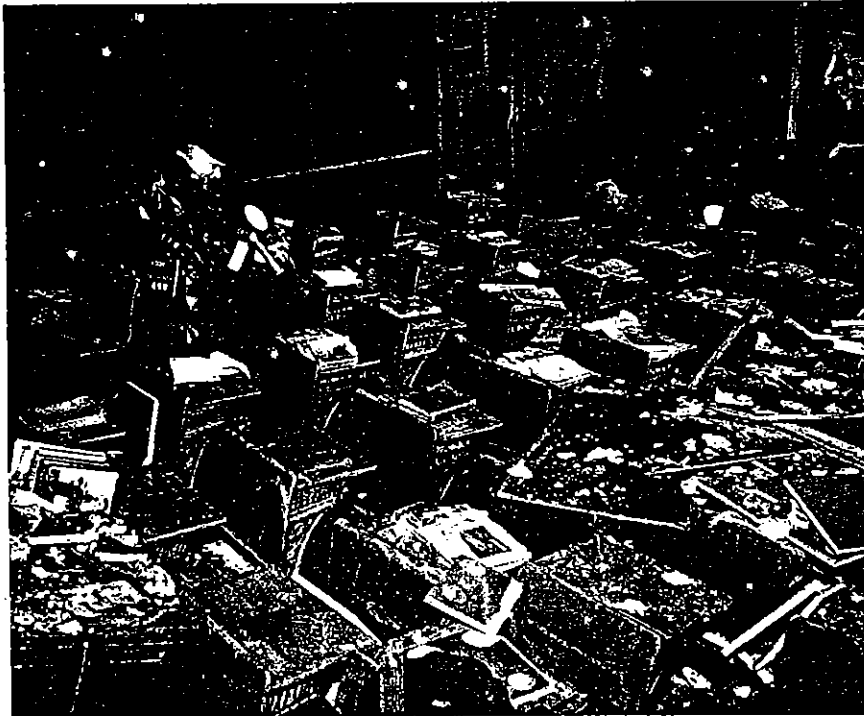
Room 212, located farthest from and least damaged by the fire, sustained the greatest number of casualties. Note the congestion of desks. The heavy smoke conditions are indicated by the dark color of the walls under the blackboards and by smoke-free spots on the desks.

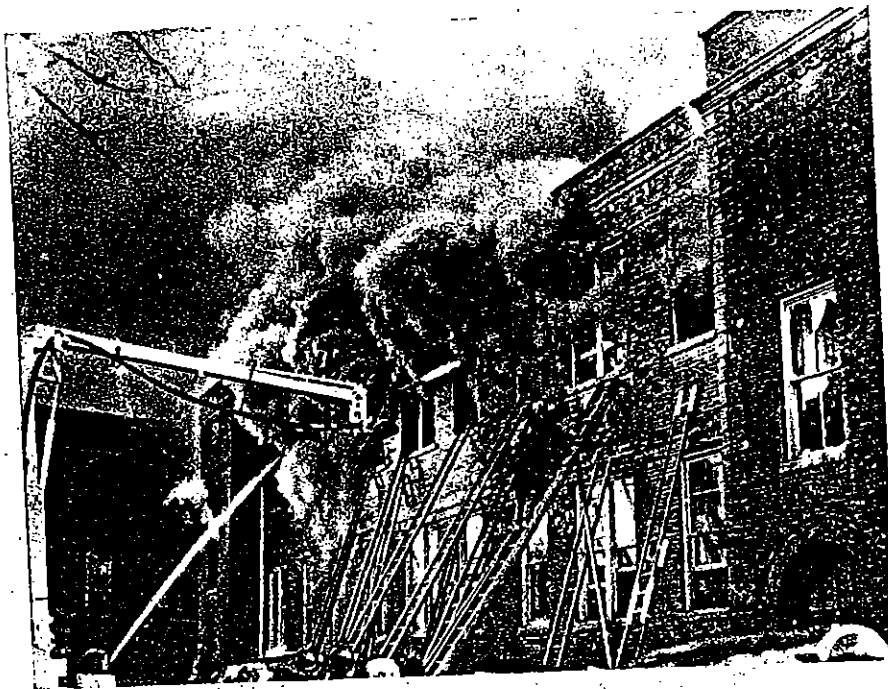
Many children were taken down fire department ladders before they were asphyxiated or burned to death. When this picture was taken those still in the building were dead. A new type of fire department apparatus used experimentally by the Chicago Fire Department and known as the Pitman "giraffe" is shown in use.

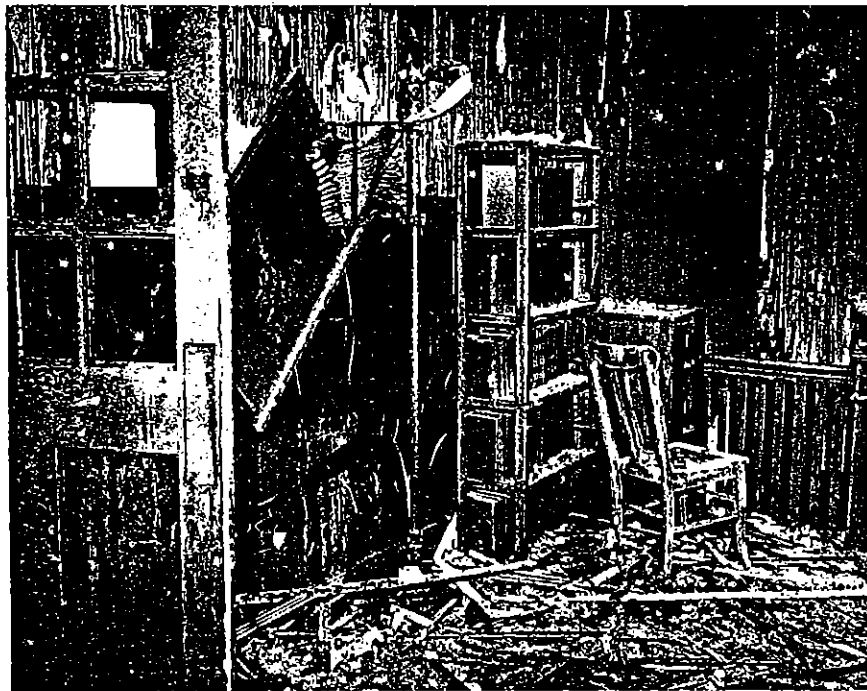
Second story landing at front of north wing. Open door at left was one of two at opening to corridor. There were no doors at other end of corridor.

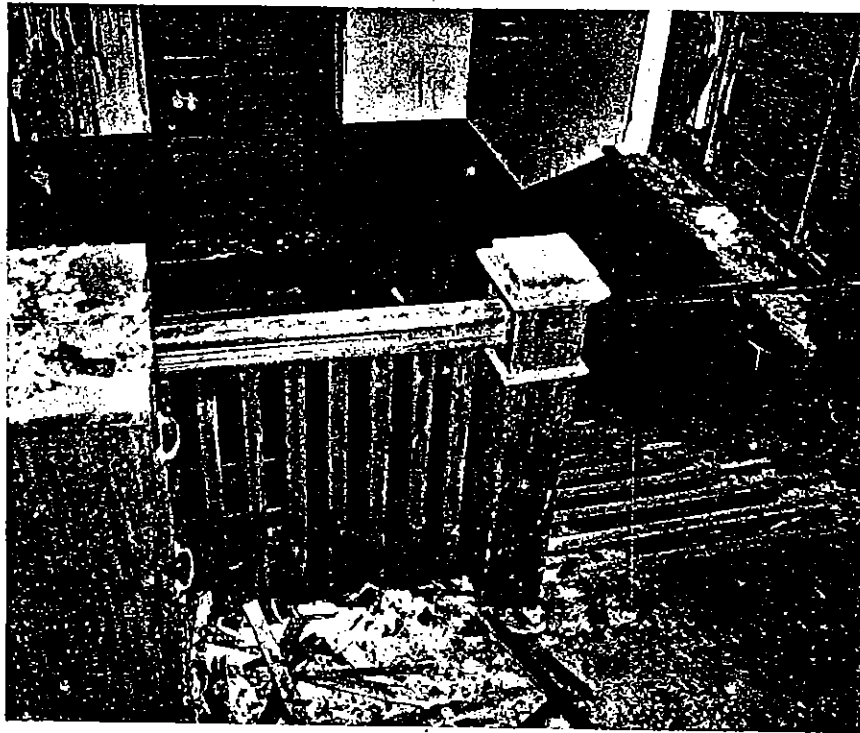
Looking down one of the two front stairways from the second story landing of the north wing. Rear stairway where fire started was similar in construction.
