Fire Investigation Summary

Cruise Ship Fire

**Miami, Florida
July 20, 1998**

**National Fire Protection Association
Fire Investigations Department**

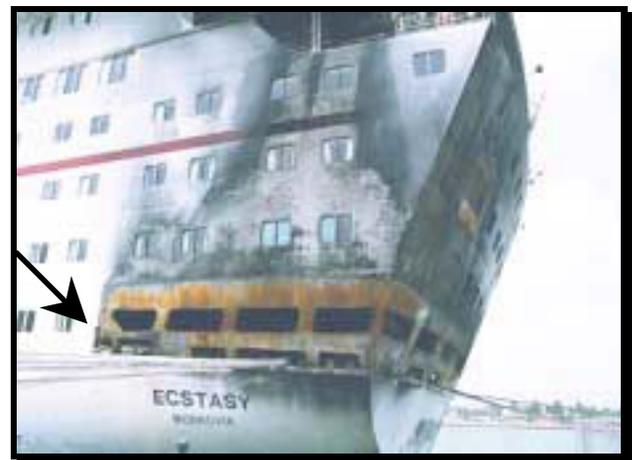
Photo showing damage on the port side of the ship, outside the mooring deck. The arrow shows the location of the bulkhead where the fire brigade held the fire's spread. (NFPA)
