Fire Investigation Summary

Supermarket

Phoenix, Arizona
March 14, 2001

National Fire Protection Association
Fire Investigations Department

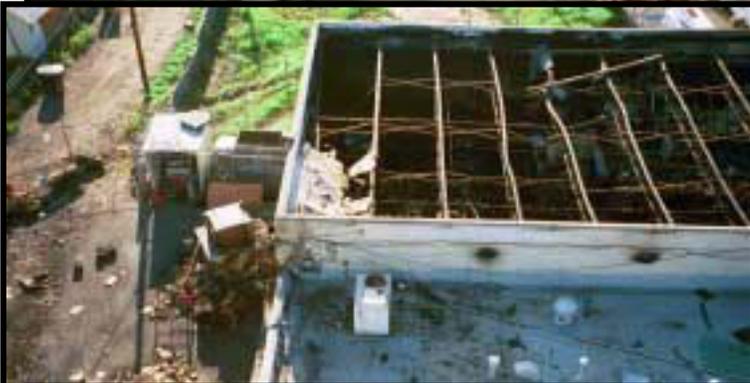
The fire, which began in combustibles stored outside near a loading dock, spread into the rear stock room of the supermarket. The fire fighter was on one of the initial attack hoselines when his air supply began to run low. During his attempts to exit the building he became disoriented and sounded a Mayday call.

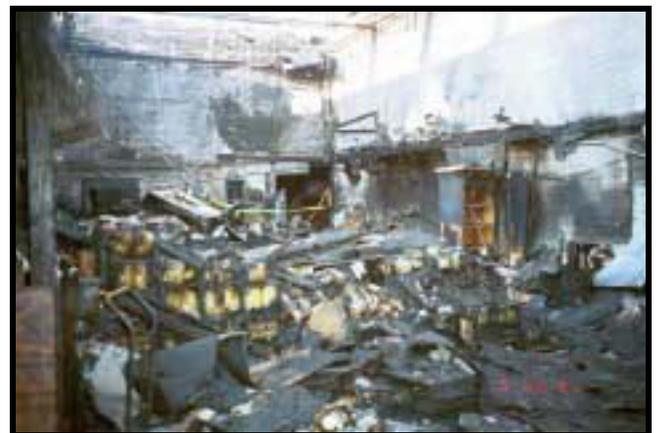
**View of supermarket stock room
(NFPA)**

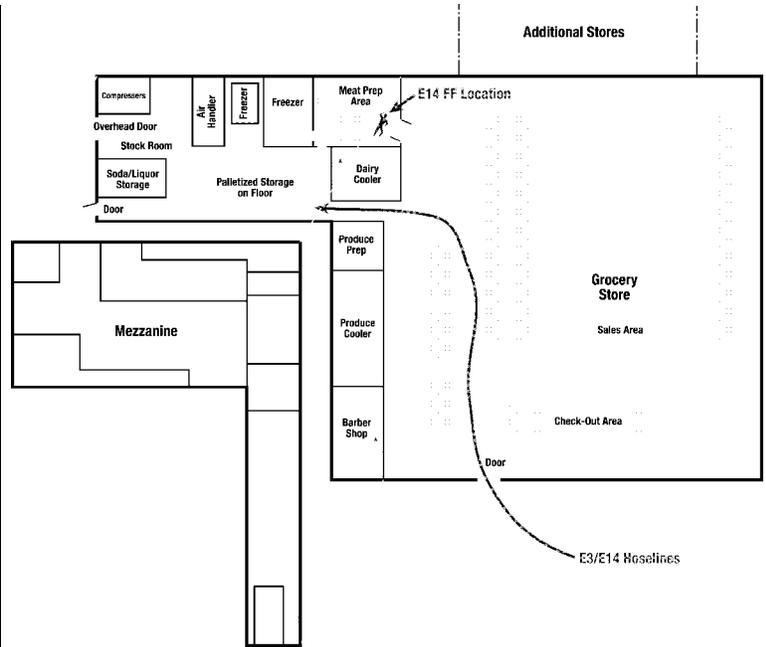
Building Layout/FF Location

Several Rapid Intervention Crews (RICs) were sent to search for the remaining missing fire fighter, as conditions within the store worsened. Eventually the missing fire fighter was located, unconscious in the meat preparation portion of the store. Removal of the fire fighter was difficult due to his size and the obstructions located in the storage room and in the path to the exit. His removal required several additional crews. He was eventually removed through the storage room in the southeast corner of the store. He was transported to the hospital where he was pronounced dead.
