# Fire Investigation Summary

## Church Fire

Lake Worth, Texas

February 15, 1999

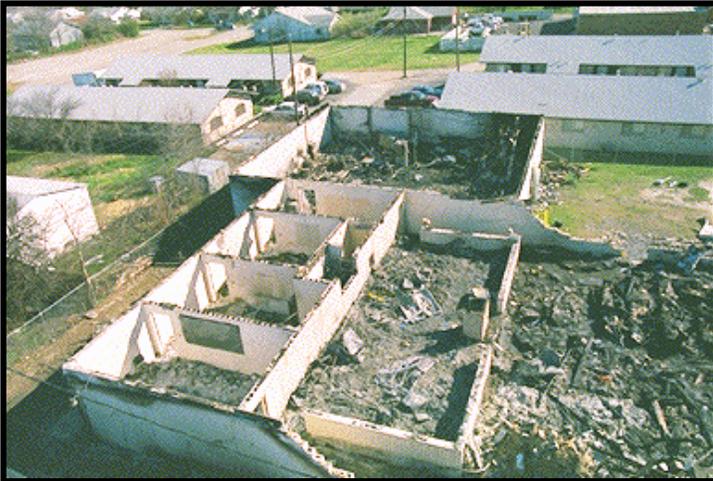
A fire in a single-story church building resulted in the deaths of three fire fighters after a collapse of the truss roof system.

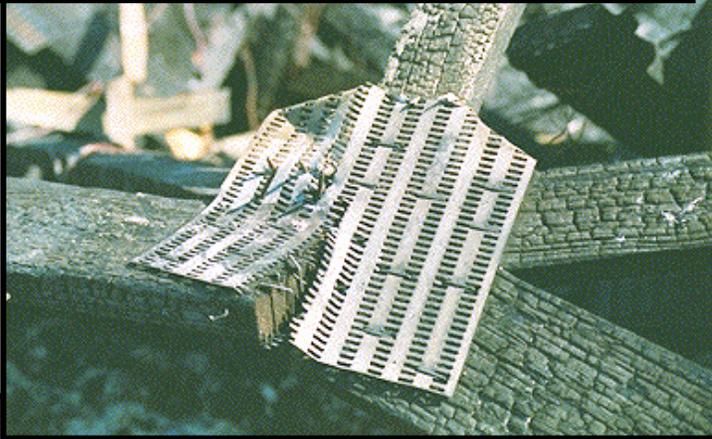
The fire began in an adjacent storage shed and spread rapidly, driven by the wind, into the attic space of the church. The fire continued to spread rapidly through the concealed attic space.

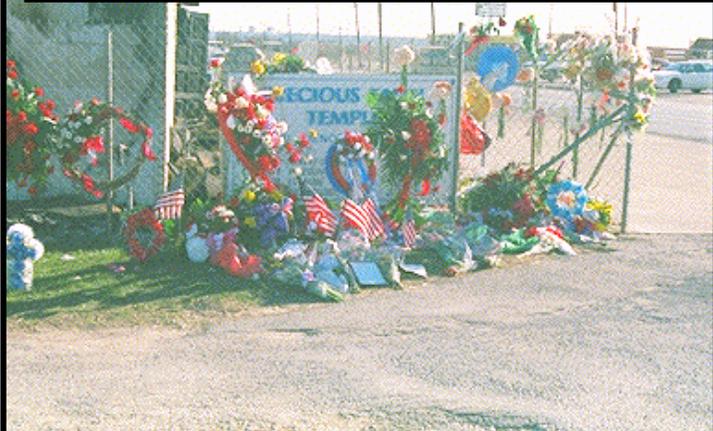
While fire fighters simultaneously battled the fire from within the church and ventilated the attic space from above, the roof system collapsed. The sudden collapse trapped five fire fighters inside the building. The four fire fighters on the roof narrowly escaped.

Rescue attempts successfully removed two fire fighters from the building before conditions precluded any further attempts.
