## The London, Texas, School Disaster.

By H. Oram Smith,  
Texas Inspection Bureau.  
(Member N.F.P.A.)

A gas explosion that caused the death of 294 school children and teachers, resulting in one of the major disasters of the present century, occurred in the East Texas oil field district about 3:15 P.M. on March 18, 1937. The site of the explosion was the unincorporated community of London, about four miles east of the little town of Overton in the northwest corner of Rusk County, ten miles from Henderson, Texas. The community consists principally of the school property of the London Independent School District, Inc., comprising the large high school building, several smaller buildings and seven active oil wells owned by the school district. Beyond the school property on all sides were oil well derricks, gas flares, and a distant refinery, all typical of the oil field industry. Because of the wells on its property it had the unique distinction of being about the wealthiest rural school district in the world, catering largely to families of the oil field workers over a territory as much as 15 miles distant in several directions.

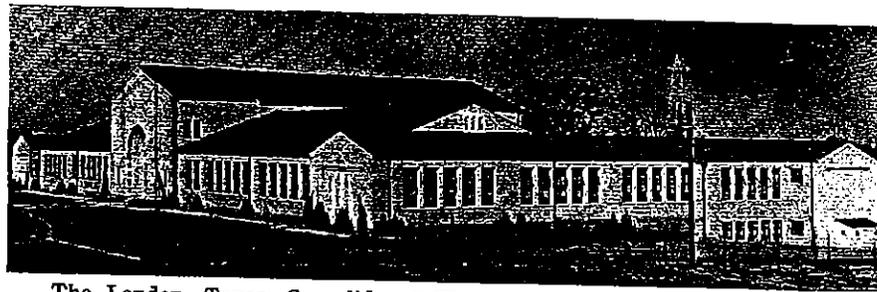
The London, Texas, Consolidated High School was a building of modern construction. This picture is taken from the southwest.

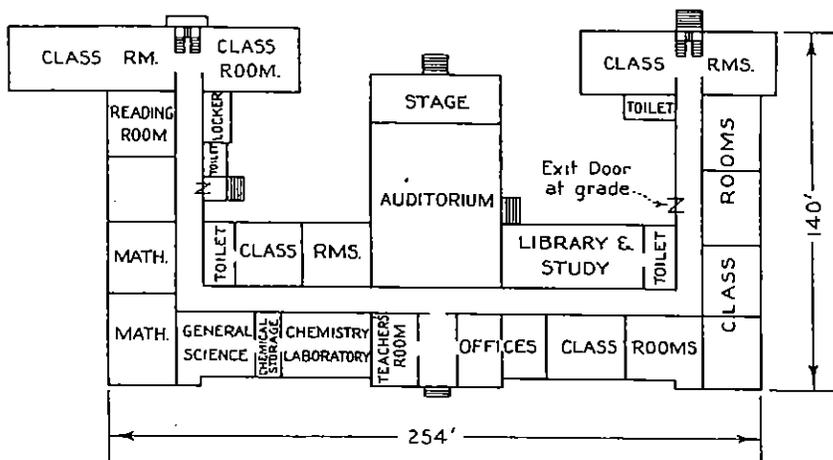
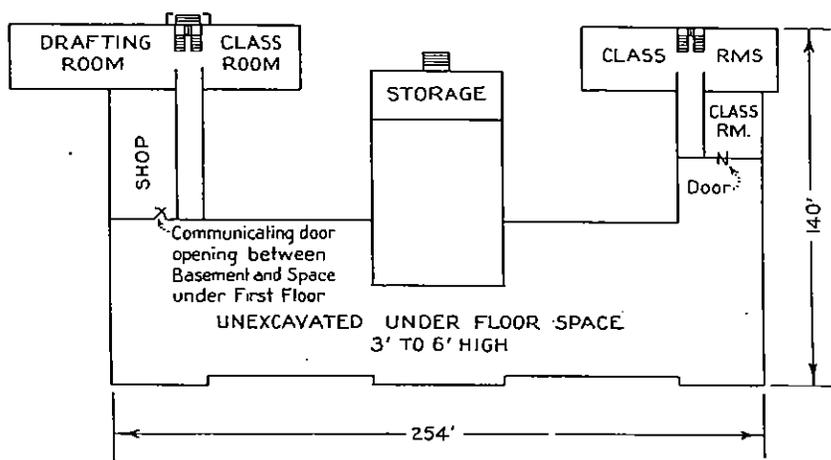
Plan of the London High School Building.

rooms of both the north and south wings. The depth of this space varied from two or three feet to as much as six feet at some points. A conservative estimate of three-foot average depth means about 46,000 cu. ft. of dead space for which only four small 12 by 24-in. vents were provided. Two of these vents were at the north and south ends, 254 ft. apart, and two on the east wall where the distance and angle to the opposite ends could not give proper circulation.

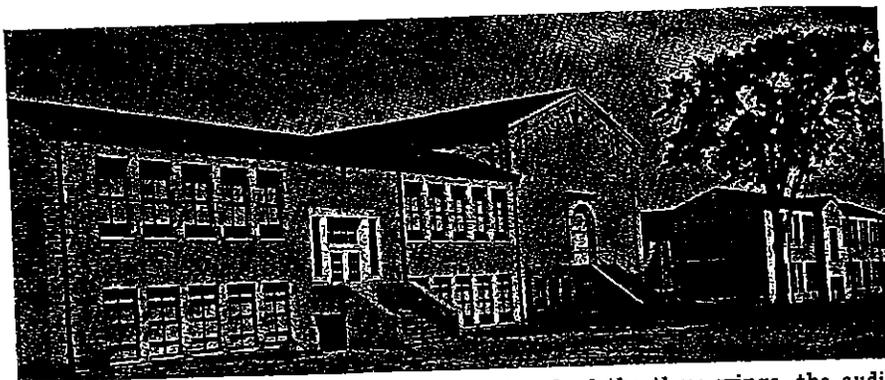
The rear of the school, showing the east end of the three wings, the auditorium in the center. Owing to the slope of the ground, the building was two stories at this end.

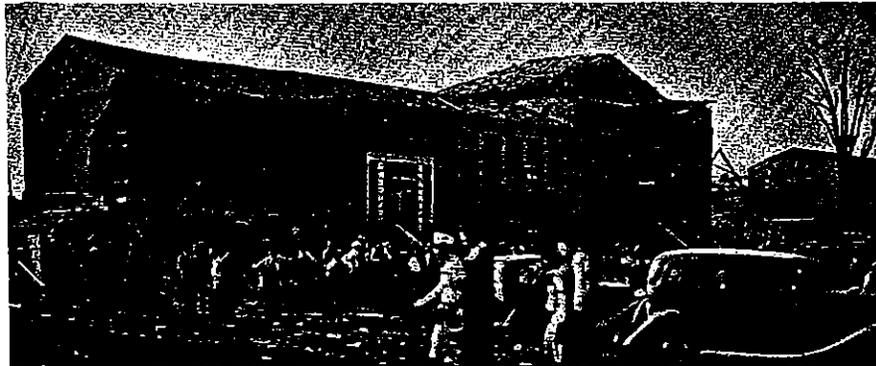
The rear of the auditorium and south wing immediately after the explosion, before removal of wreckage had started. This picture is taken from the east, showing the damage on the side away from the main force of the explosion.
