# Marine Field Service Newsletter

Spring Edition  
April 2011

### WRONG DIRECTIONS: A RECIPE FOR FAILURE

### SIMPLE FAILURES RENDER CO2 SYSTEM INOPERATIVE

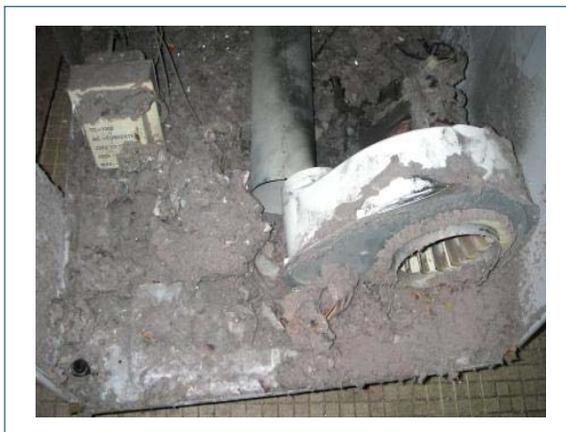
During a routine inspection of dryers in a ship's laundry room a large amount of lint was discovered inside one of the dryers. Further investigation revealed the dryer vent pipe had become disconnected on the inside of the machine as shown in the photograph. Excessive lint accumulation is also noticeable.

*Disconnected vent pipe & lint accumulation inside dryer.  
Photo provided by J. Doran, NSC Marine Section WTG.*

- Do not use the dryer without a lint filter.
- Make sure you clean the lint filter before or after each load of laundry. Remove lint that has collected around the drum.

- Rigid or flexible metal venting material should be used to sustain proper air flow and drying time.
- Make sure the air exhaust vent pipe is not restricted

- At least once a year, or more often if you notice that it is taking longer than normal for your clothes to dry, clean lint out of the vent pipe or have a dryer lint removal service do it for you.

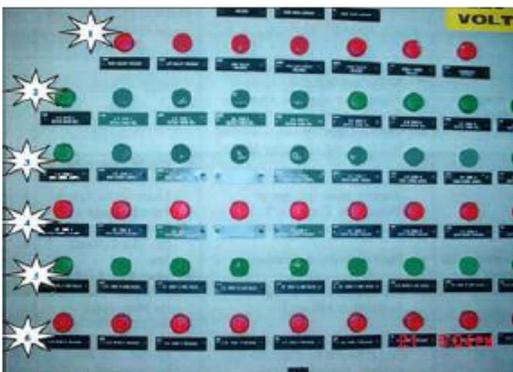
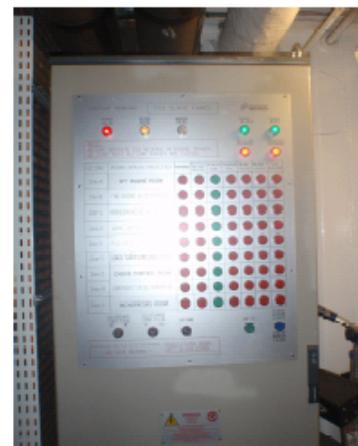
- Shipyard commissioning test procedures appear to differ from procedures documented in the vessel's Firefighting Instruction Manual (FIM). Commissioning procedures indicate that the discharge line selection to a specific protected zone should be made prior to releasing the gas contrary to the directions in the FIM.
- The FIM refers extensively to a Control Panel (left following image) that differs vastly from the one onboard the vessel (right following image).

- Ensure that all supporting documentation, piping schematics, plans, manuals, component labeling and instructions are consistent with each other and relevant to the systems, equipment, and components installed onboard the vessel.

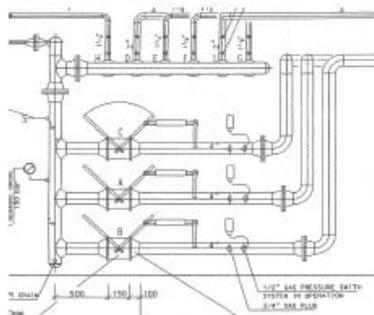
- Shipyard piping schematics and drawings do not appear to match the actual installation. The schematic at the right shows the "A valve" for the Aft Machinery Space in the center position vice the bottom position as it is installed on the vessel.

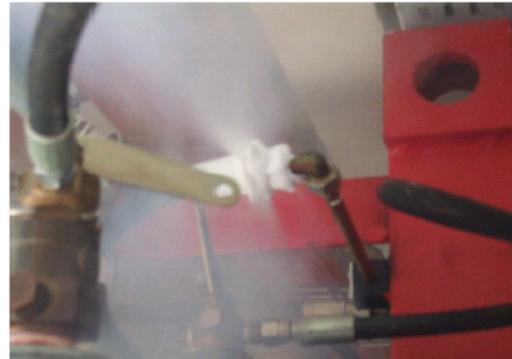
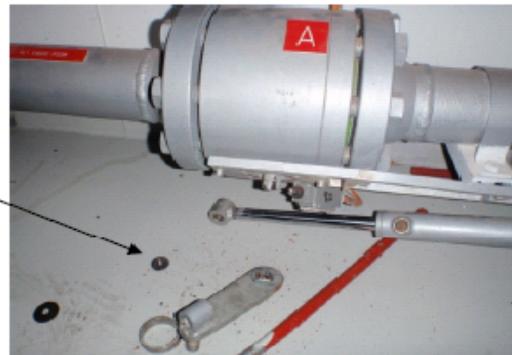
- Numerous piping and hose connections leaked extensively. When the system was activated, on scene video taken by the firefighters showed numerous leakages into the CO2 room. Post casualty, while pressure was still on the system, some of these leaks continued even after the connections were tightened. (Photograph at right.)
- The zone valve for the aft machinery space which admits CO2 from the bottle bank manifold to the space failed. Specifically, the ball valve's opening actuating arm fell off the valve when the gas powered piston actuator attempted to move it. The ball valve actuating arm was held in place by a very small machine screw and washer. When firefighters attempted to open the valve manually using the provided hardware it could not be moved. The valve was only able to be moved after the gas pressure was relieved from the inlet side of the valve. (Photograph at right.)

- Carefully and critically review, routinely inspect and maintain, verify and test their Fixed Fire Fighting installations to ensure that they will operate correctly during an emergency.

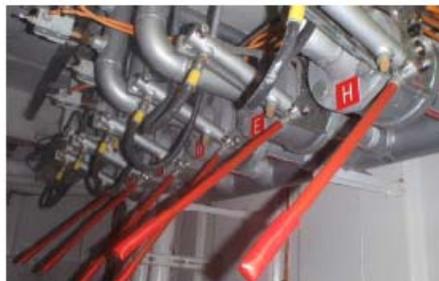
- Actuating arms to five of the six other zone valves were found loose. They were also attached by small machine screws. (Photograph at right.)

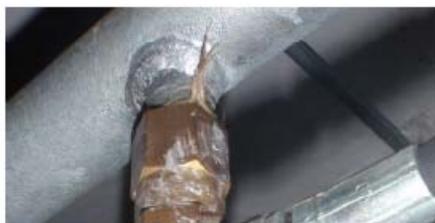
- Hemp type pipe sealant was used extensively on pipe threads throughout the system and in some instances seems to have entered the system. (Photograph at right.)

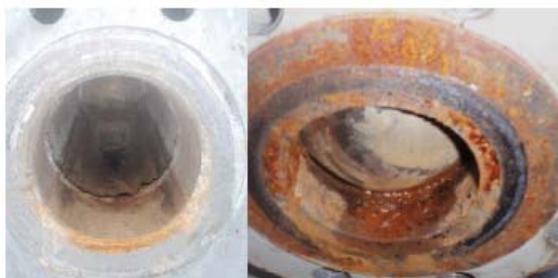
- Certain elements of the distribution manifold contained low points which allowed the accumulation of water within piping that could not be drained. Such a circumstance could cause corrosion that could possibly negatively effect operation of other components. (Photographs at right.)
