INVESTIGATION REPORT

HOTEL FIRE
GREECE, NEW YORK
TEN FATALITIES
NOVEMBER 26, 1978

DAVID P. DEMERS
FIRE ANALYSIS SPECIALIST
FIRE INVESTIGATIONS DEPARTMENT

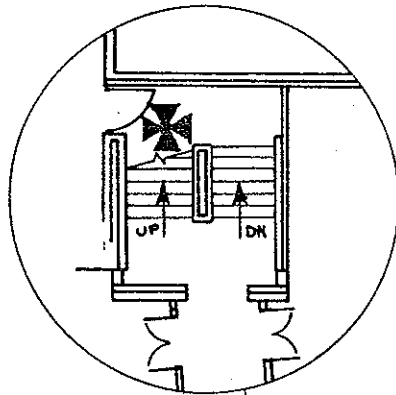
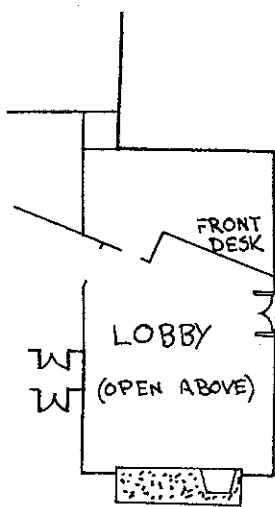
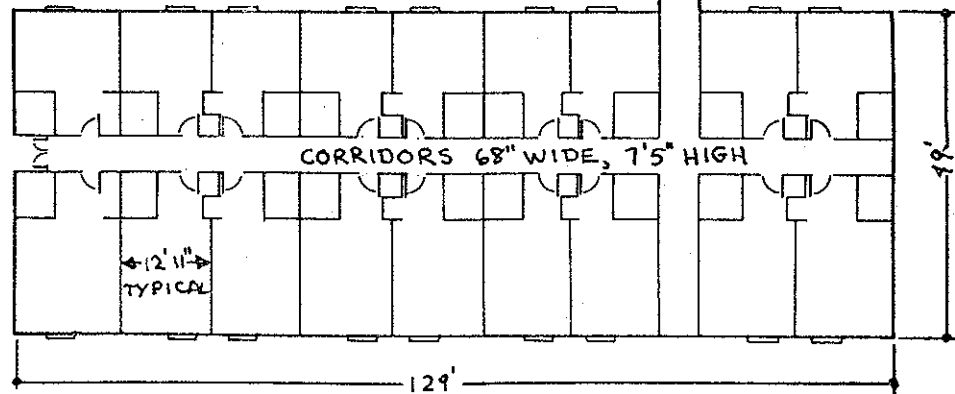
FIRST FLOOR		FIG. 2
	DATE	DRAWN BY	
	2-12-79	DWD

FIRST FLOOR OF WEST WING
AT HIGHER ELEVATION THAN
FIRST FLOOR OF NORTH WING

COMBUSTIBLE
CLOSET ON GROUND
FLOOR UNDER STAIRS

APPROXIMATE AREA OF
ORIGIN ON GROUND FLOOR

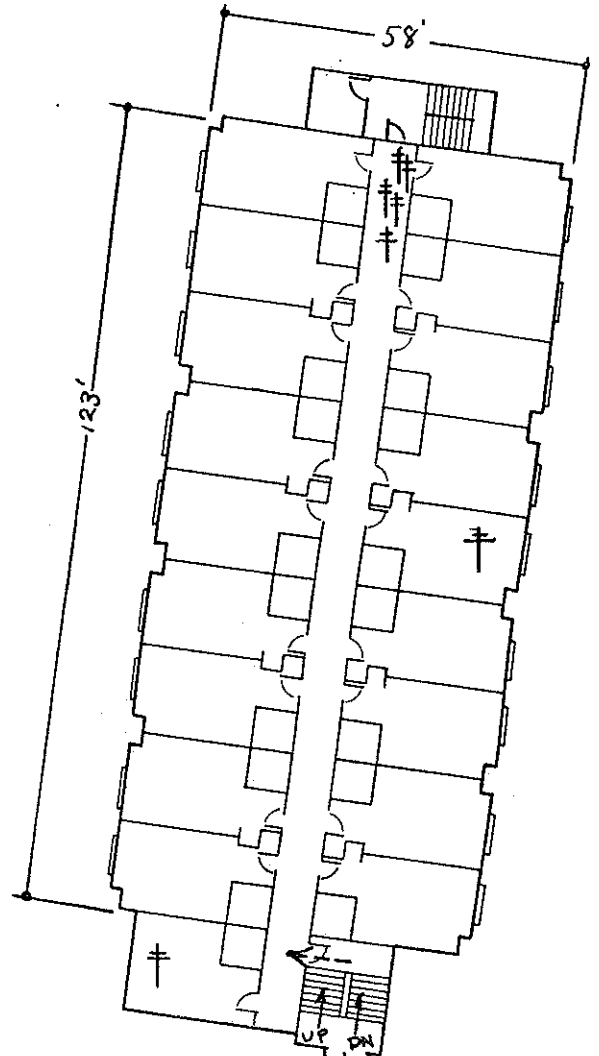
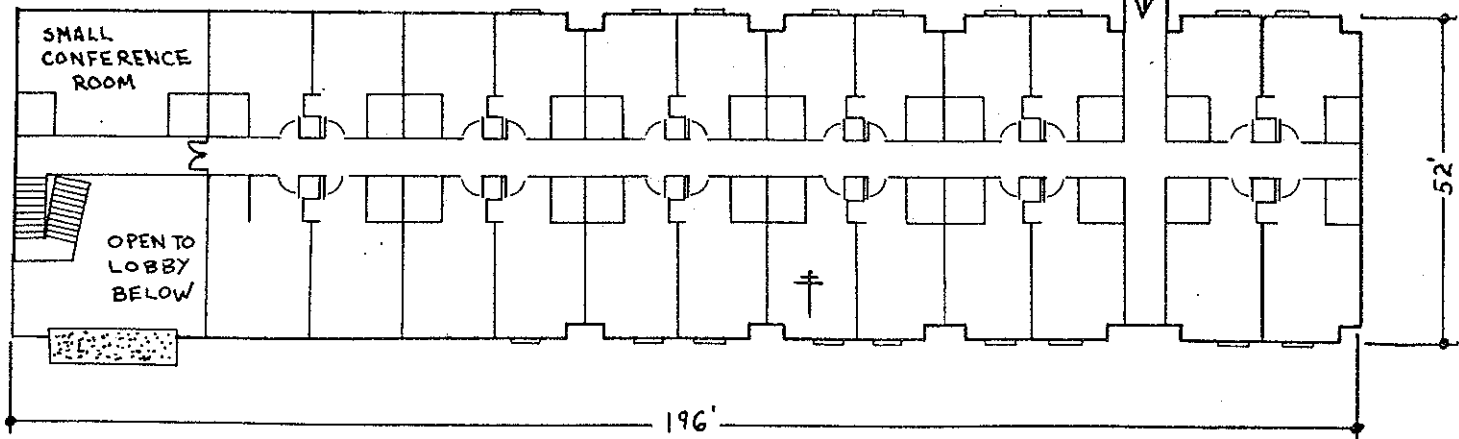
SECOND FLR.		FIG. 3
	DATE 2-12-79	DRAWN BY DWD

† FATALITIES, 2 WERE DOA
AND CAME FROM UNKNOWN
LOCATIONS
10 FATALITIES TOTAL

--> INITIAL FIRE SPREAD
OUT OF CENTRAL STAIRWAY

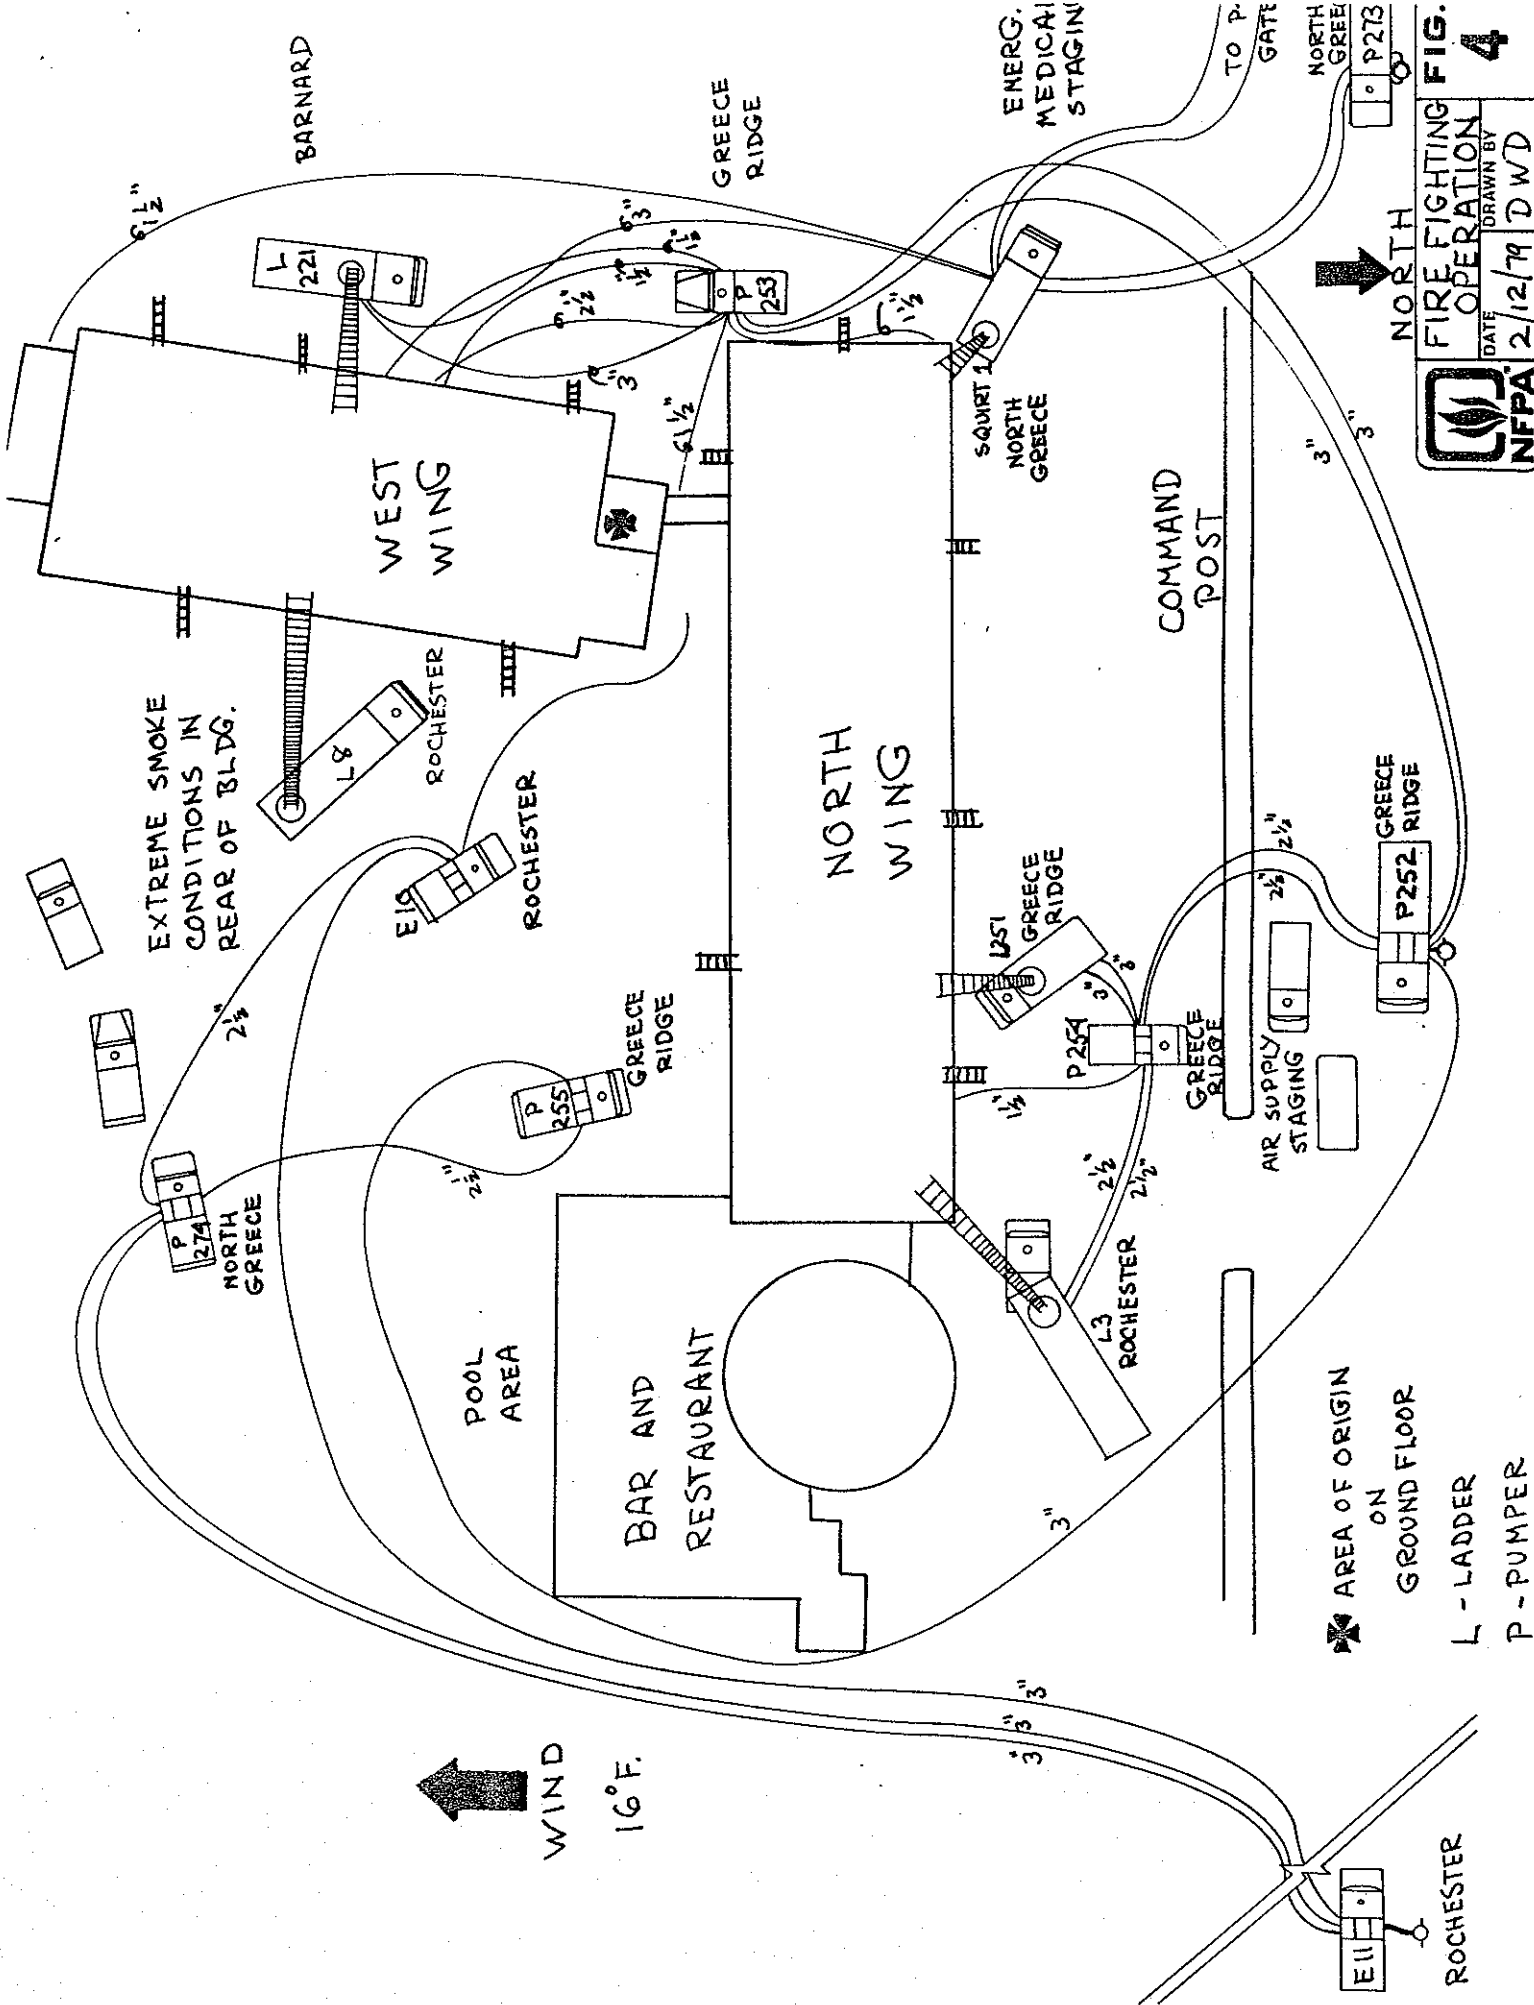
FIG. 4

FIRE FIGHTING OPERATION

★ AREA OF ORIGIN ON GROUND FLOOR
