**HOTEL FIRE**  
Las Vegas, NV  
February 10, 1981

**Fire Investigation Report**

**Hotel Fire  
Las Vegas, Nevada  
Eight Fatalities  
February 10, 1981**

**David P. Demers, P.E.,  
Consultant to  
NFPA Fire Investigations Department**

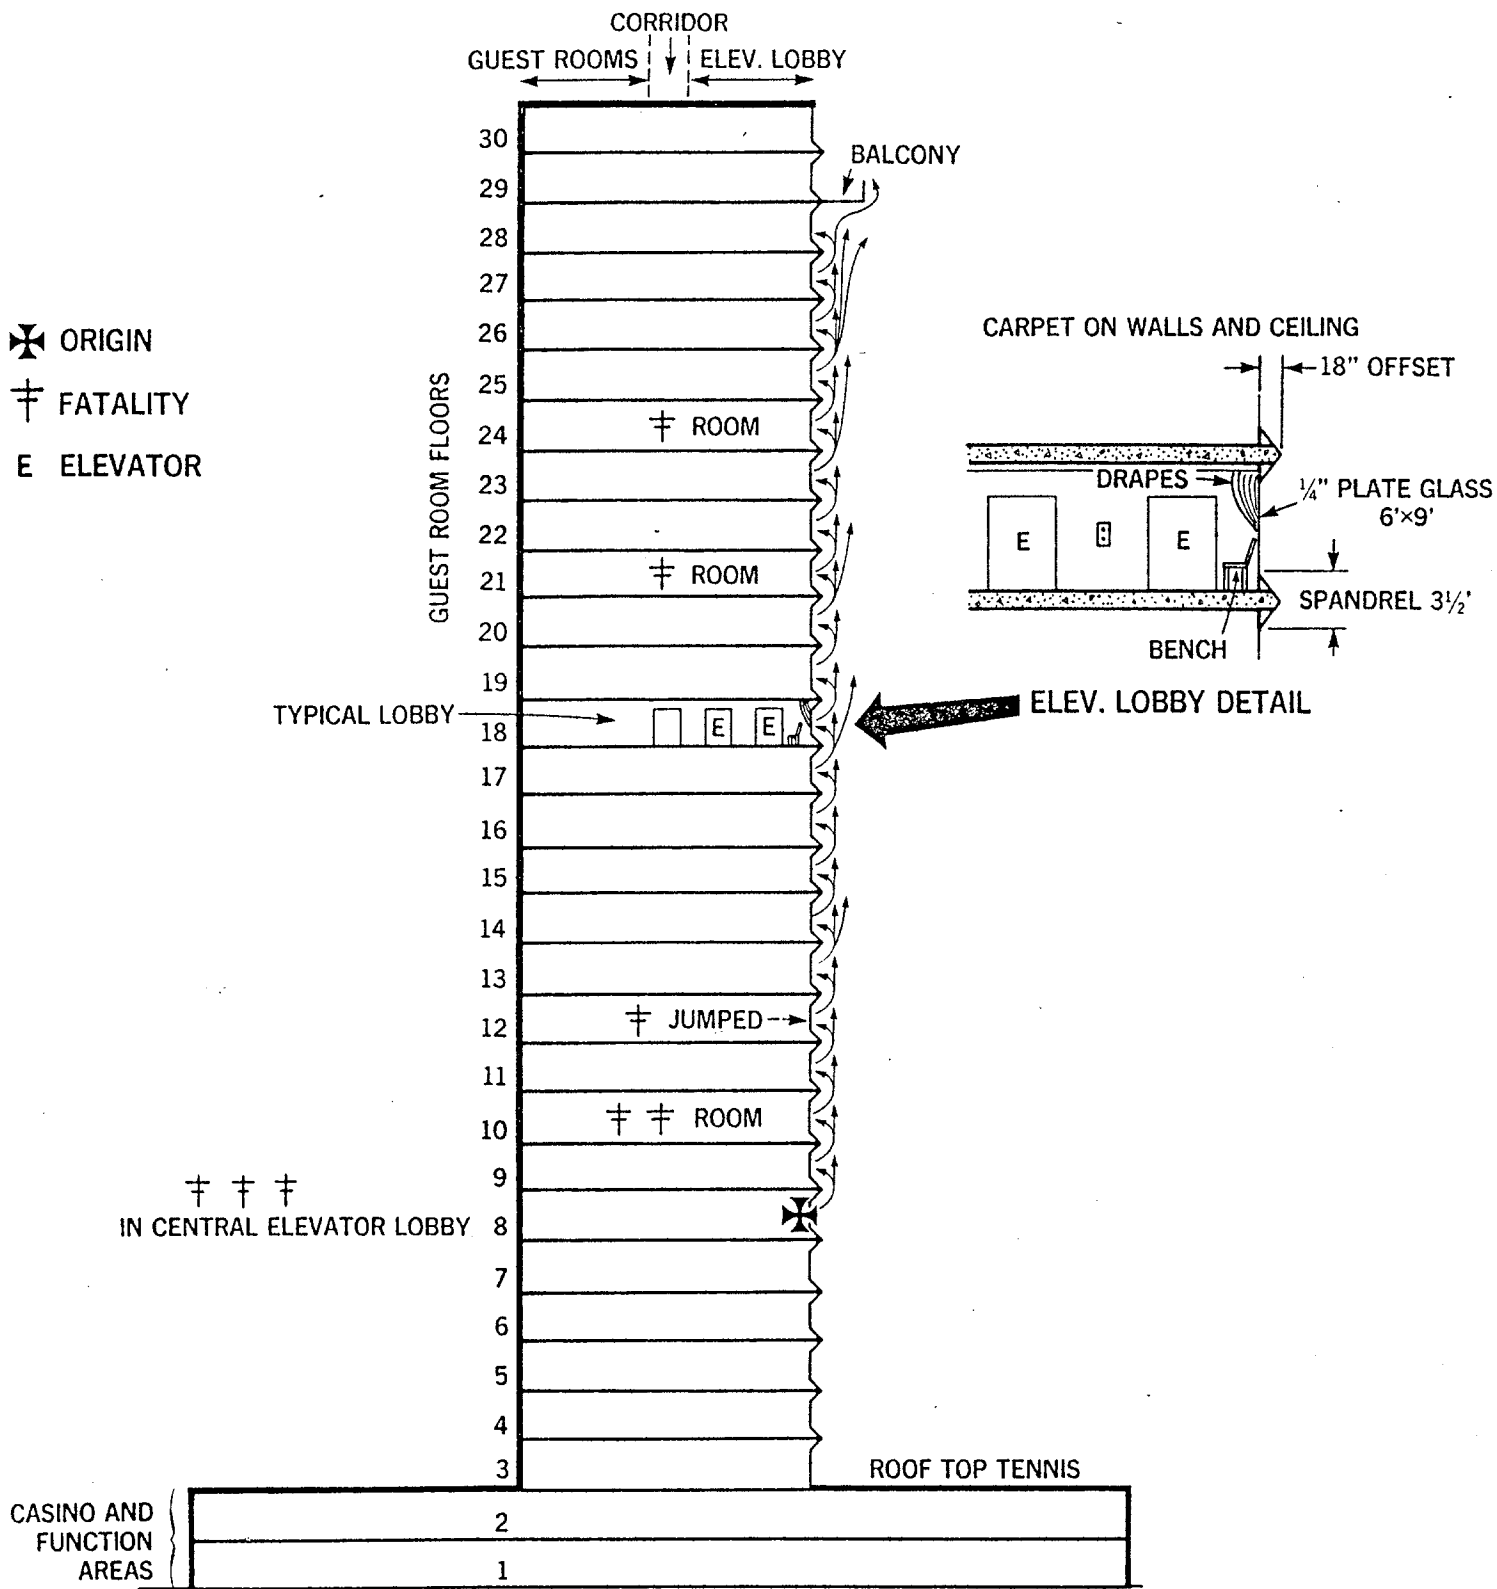
Figure 1

SECTION A-A OF EAST TOWER

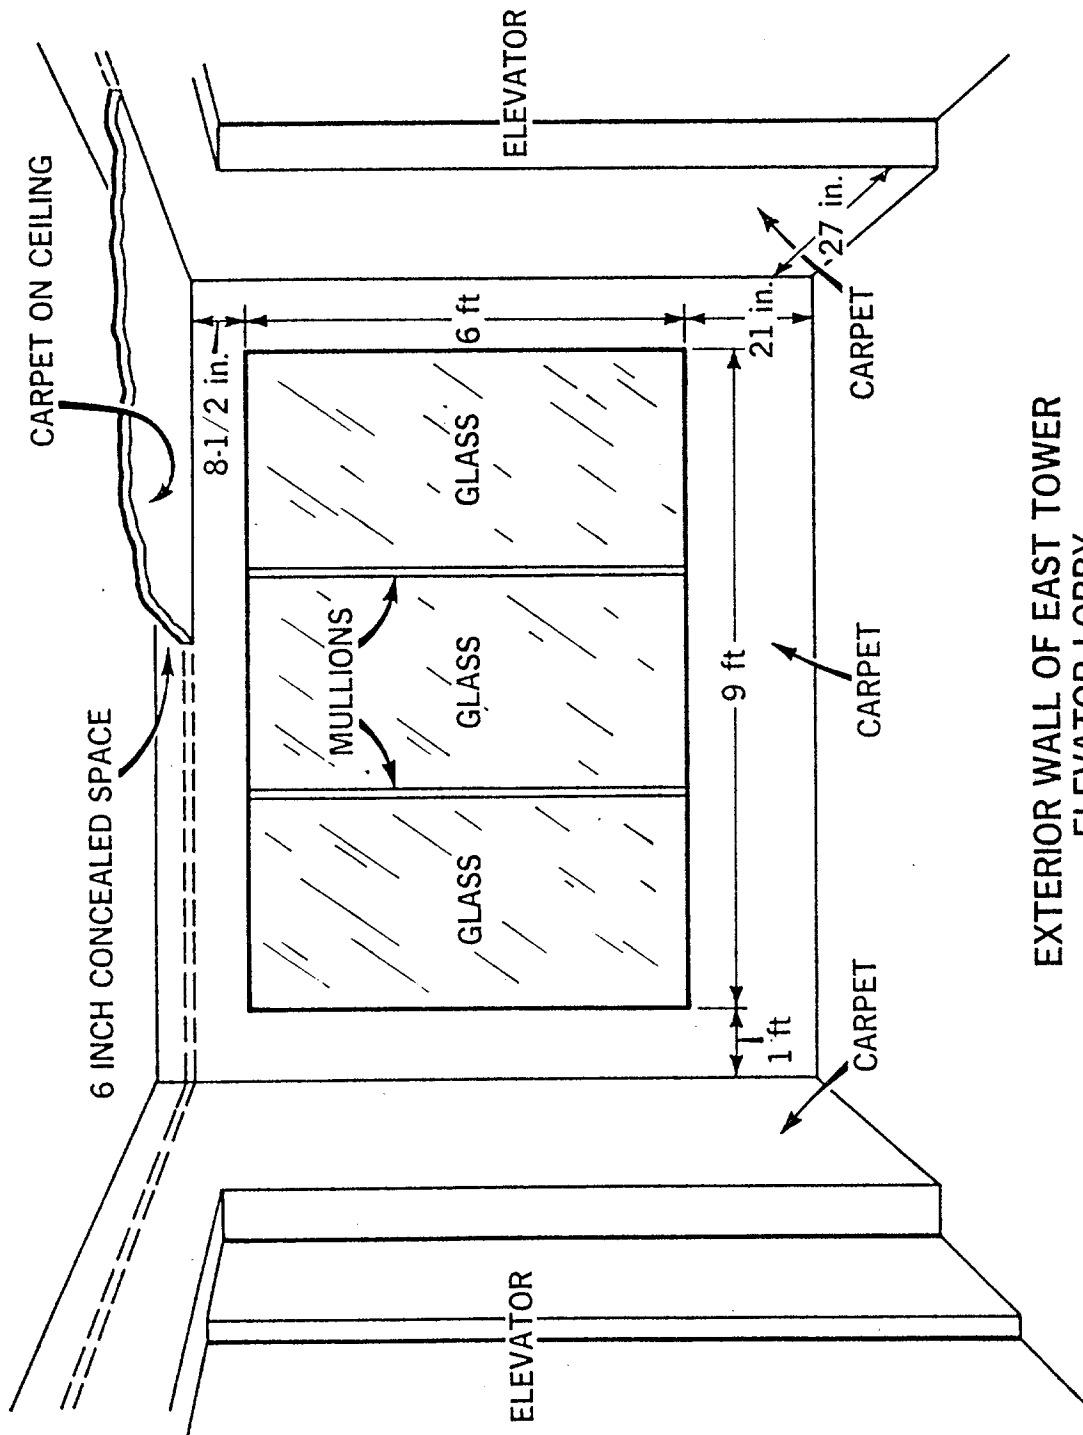
Figure 3

The East Tower elevator lobbies had four elevators; there were two on each side. Each pair was in an individual hoistway. On the exterior wall, there were three 3-foot by 6-foot double strength plate glass windows, creating a large glass area 6 feet by 9 feet (see Figure 3). The lights of glass were recessed 18 inches and were separated vertically by a 3 1/2-foot spandrel (see Figure 1).

The spandrel was a prefabricated masonry, plaster and gypsum wallboard on steel stud assembly. There was no apparent evidence of any combustible material, such as foam plastic insulation, associated with the assembly. This spandrel unit was attached to the reinforced concrete building structure. The type of caulking used was undetermined.

EXTERIOR WALL OF EAST TOWER  
 ELEVATOR LOBBY  
 LAS VEGAS HILTON

The vertically extending flame on the building's exterior probably involved two mechanisms of heat transfer to the glass and elevator lobby on the next level. There would have been a great deal of radiant thermal energy transfer through the glass, possibly igniting the draperies, wooden bench and foam plastic cushion. These would have acted as kindling fuels that soon ignited the carpeting on the walls and ceiling.

In addition to the radiant heat transfer, with the recessed plate glass and the shape of the spandrels (triangular cross section), the flow of flame and heated gases most likely would have created turbulence and a rolling effect, causing direct flame contact with the glass. This would have contributed to the heat transfer into the elevator lobby along with early failure of the glass.
