FATAL HOTEL FIRE

New Orleans

LAURENCE D. WATROUS

Supervisor, NFPA Fire Record Department

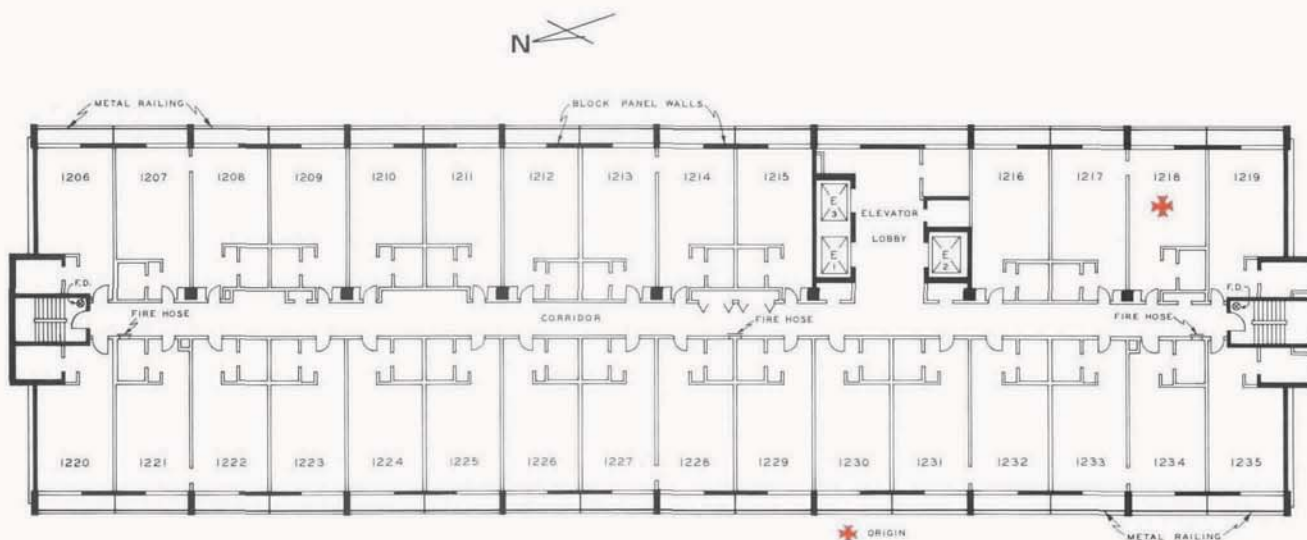
Floor plan of the twelfth floor. The fire, which was reported to the Fire Department by the occupants of Room 1214, originated in Room 1218. Five of the six victims occupied rooms on the fifteenth floor. They lost their lives when the elevator they were using as a means of escape stopped at the twelfth floor.

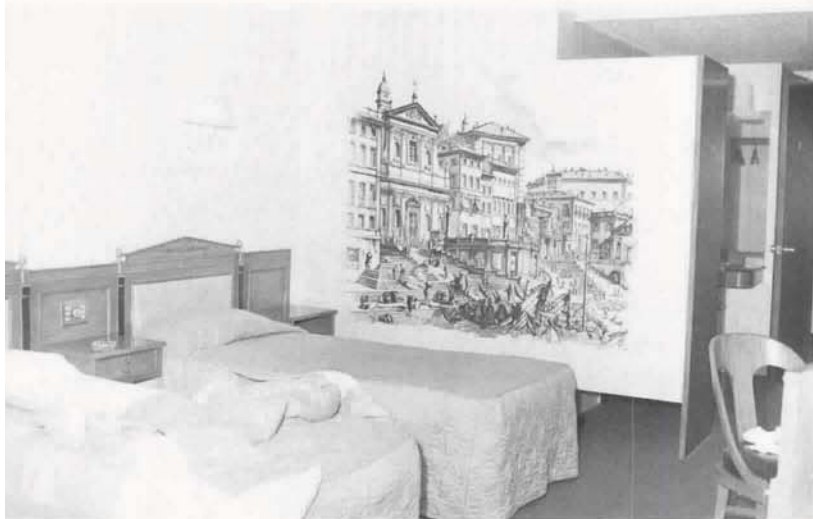
The room directly over the room of origin. Layout, furnishings, and decor are the same.

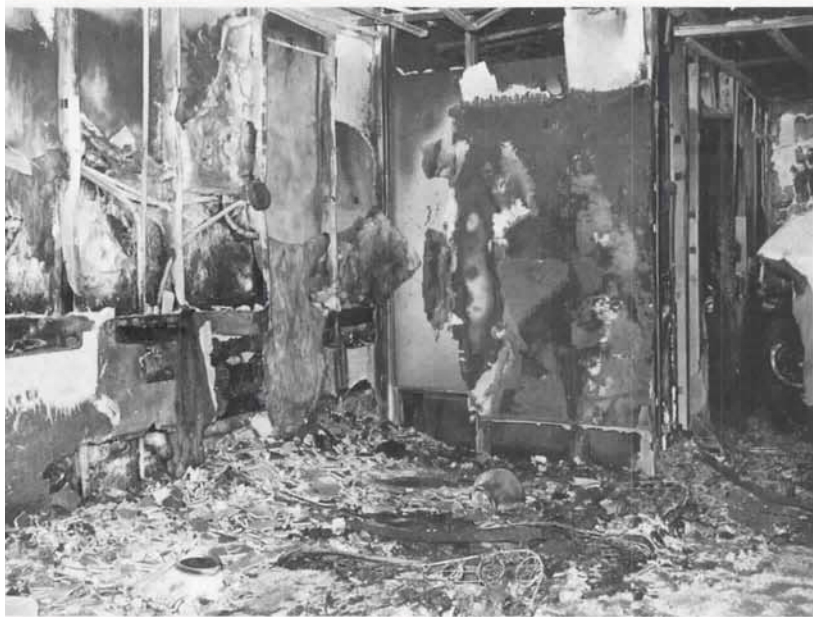
The room of origin received heavy damage. Here the bedsprings can be seen in the foreground.

Damage was confined to the twelfth story (only a small amount of smoke ever reached the upper stories), with heavy damage to the room of origin and heat and smoke damage extending throughout most of the twelfth-story corridor. The solid-core wood doors had held most of the heat and smoke out of the various rooms. Six people were dead. Many others required first aid for smoke inhalation. The loss was estimated at \$150,000.

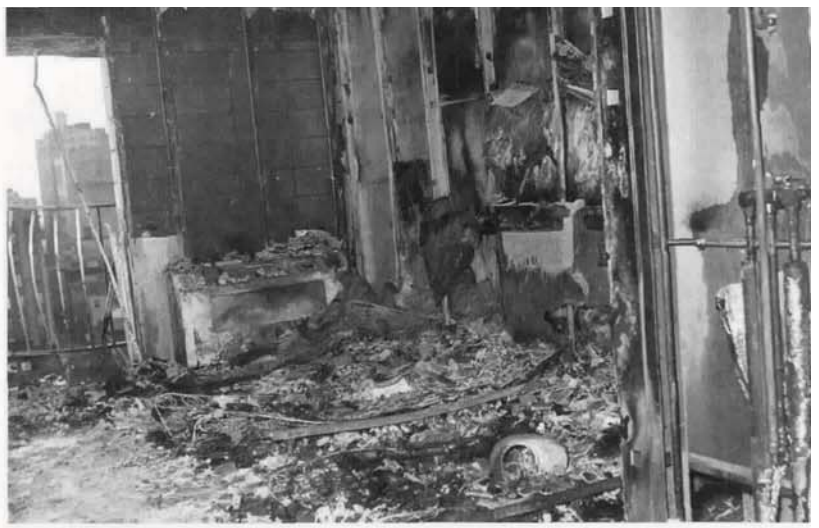
Each room has an air conditioner built into the masonry-block wall, as shown here. The doorway to the railed-in balcony is at the left.

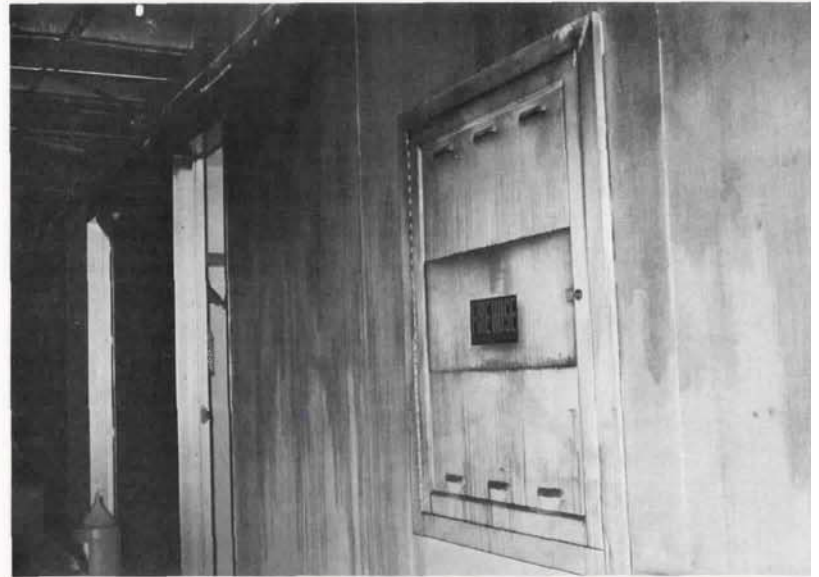
This hose cabinet, located about 150 feet from the room of origin in the twelfth story, was not used. The degree of smoke damage is obvious.
