MOTEL FIRE KILLS TWO, INJURES ELEVEN

JOHN A. SHARRY and WALTER R. STONE

NFPA Fire Record Department

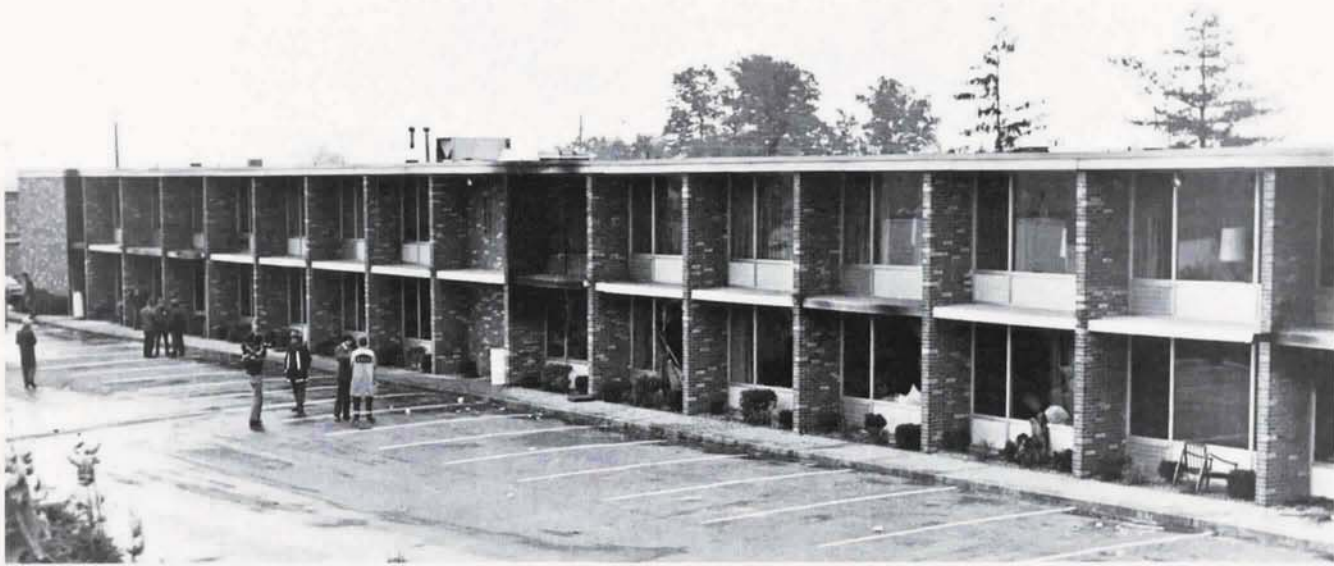
The fire originated in the first-floor room to the right of the white barrel in the center of the photo. Flames exposed the balcony of the room directly above.

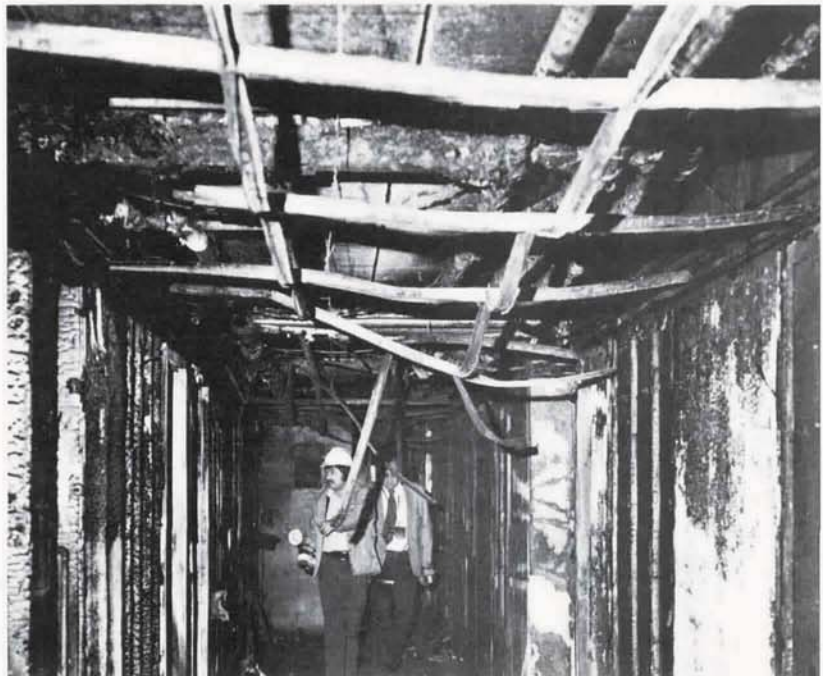
Part of the undivided 500-foot-long first-floor corridor through which the fire spread. Walls were plywood and the ceiling consisted of combustible tiles.

The fire was assumed to have been caused by smoking materials discarded by the occupants who departed at 12:30 am. Between the time that it was discovered at 2:30 am and reported at 3:27 am, the fire burned through the plywood-covered, wood-frame wall into the corridor and spread on the wall and ceiling in both directions. The estimated property damage was \$1 million. \triangle

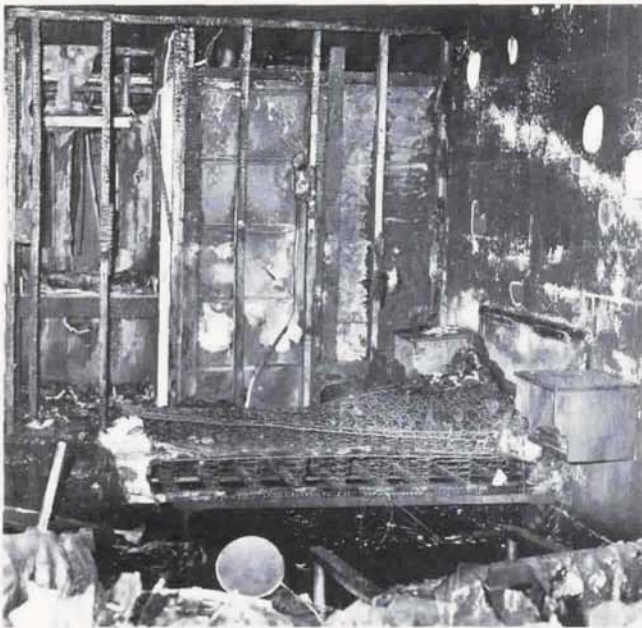
The room where the fire started. PHOTO-GRAPHIC

under the door of Room 137 and notified the desk clerk. Instead of calling the Fire Department, the clerk went to investigate. He opened the door to the room; as he did, hot air rushed out and a flash fire erupted, breaking the window in the room. The clerk shut the door and pulled the evacuation alarm, mistakenly thinking that it alerted the Fire Department. The clerk then alerted the occupants of both floors by
