An Atrium Fire

JOHN A. SHARRY

NFPA Fire Record Department Specialist

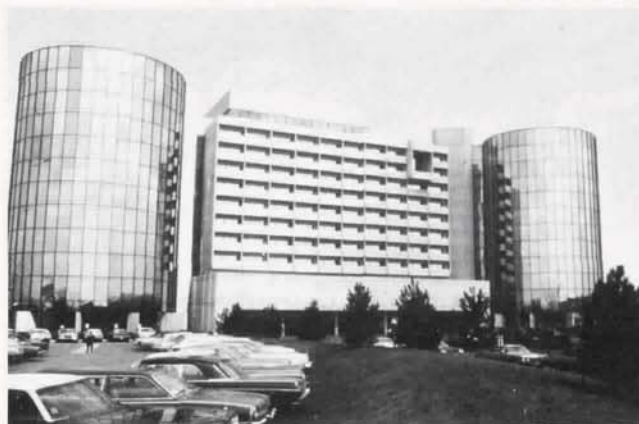
The atrium is within the center balconied building. Two of the four towers are at left and right. NFPA

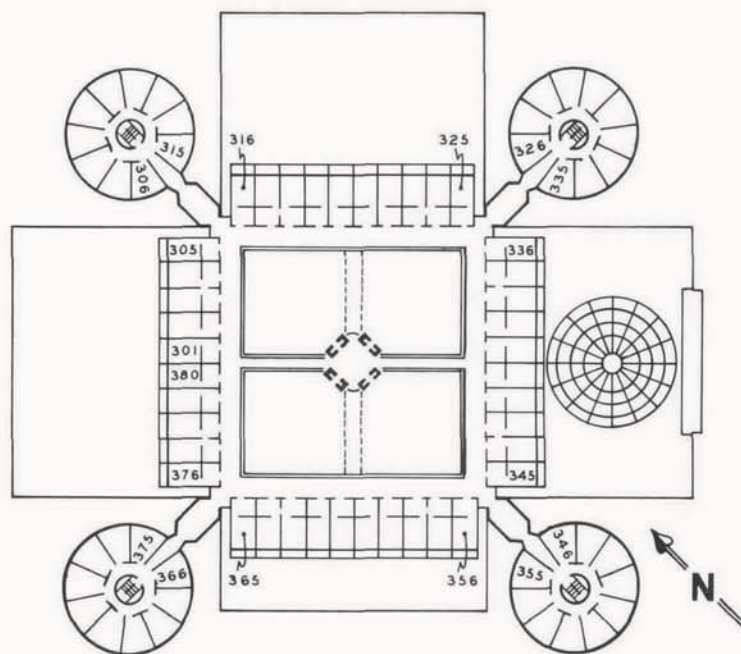
Figure 1

Guest rooms were arranged in the walls surrounding the atrium as well as in the four circular tower structures located at the corners of the atrium (see Figure 1). Guest rooms in the atrium opened to interior concrete balconies in the atrium and to balconies on the exterior of the building. Rooms in the four towers opened to interior corridors that in turn opened to the balconies in the atrium.

THIRD THRU SIXTH LEVELS

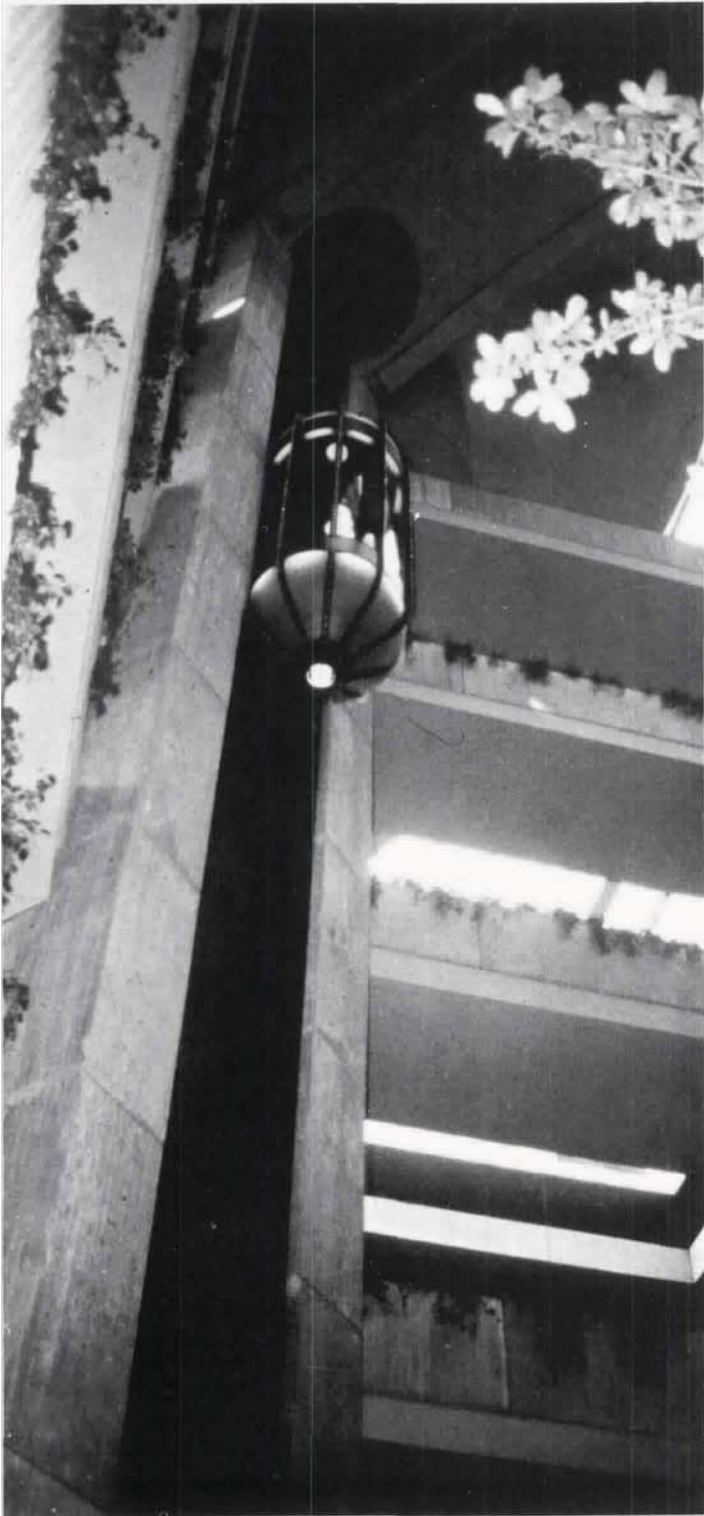
Above: Looking toward the top of the atrium from the seventh-floor balcony. One of the elevator cars on the outside of the central core is at upper left.

Photo at right: Entrance to escalator in the first-story lobby. The maintenance employee who discovered the fire directed a 1½-inch hose stream up the escalator opening to the club entrance, near the escalator discharge on the second floor.

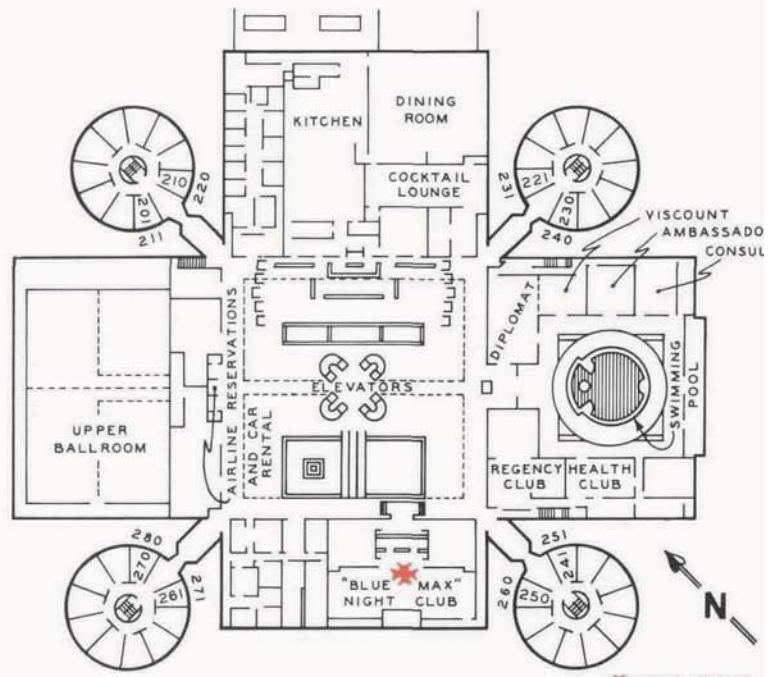
Figure 2

LOBBY LEVEL

The Blue Max night club was located on the second floor of the hotel (see Figure 2) and was separated from the atrium by a plywood-on-wood-stud partition. The entrance doors were located directly below interior guest-room balconies. The club measured 60 feet by 80 feet and was divided into two areas, a bar area and a night club.
