# FATAL HOTEL FIRE

## Bath, Maine

WALTER R. STONE, *NFPA Fire Record Department*

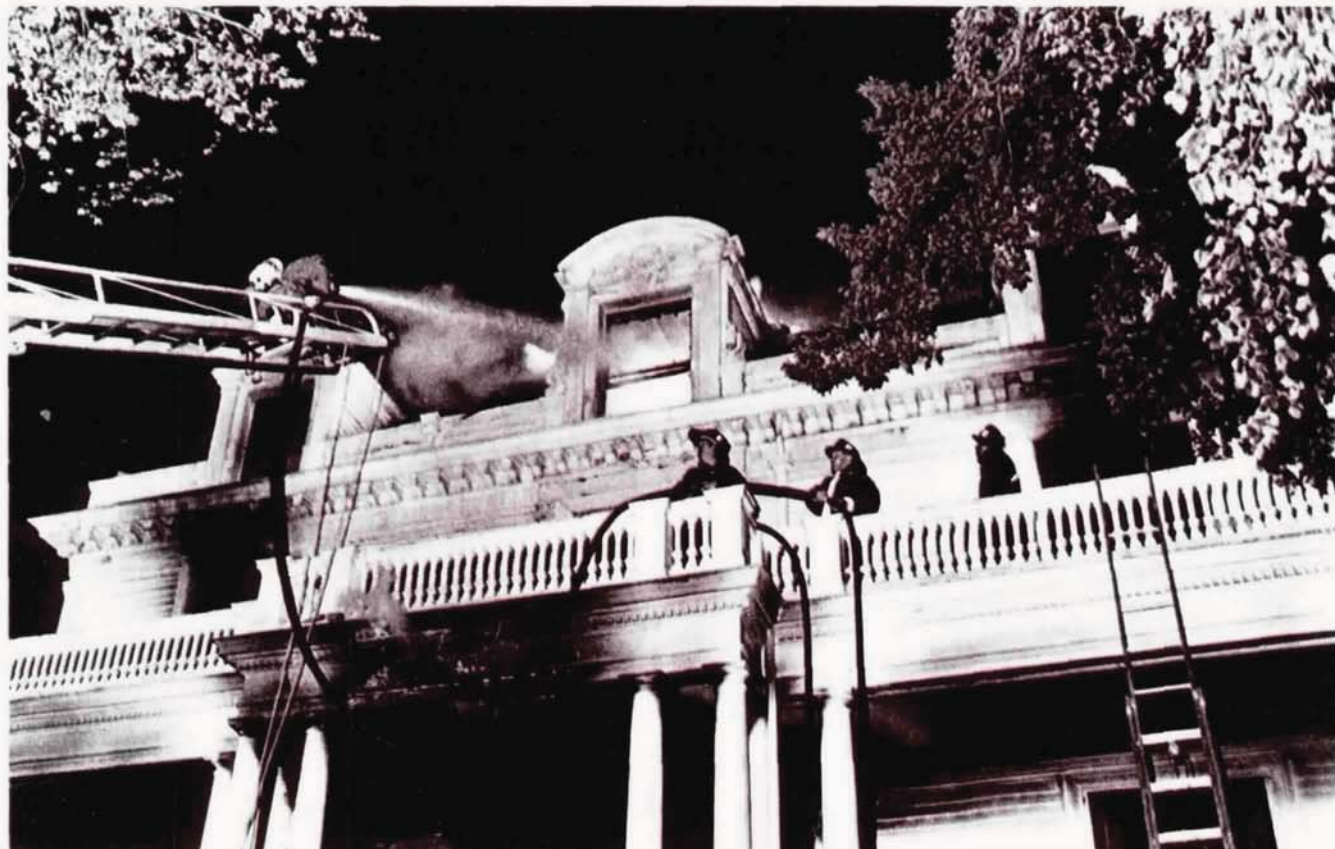
Photo 1. A substandard heating system installation, nonfirestopped concealed spaces, open stairways, and lack of automatic fire protection combined to cause this fatal fire. UPI

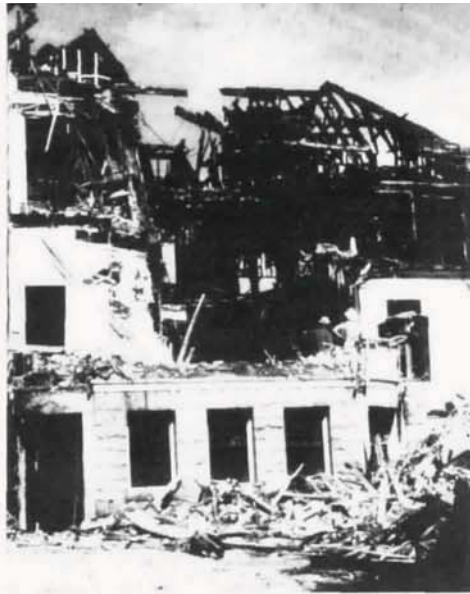
Photo 2. Sedgwick Hotel after fire on September 9, 1973.  
DONALD M. BISSET

Some guests were awakened by the heat and shouted to awaken others. Some third-floor guests went down a fire escape to a second-floor balcony, from which they jumped or were rescued. Several guests were taken down Fire Department ladders from second- and third-floor windows, and a few second-floor guests jumped from windows. Two of the victims were found on the third floor. Another third-floor guest's body was found in the lobby, where it had fallen when a part of the center section of the building collapsed. The fourth victim's body was removed after extensive digging and removal of debris. Photo 1 was taken before the collapse of the center section of the building; Photo 2 was taken afterward.
