ONE OF SEVERAL TV SET FIRES

Motel, Pine Castle, Florida

JOHN A. SHARRY, *NFPA Fire Record Department Specialist*

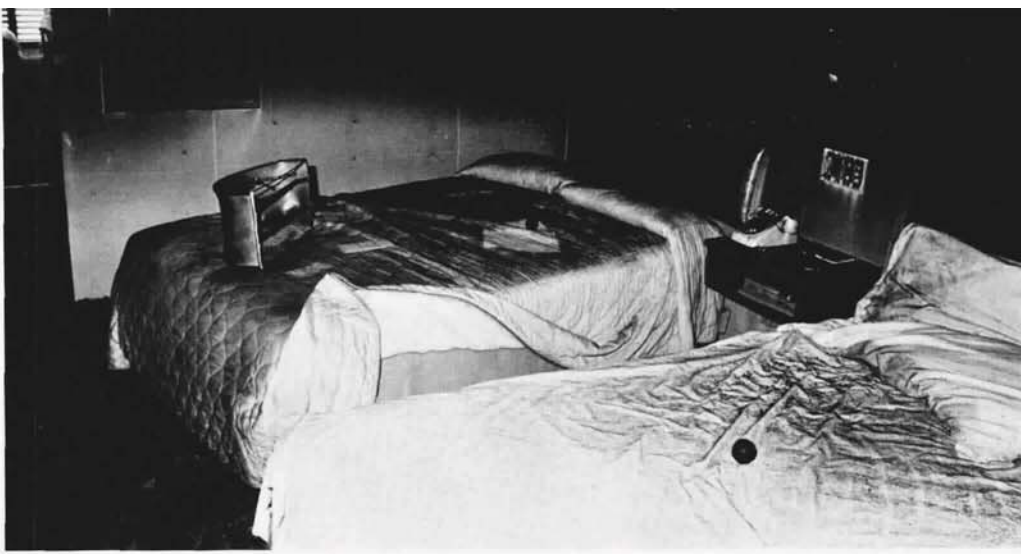
Smoke damage to room resulting from TV set fire.

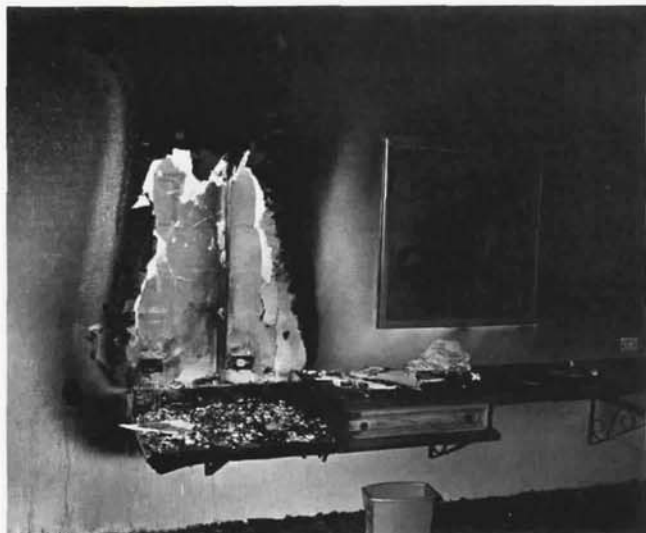
The TV set in Room 296 was completely destroyed. The vinyl wall covering behind the set was burned for approximately two feet above the TV set (see Photo 1). The shag rug was burned under and in front of the TV set in an irregular pattern for about two feet. Heavy smoke damage occurred in the room and in the hallway immediately surrounding the room door. Minor smoke damage was sustained in other rooms, but only in rooms in which doors had been left open.

Photo 1. Damage to wall covering directly over TV set location.

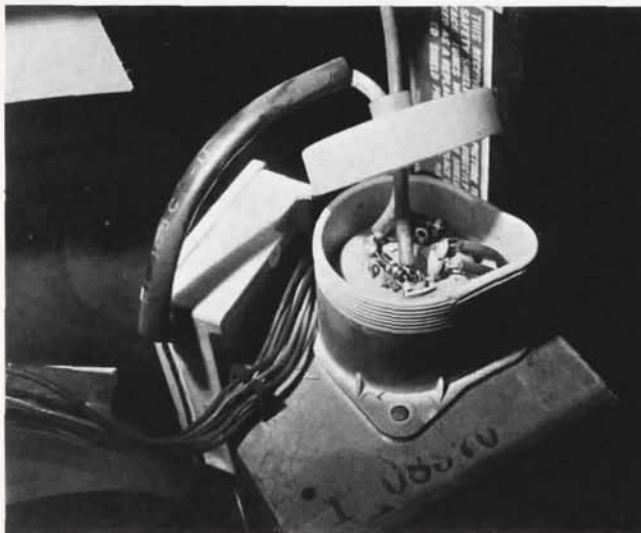
Nineteen of the twenty malfunctions involved a polypropylene insulating cup surrounding the base of a

Photo 2. Polypropylene insulating cup and polyethylene cap surrounding base of high voltage tube.

high voltage tube (see Photo 2). A search of the motel's TV repair records for the past year revealed 20 incidents of TV set malfunctions resulting in arcing, smoking, or fire. Two of those incidents resulted in major fires, while the other 18 were handled by motel personnel and damage was confined to the sets. The corrective action taken on sets able to be repaired and returned to use involved the replacement of the polypropylene insulating cup and its polyethylene cap. No injuries were sustained in the other fires, probably because they occurred at times when the room occupants were awake and able to take positive action.

The Consumer Products Safety Commission, when notified of the series of fires, checked immediately to ensure that the manufacturer was taking action to

correct the "substantial hazard." The manufacturer, upon being notified of the problem by the motel owner, began an investigation of his own and eventually issued a news release warning users of the potential fire dangers. The manufacturer also established a "national safety alert" program to improve its communications with field-service agents.
