# HIGH-RISE HOTEL FIRE

Virginia Beach,  
Virginia

A fire in a ninth-floor room of this modern 11-story high-rise hotel on September 8, 1974 destroyed the room and eventually involved the nearby elevator lobby on that floor. A motel employee who attempted to extinguish the fire was killed. Of significance in this fire was the delayed alarm and the failure of certain fire protection devices to function properly.

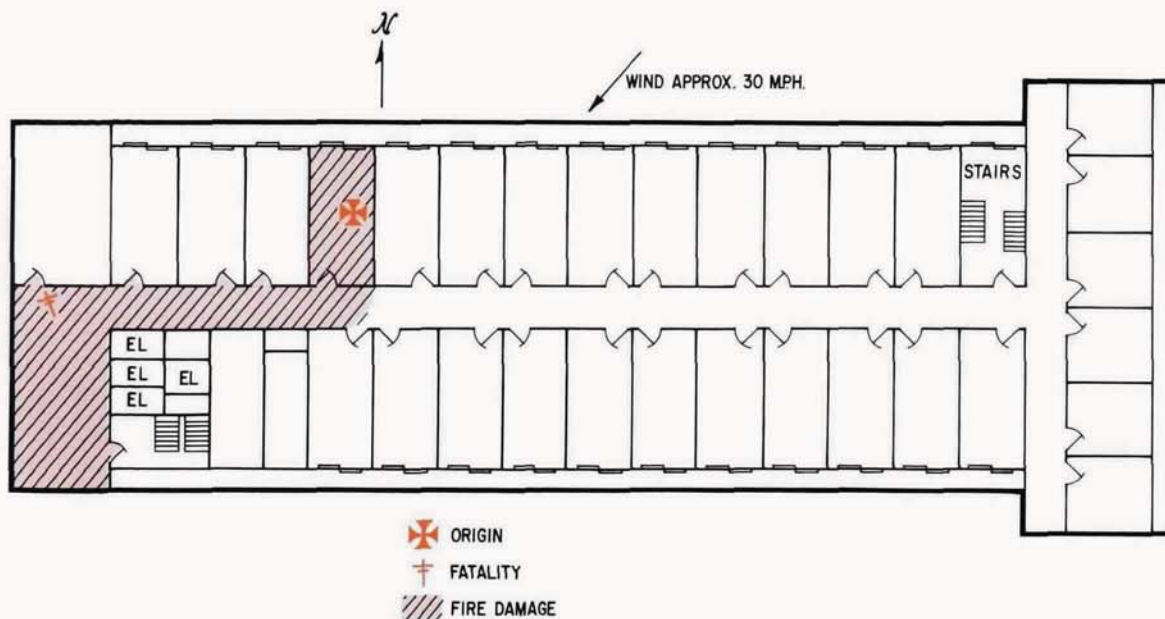
Figure 1. Floor plan for ninth floor.

A maid making her rounds on the ninth floor noticed smoke coming from around the door of Room 906 at about 11:35 am. She immediately pulled a fire alarm on the ninth floor. Hotel maintenance personnel responded to the ninth floor to determine the extent of the fire but upon arrival, they decided not to open the door to Room 906. The assistant hotel manager arrived and decided to attempt to fight the fire. He opened the door and an attempt was made to fight the fire from the doorway using a pressurized water extinguisher and one carbon dioxide extinguisher.

The assistant manager told the other personnel to start evacuating anyone still on the ninth floor. As they moved down to the east end of the hall, the fire burst out of the room of origin into the hallway, isolating the assistant manager from the other personnel. Apparently the assistant manager was slightly burned, became disoriented, and could not find his way to the

The assistant manager was found in the northwest corner of the elevator lobby at the west end of the ninth floor hallway. He was transported to the hospital and pronounced dead on arrival. Cause of death was carbon monoxide poisoning (blood analysis showed 50 percent carbon monoxide content).

The west stairwell filled with smoke and heat early in the fire, although the door to the stairway was closed. It appears that a great deal of heat and smoke entered the stairwell because of poor installation of the stairwell door.
