FIRE IN PHILIPPINES HOTEL KILLS 47

WAYNE G. CARSON

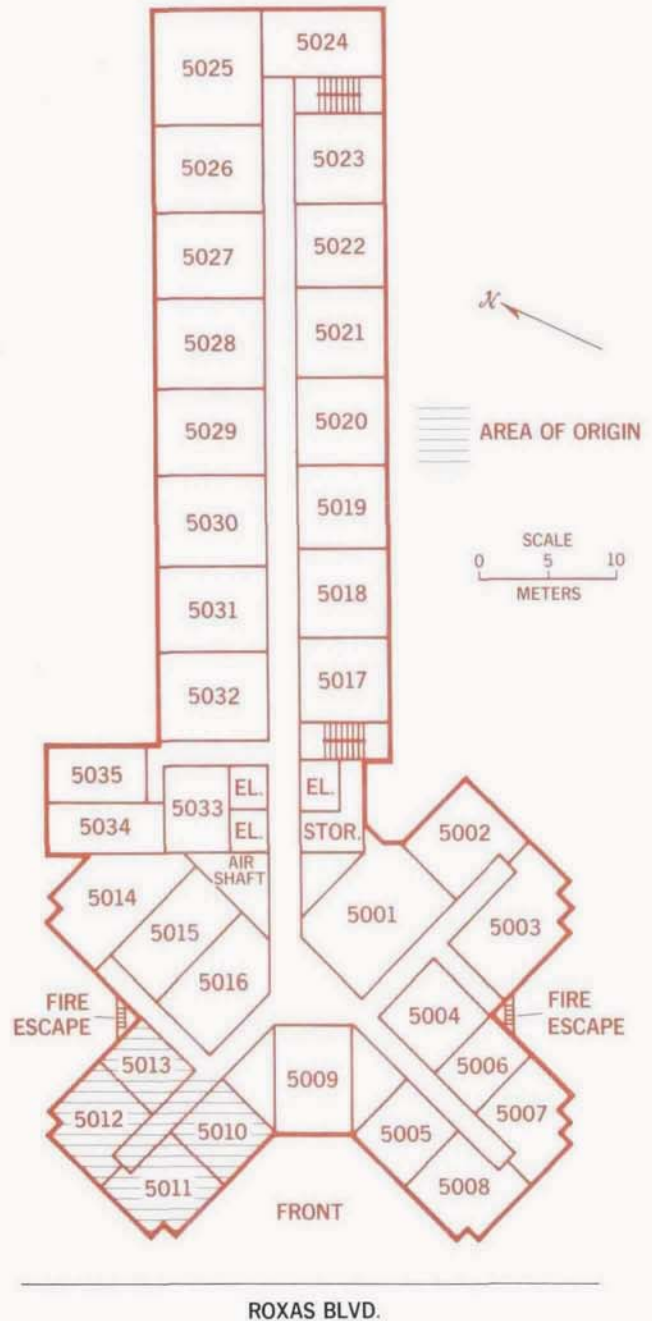
Floor plan of fifth floor.

The exact details of the origin or time of the fire are not known. However, the fire was discovered at approximately 6:30 to 6:45 am in the vicinity of Room 5010. This room was occupied at the time of the fire, as were Rooms 5009, 5012, and 5013. There were unconfirmed reports of an explosion immediately before the fire. It is not known whether the fire was discovered by a hotel guest or by a bellboy on the fifth floor. Guests were

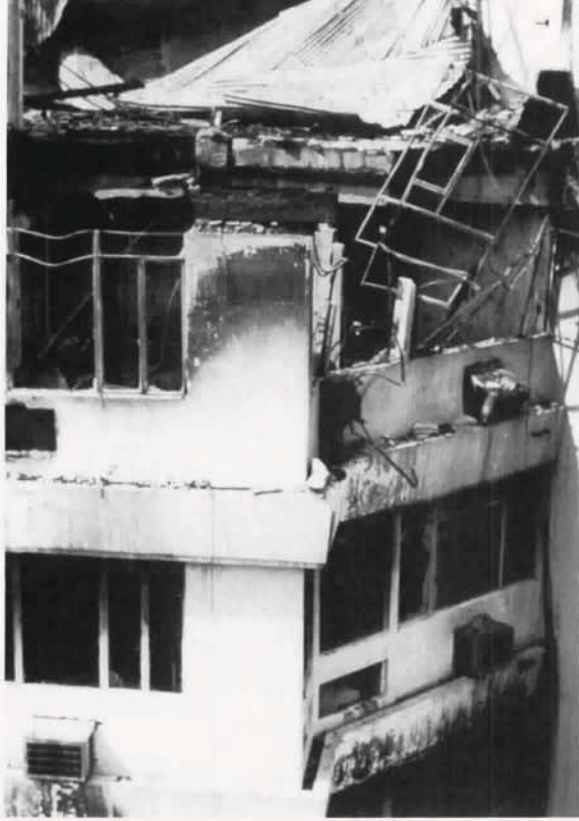
Destruction in the front portion of Main 1 building as seen from the roof of the adjacent Hotel Aurelio.

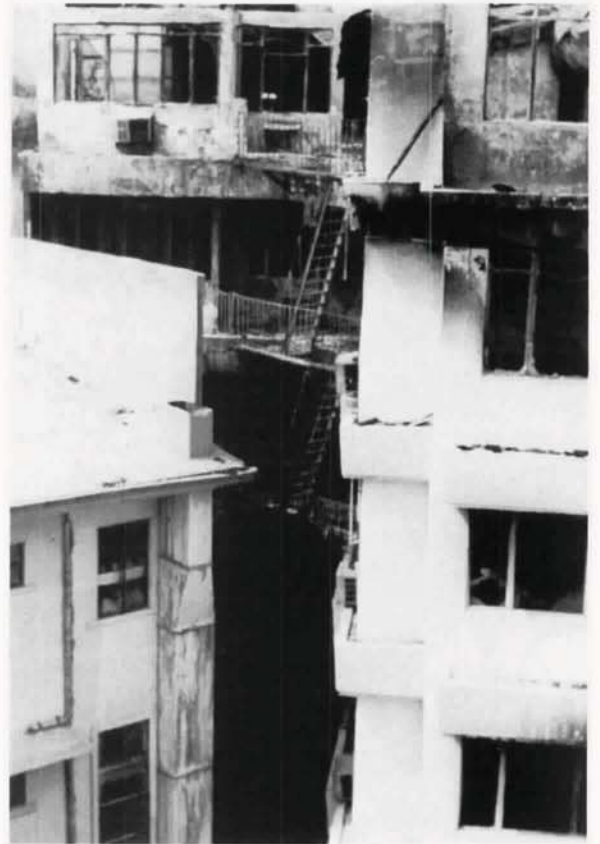
The exterior fire escape of the Hotel Filipinas as seen from the Hotel Aurelio.

The open interior stairs quickly filled with smoke. As described earlier, the doors to the exterior fire escape stairways were locked each night about midnight with a slide-bolt-type lock, and this apparently caused considerable confusion among persons who tried to use these stairs to leave the building. Three persons reportedly jumped from the eighth and ninth floor of the Main 2 building to the roof of the Litton Apartments. Several persons jumped from windows. At least three persons reportedly attempted to jump into fire-fighters' nets, but missed and were killed. There was an unconfirmed report that a British photographer jumped from the ninth floor into the hotel swimming pool and suffered only minor back injuries. One woman was rescued from the fifth-floor ledge at the front of the building by means of an aerial ladder while a fire department water tower used a fog pattern to keep the fire from coming out of the window over the ledge.

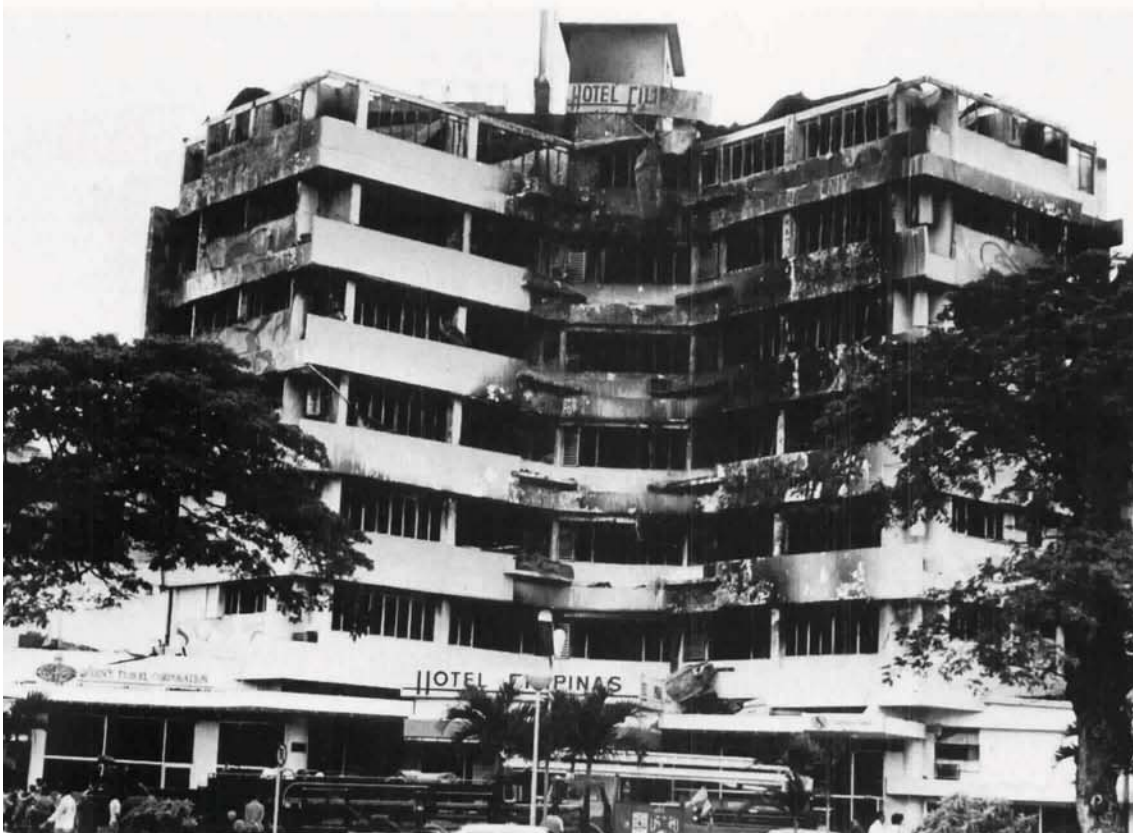
Front view of the Hotel Filipinas. *Times Journal*
