FIRE AT THE MGM GRAND

A Preliminary Report

The NFPA has completed a preliminary report of its investigation of the MGM Grand Hotel fire that killed 84 people and injured 679 others in Las Vegas, Nevada, on November 21, 1980.

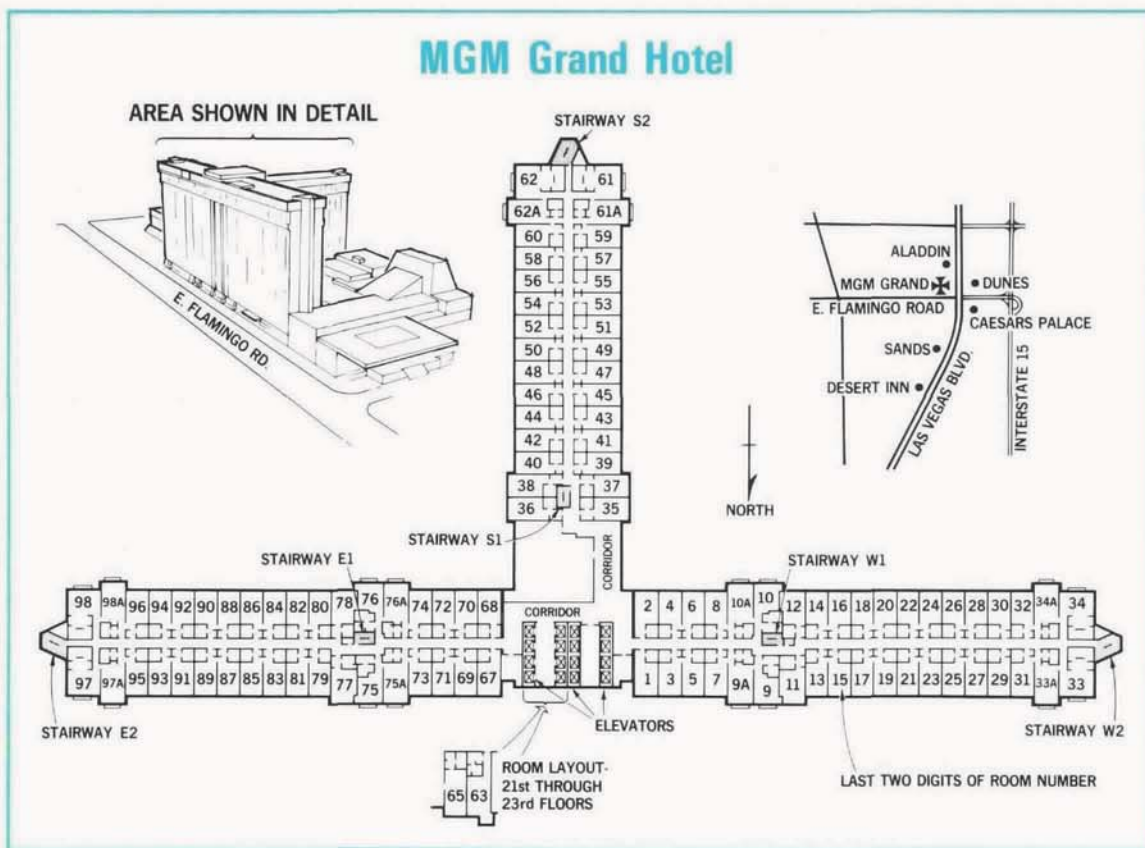
Figure 1.

The building consisted of a very large ground floor area that contained the Casino, restaurants, showrooms, a convention center, and the upper level of a jai alai fronton. (See Figures 1 and 2.) The below-grade level (Arcade level), which had approximate outside dimensions the same as the Casino level, contained the lower level of the jai alai fronton, a movie theatre, a large number of shops and boutiques, service areas, and underground parking. The Casino and Arcade levels were directly connected by an open stairway. The gross dimensions of the Casino and Arcade levels were 380 feet by 1,200 feet; the huge Casino itself measured approximately 150 feet by 400 feet. The Hotel, which consisted of three wings, was built on top of the Casino and Arcade levels. Each wing was approximately 320 feet long and 70 feet wide.
