FIRE AT STOUFFER'S INN HARRISON, NEW YORK

A Preliminary Report

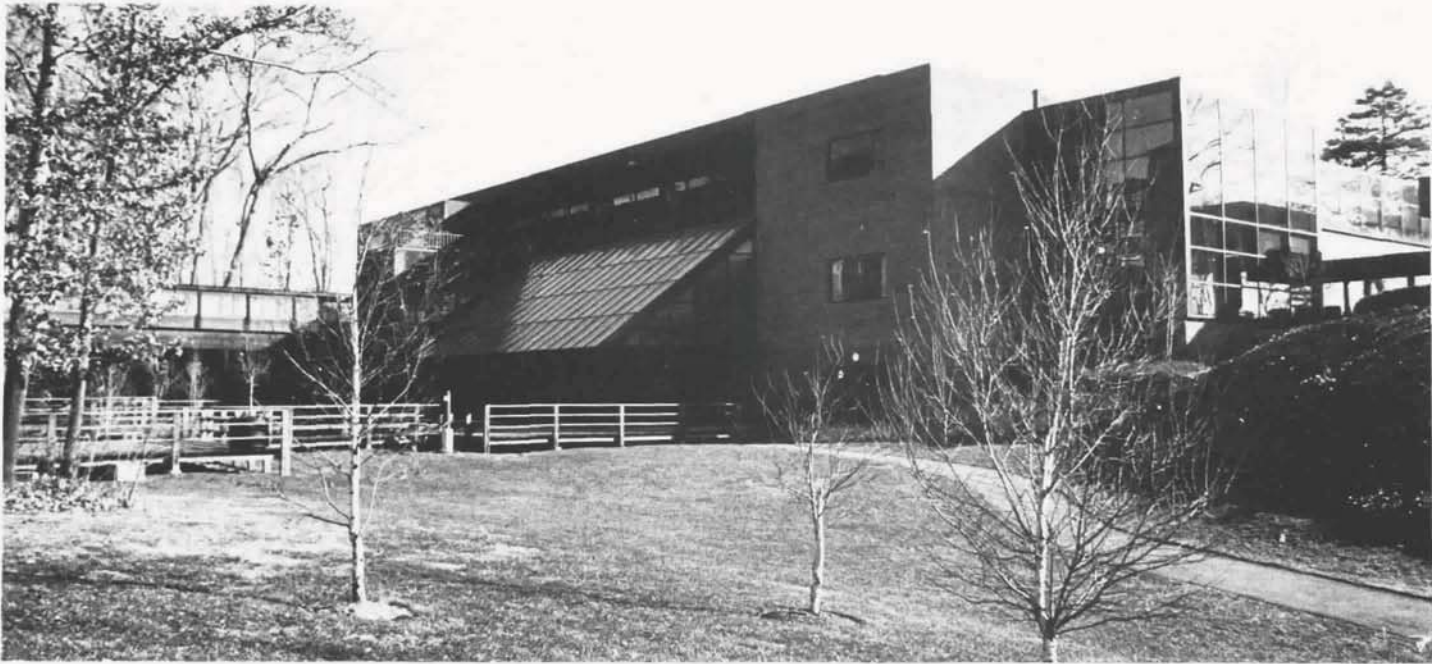
Left: The conference facility from the southwest. The railings of the promenade deck and windows of the burned-out Commons area of the third floor are above the slanted, glassed-in area housing the indoor swimming pool.

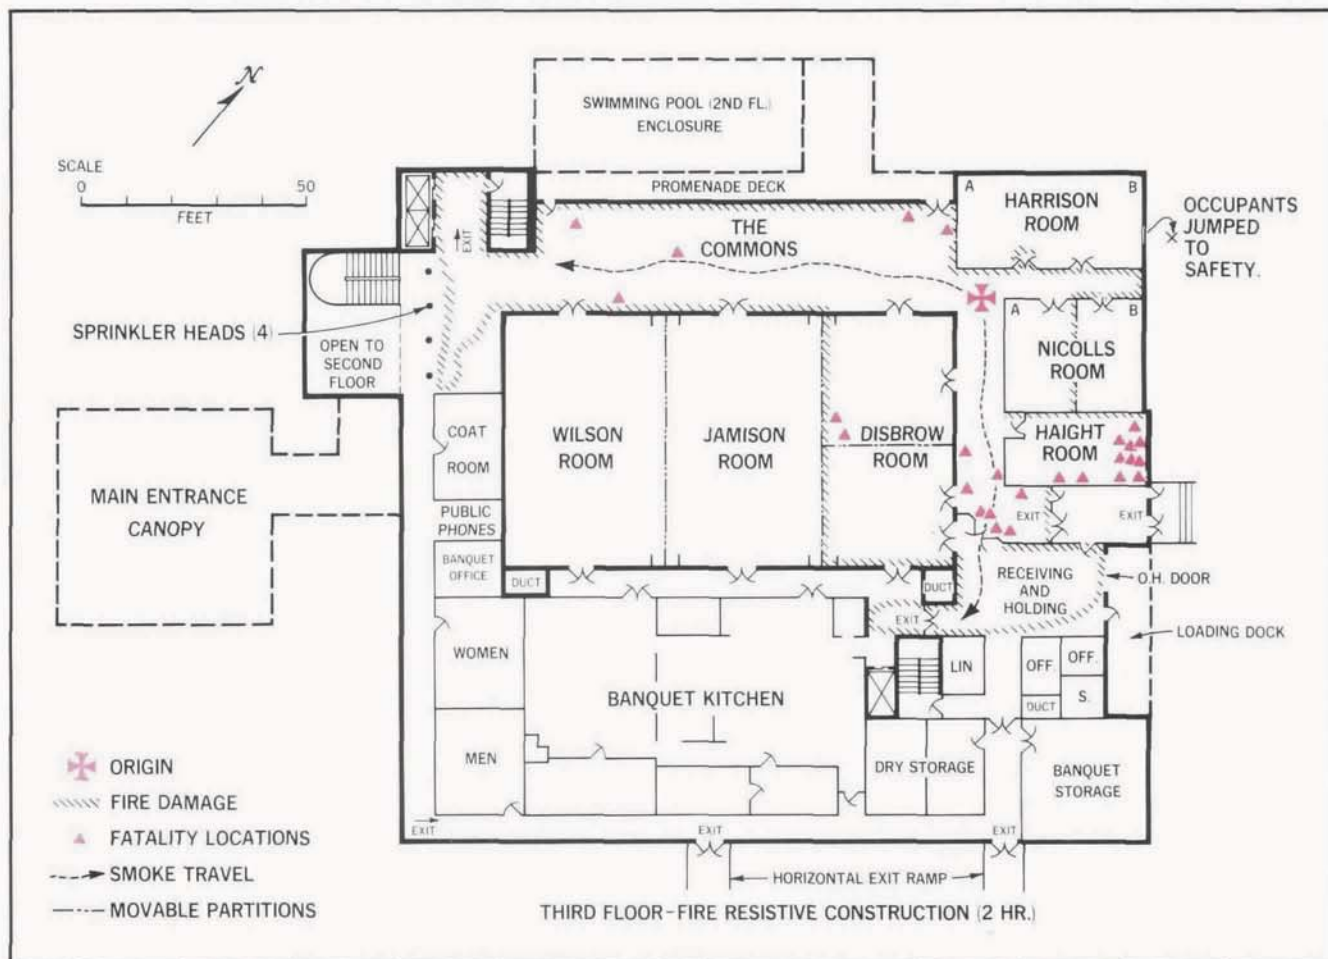
Floor plan of third floor.

As determined by local investigators, the fire was of incendiary origin and involved flammable liquid on the carpet in the vicinity of the intersection of the Commons and the east corridor. It developed rapidly and extended into the Commons and the adjoining corridors, exposing those areas to heavy smoke and heat.

The fire quickly extended to the Commons, the adjoining corridors, three meeting rooms, and two of the three partitioned meeting areas in the ballroom, causing severe damage to these areas. It also extended into the receiving and holding area through double doors that had been opened after the onset of the fire. Structural steel and masonry walls were damaged in the northeast corner of the ballroom.

Eleven of the 13 occupants in the Haight Room (which had a single exit door opening to the corridor, but no window) died in the room. The bodies of the other two occupants of the Haight Room were found in the adjacent corridor. An additional 11 victims who had been in the Disbrow and Wilson Rooms were found in the Commons and in the corridor outside the Disbrow Room. Two victims also died in the Disbrow Room. △
