Fire and Explosion

Fireworks Manufacturer and Distributor

Jaffrey, New Hampshire

August 14, 1988

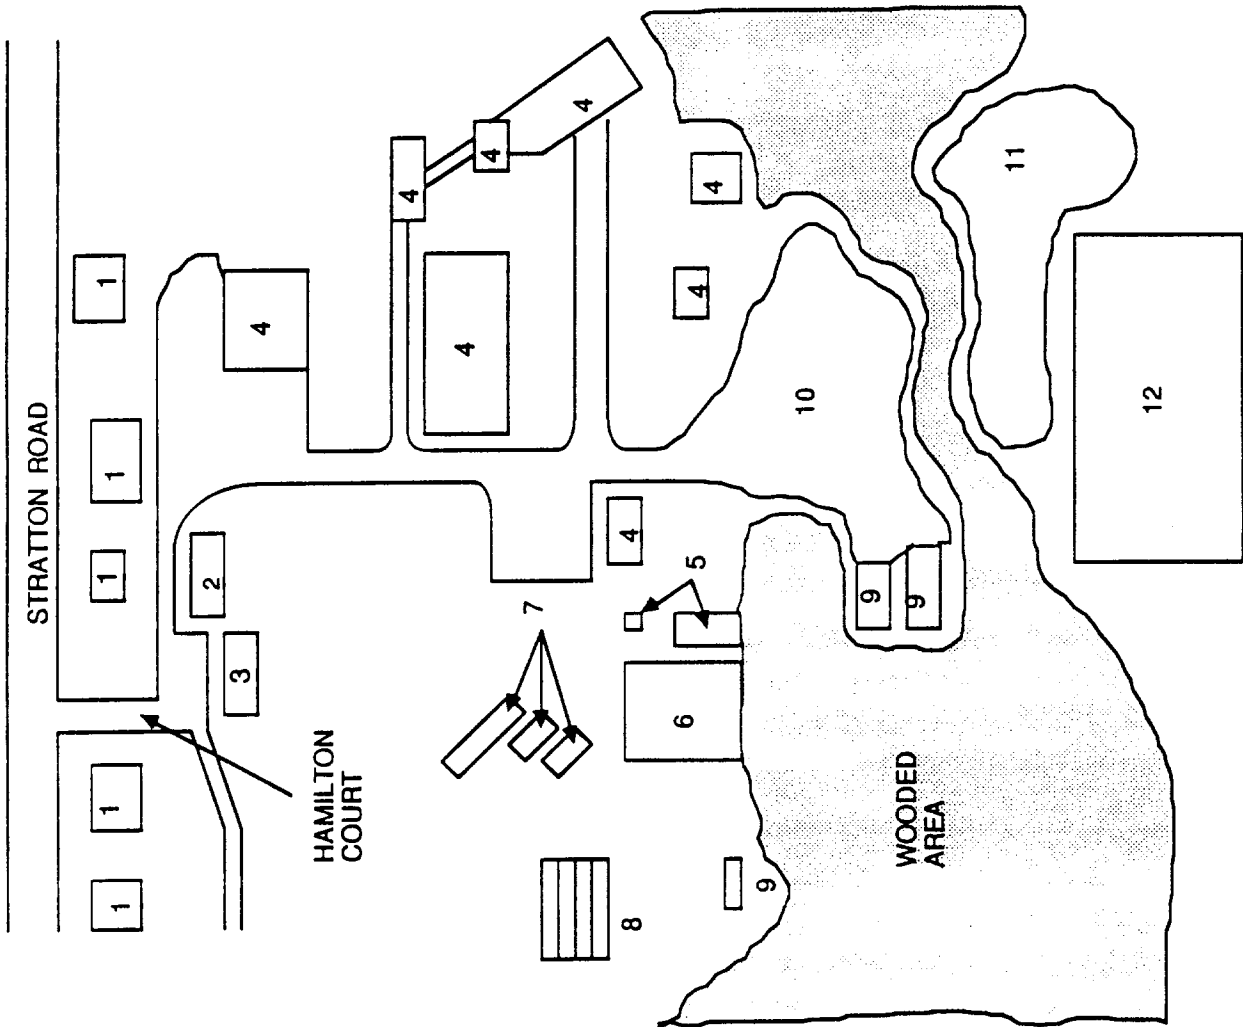
PLOT PLAN: ATLAS FIREWORKS

The fireworks facility is located in a residential area. The business office building is adjacent to a two-story apartment building and is about 150 feet from the street. (See attached figure.) The building and trailers involved in the fire are about 200 feet from the business office and about 350 feet from the street. Other exposed dwellings are 300 to 500 feet away from the fire area. One of the magazines used to store fireworks is about 150 feet from public tennis courts and 1/4 mile from a school.
