UNION BANK BUILDING

Los Angeles, CA

July 18, 1988

UNION BANK BUILDING FIRE
LOS ANGELES, CALIFORNIA

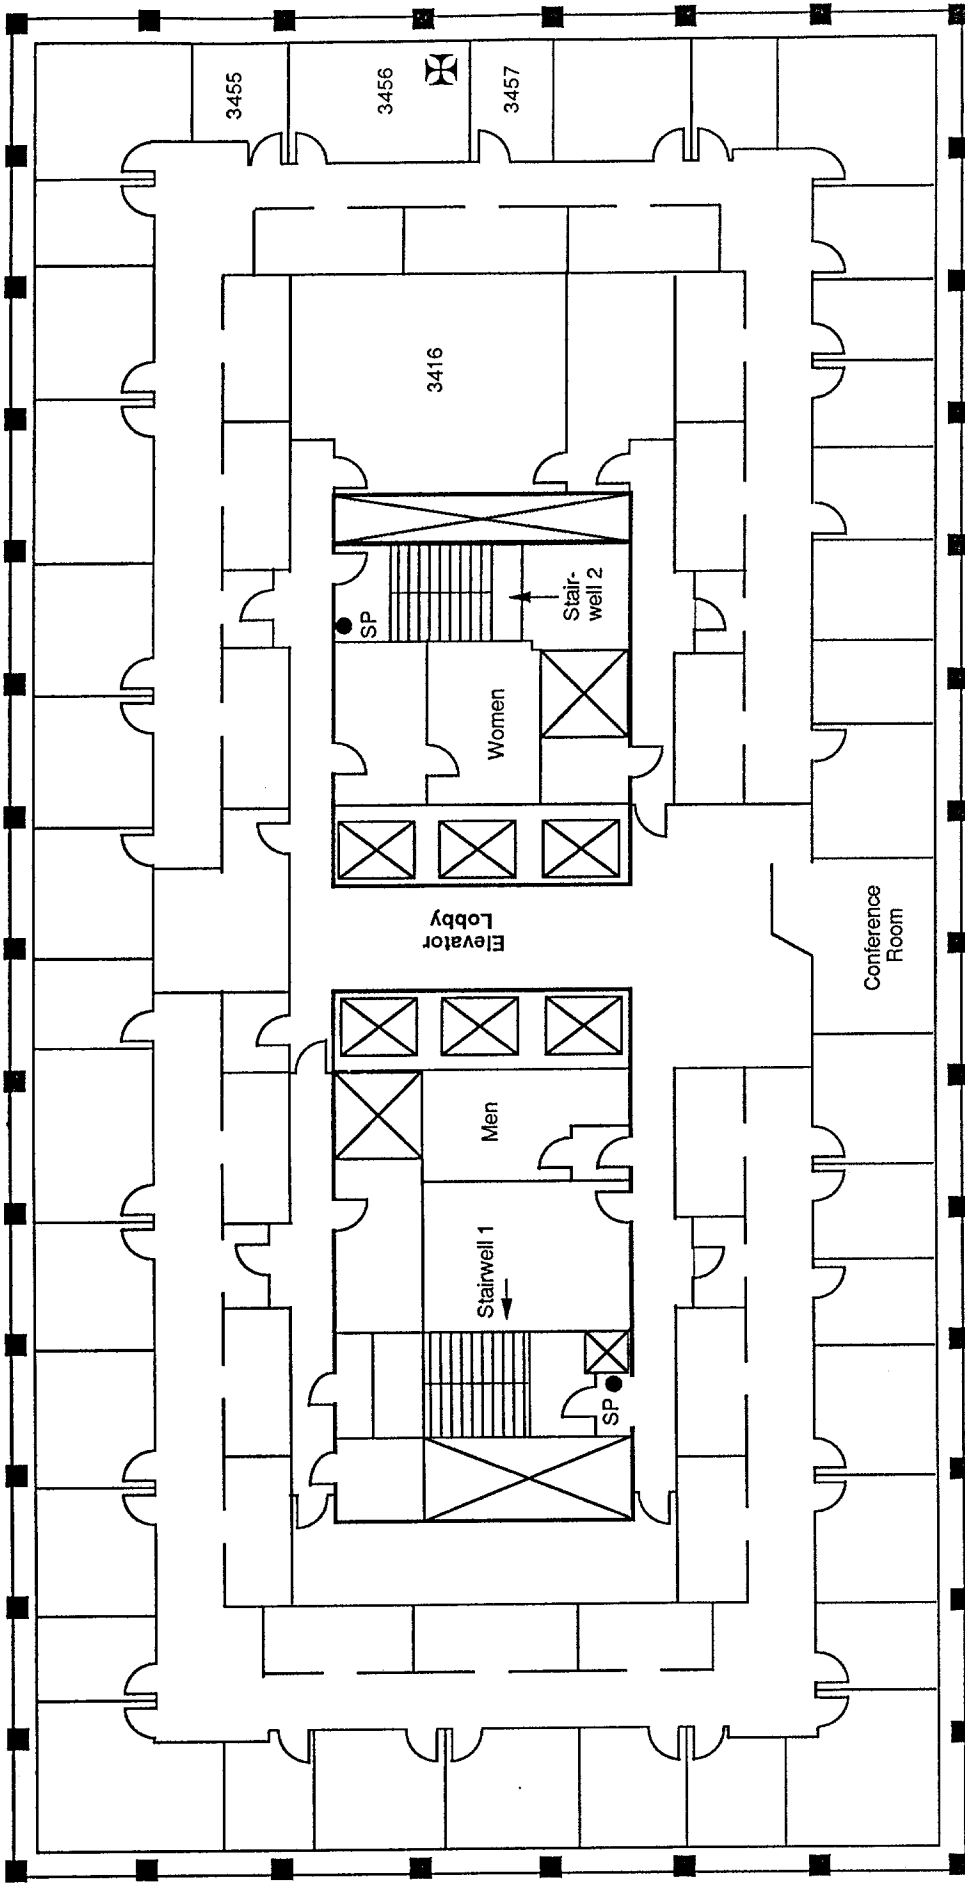
Union Bank Building
 34th Floor
 X Area of origin

The actual area damaged by the flames was confined to Room 3455, 3456, and 3457, as well as two of the secretarial areas immediately outside of those rooms. The fire destroyed the partitions between Room 3455 and 3456 and between Room 3456 and 3457. One of these walls had the credenza/bookcase against it, and the other had the sofa and two side chairs against it. The fire also totally consumed the doors to those three offices, as well as all combustible materials in those offices. The gypsum wallboard between these three offices, and the corridor remained intact. There was burning in the two secretarial areas outside of these offices, but the fire was extinguished before there was complete destruction. The plastic in the enclosure and the aluminum framing were melted, but some materials at floor level showed few signs of direct burning.
