Summary Investigation Report

Jefferson Dormitory Fire  
College of William and Mary  
Williamsburg, Virginia  
January 20, 1983

James R. Bell  
Legislative Technical Specialist  
National Fire Protection Association

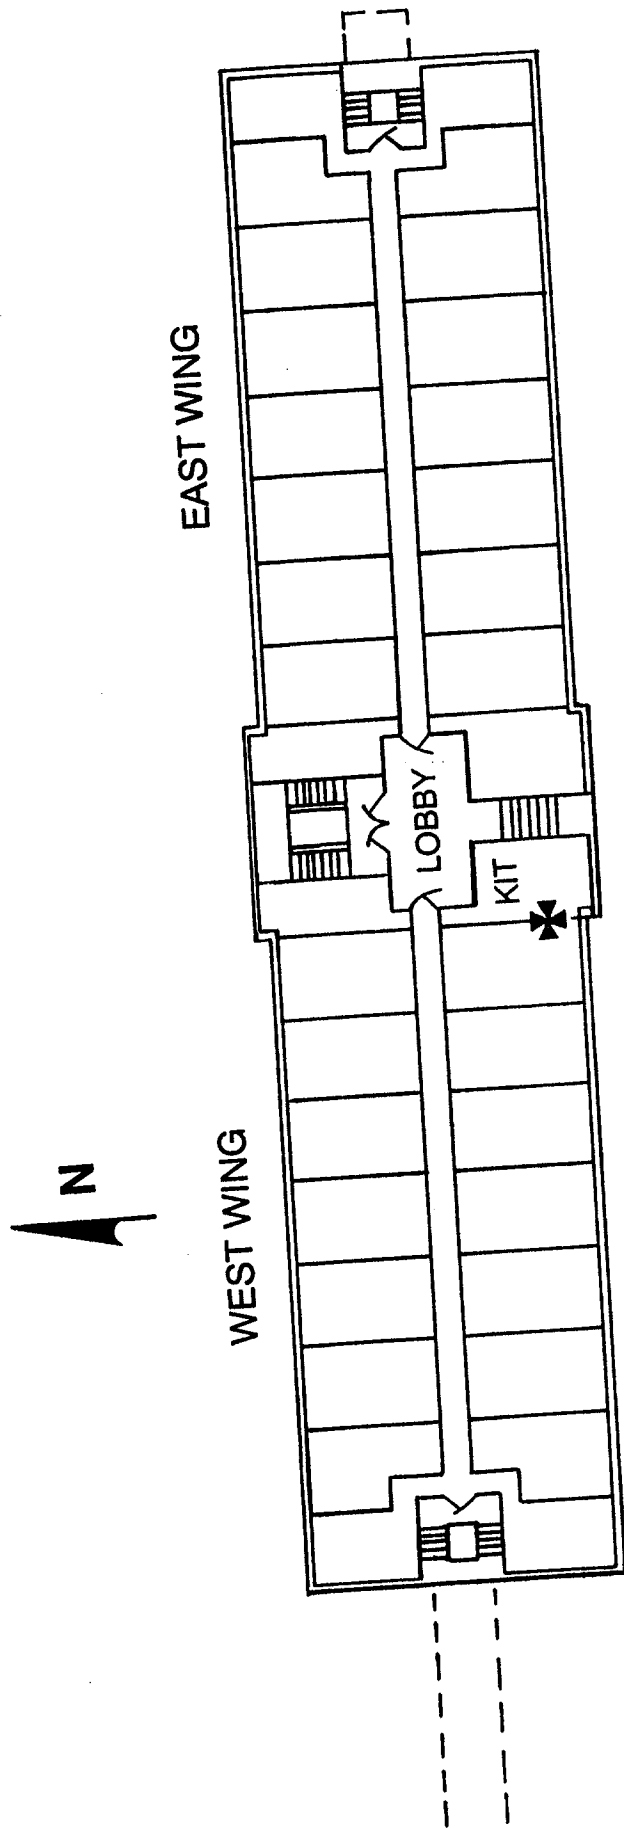
**FIGURE 1. FLOOR PLAN (FIRST FLOOR)**

The area of origin was initially determined by investigators from the State Fire Marshal's Office and the Virginia State Police to be in a kitchen

near the center of the building, located on the first floor of the West Wing. The investigators concluded that the fire may have started in the vicinity of the floor behind a refrigerator, and may have burned through the floor or baseboard behind the refrigerator entering the concealed space above the ground floor ceiling.
