# Fire Investigation Summary

## Church Fire

Lake Worth, Texas

February 15, 1999

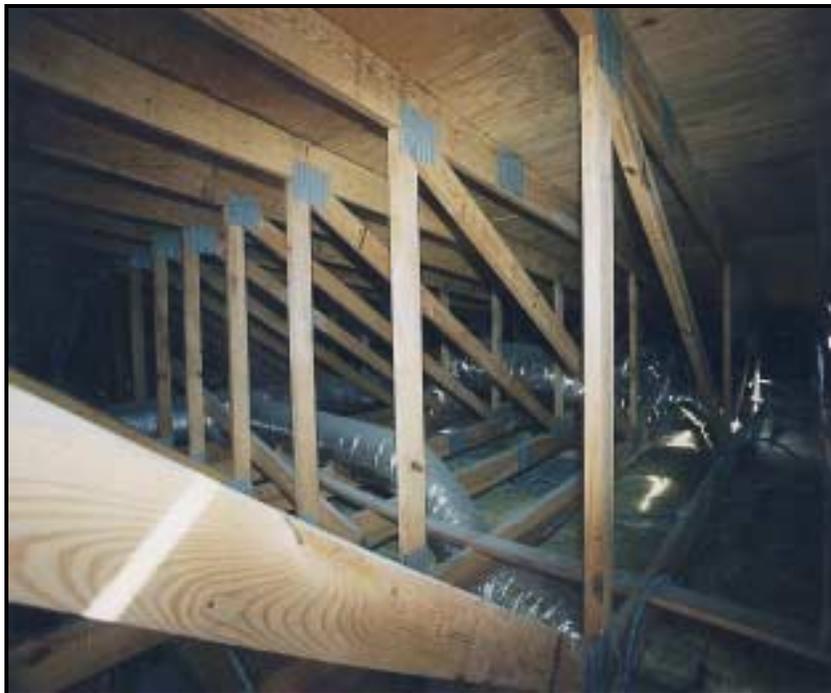
The truss members were constructed using metal gusset plates.

**Photo 1 – Gusset plates on typical lightweight truss installation (NFPA Photo)**

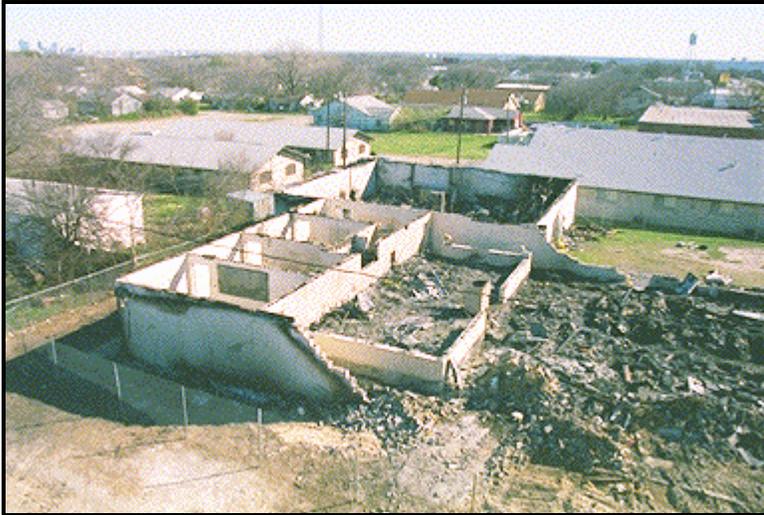
**Photo 2 - Aerial photo showing altar, classrooms, and the Fellowship Hall (NFPA photo)**

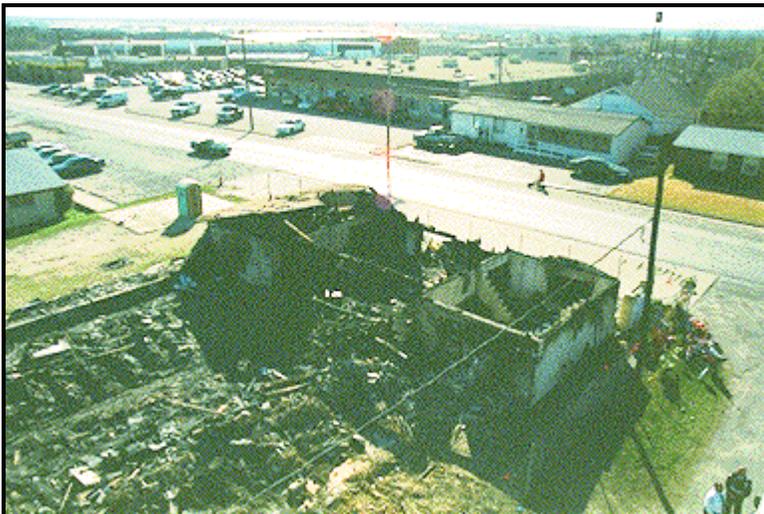
**Photo 3 - Aerial photo showing entrance and remainder of the church hall (NFPA photo)**

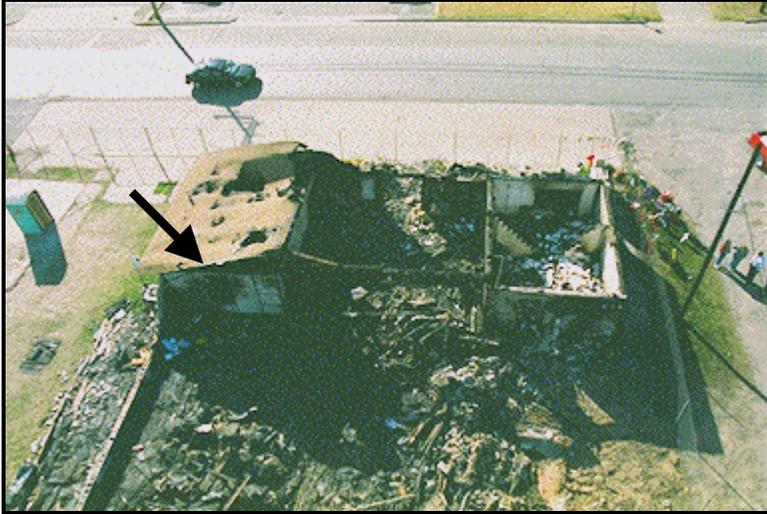
**Photo 4 - View showing entrance foyer and the only portion of the roof to survive the fire. Arrow points to where the fire fighter hung after the collapse. (NFPA Photo)**

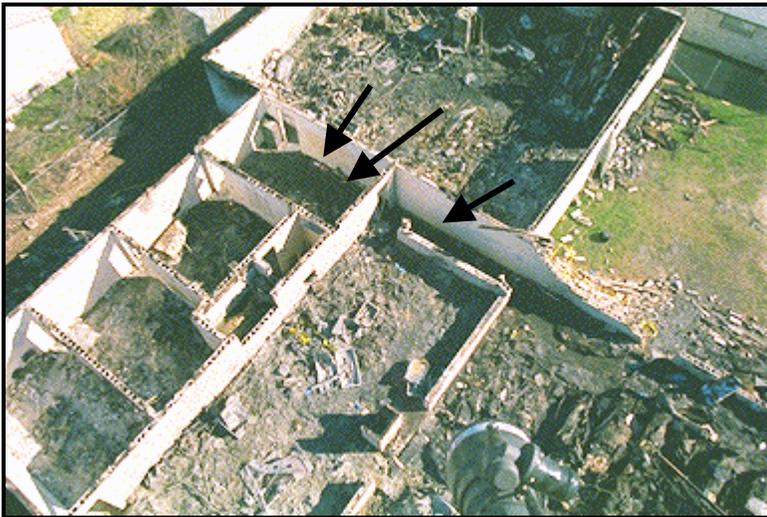
**Photo 5 – Aerial view showing the classroom and altar area where fire fighters were located at the time of the collapse. The arrows show the location of the fatalities. (NFPA Photo)**

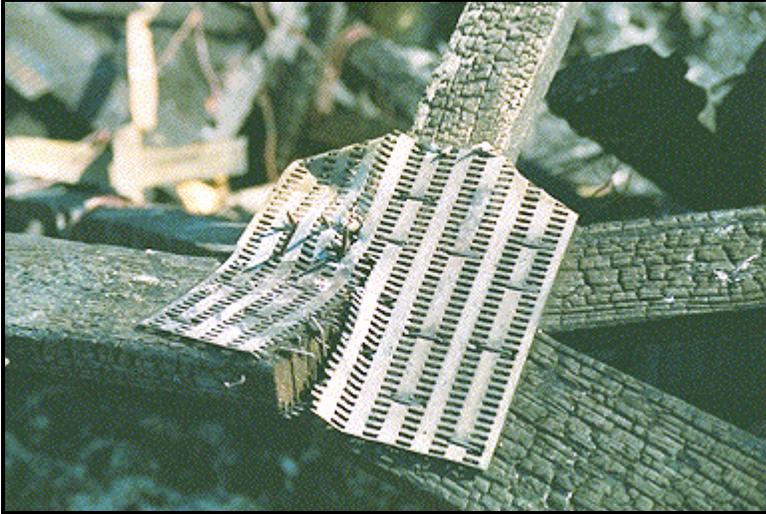
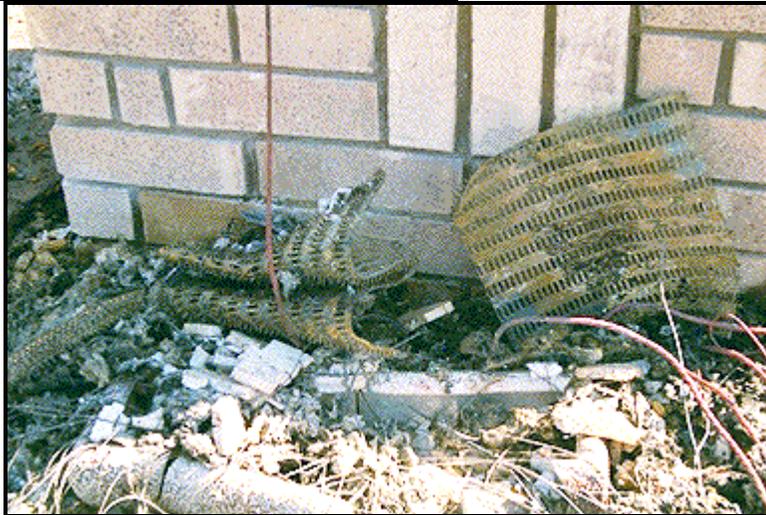
An important failure point of trusses is the connections between the individual members. As stated by one expert, “A truss’ integrity depends on the integrity of its metal connector plates.”<sup>2</sup>

These connections may fail before the members themselves lose their ability to carry the load. Since a single metal plate or plywood gusset may connect a number of members together, loss of the integrity of one plate may result in a catastrophic failure of the entire truss.

**Photos 6 and 7 – The remains of gusset plates from the Lake Worth church (NFPA photos)**
