**BED AND BREAKFAST
ALLENSTOWN, NH
JULY 17, 2001**

**FIRE
INVESTIGATIONS**

Bed and Breakfast

Allenstown, NH
July 17, 2001

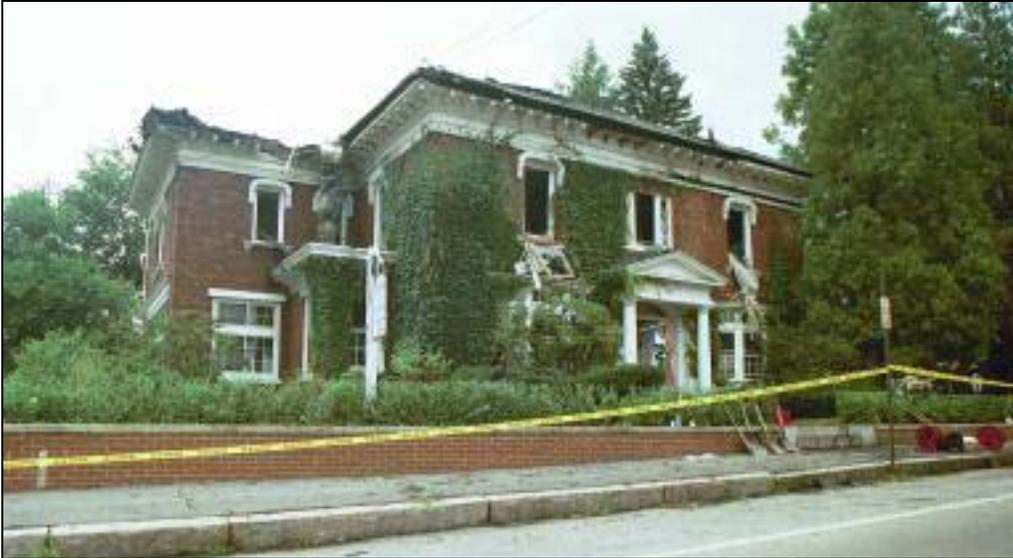
Photo 1 – Bed and Breakfast Showing the Front Entrance from the Southeast Corner. (NFPA)

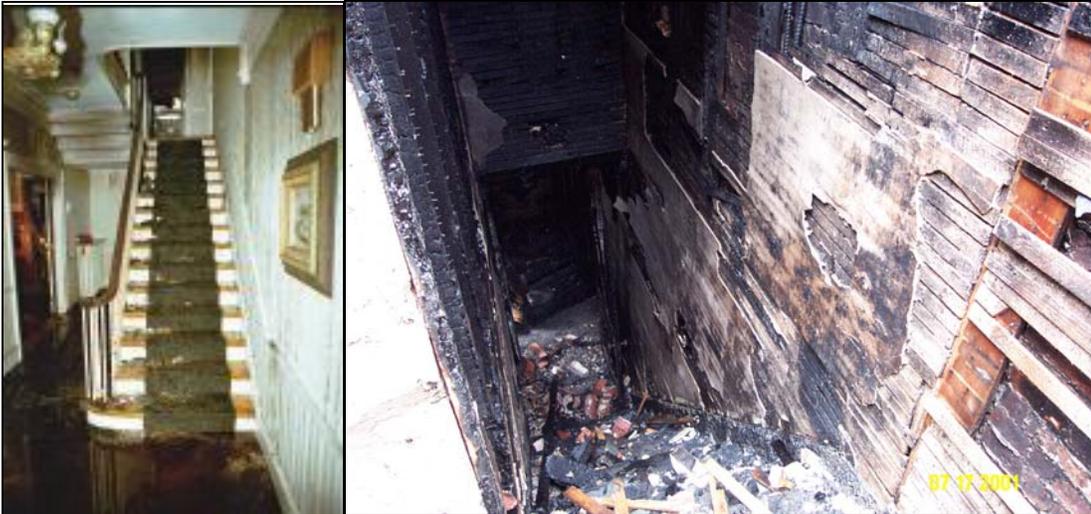
Photo 2-3 – Front Stairway (left) and Rear/Kitchen Stairway (right). (NFPA)

The guest rooms in this facility were located on the second floor. The two primary means of escape from the guest rooms were open stairs. The central stairs were located directly inside the front entrance to the building. The second set of stairs was located at the end of the rear (south) corridor. Neither stair was enclosed. A door was installed on the bottom of the south stair at the kitchen level. No door was installed at the top of this stair. Smoke and heat traveled up both sets of stairs to the second floor as the fire spread in the kitchen area. Flames spread up the rear stair from the kitchen and through the rear corridor.

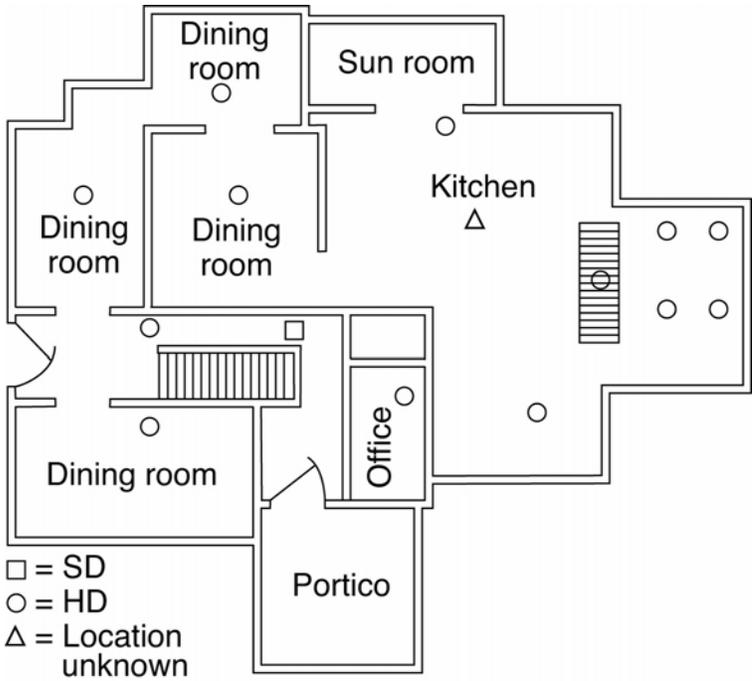
Figure 4 – Detector Locations – First Floor.

The fire alarm system for this building consisted of smoke and heat detectors located in the corridors, guest rooms, and the basement, and heat detectors in the kitchen and dining rooms. Manual fire alarm boxes were located throughout the building. Horn and strobe light notification appliances were located throughout the building on each level. The fire alarm control panel was located in a closet beneath the central staircase on the first floor. An alarm annunciator panel was located on the outside wall of the building adjacent to the portico entrance (west).

On the night of the fire no one reported hearing any audible warning horns or seeing strobe lights. The auto dialer function functioned by transmitting a signal to the fire alarm office in Concord. A manual fire alarm box was activated by a fire officer after the fire department's arrival.

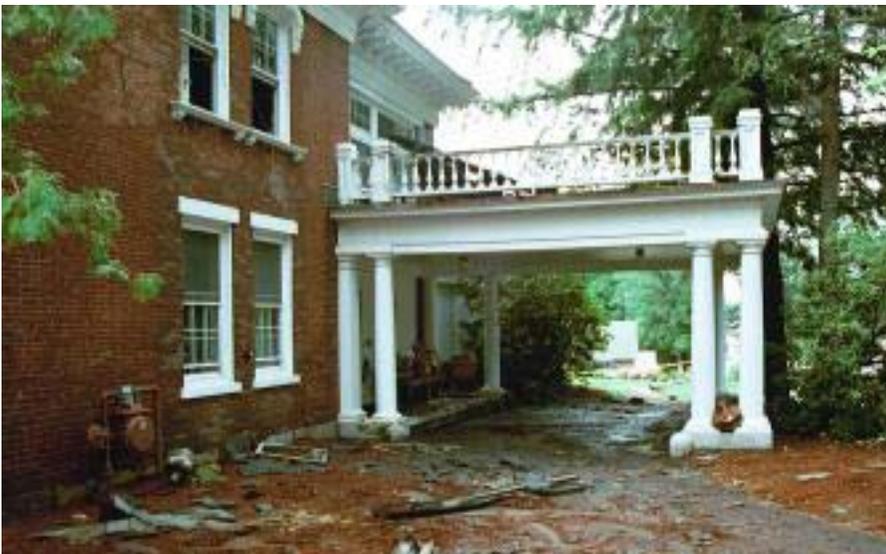
Ground ladders were raised to the portico roof and three occupants were removed (see Photo 4). Companies began searching for other occupants on the second floor as hose teams sought the seat of the fire on the first floor in the kitchen area. A 1 ¾ inch hose line was also advanced to the second floor via the central stairs. This hose line was advanced to the top of the stairs and then forward to the beginning of the corridor that ran toward the rear of the structure (south). Fire fighters encountered significant heat at this location and applied water to the corridor ceiling.

Photo 4 - Portico on North Side of Building Where Two Guests Were Rescued. (NFPA)

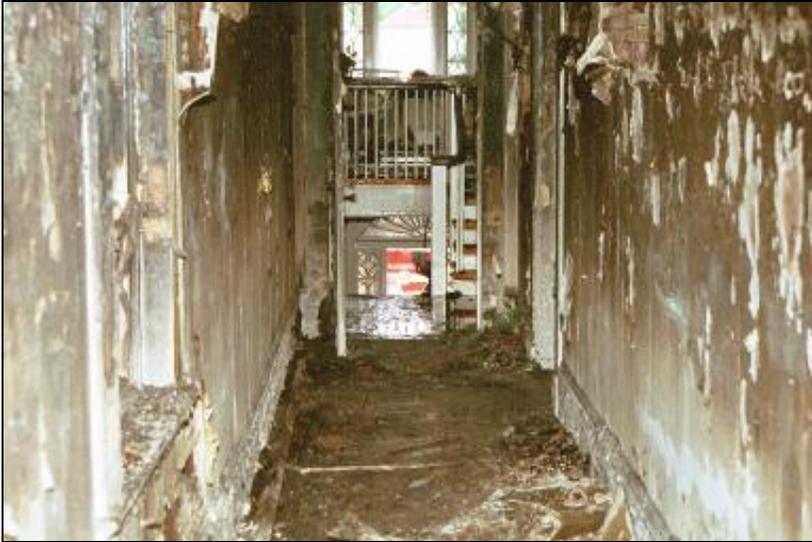
The southern portion of the second floor suffered serious fire damage. This area included the corridor, two guest rooms, and the owner's apartment located in and adjacent to the rear (south) corridor. The northern portion (front) of the second floor,

containing the remaining quest rooms, sustained heavy smoke and water damage. (see Photo 5)

Photo 5 - Damage in Second Floor Rear Corridor. (View facing central stairway/front door). (NFPA)

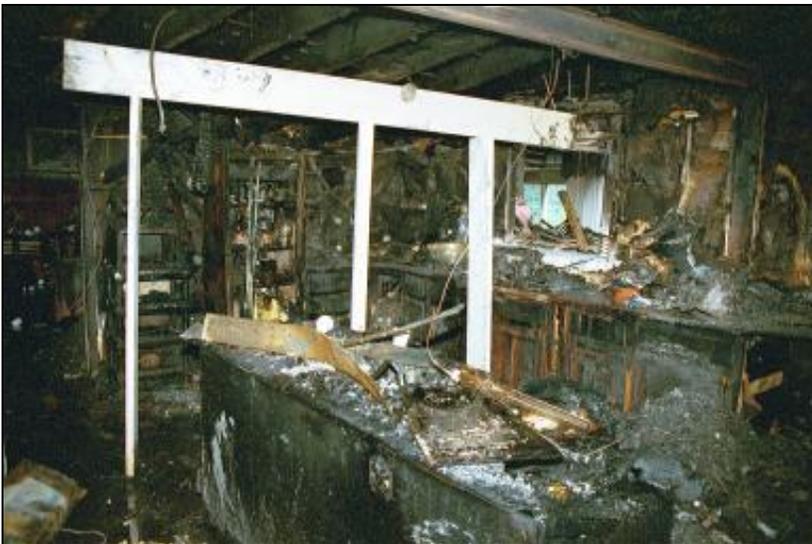
The building suffered extensive damage on all levels as a result of this fire. The kitchen area, including the sun room and the southern portion of the first floor sustained heavy damage from flame spread and heat. The majority of the kitchen area was burned out. Before the fire investigation could begin, shoring had to be installed to support a structural steel beam in the kitchen area due to visible sagging in the beam from the heat of the fire. (see Photo 6) The remaining portions of the first floor (dining rooms) sustained heavy smoke and water damage.

Photo 6 - Damage in Kitchen Near Area of Origin. (Note: Bracing added after fire to support fire-weakened beams.)(NFPA)

The Fire Marshal's Office of the State of New Hampshire has determined that the fire began in the kitchen food preparation area. The cause of the fire was determined to be accidental by the New Hampshire State Fire Marshal's Office.

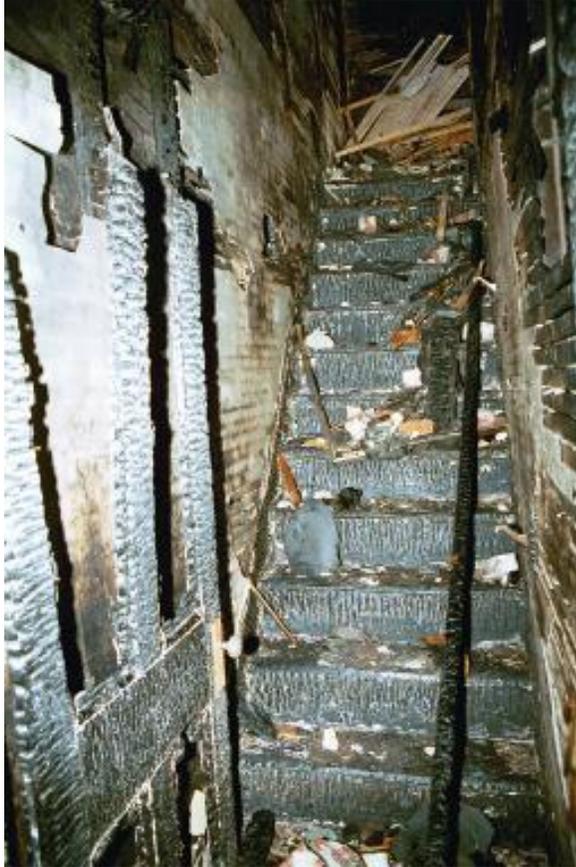
The fire started in the kitchen area after the occupants had retired for the evening. The fire heavily damaged the kitchen area and rear corridor leading to the back stairs to the second floor. The fire spread up the rear stairs to the second floor and into the south corridor (see Photo 7). The sun room, adjacent to the kitchen/dining areas, also suffered significant fire damage.

Photo 7 – Damage to Rear Stairway. Remains of Door are Visible on the Left of the Photo. (NFPA)

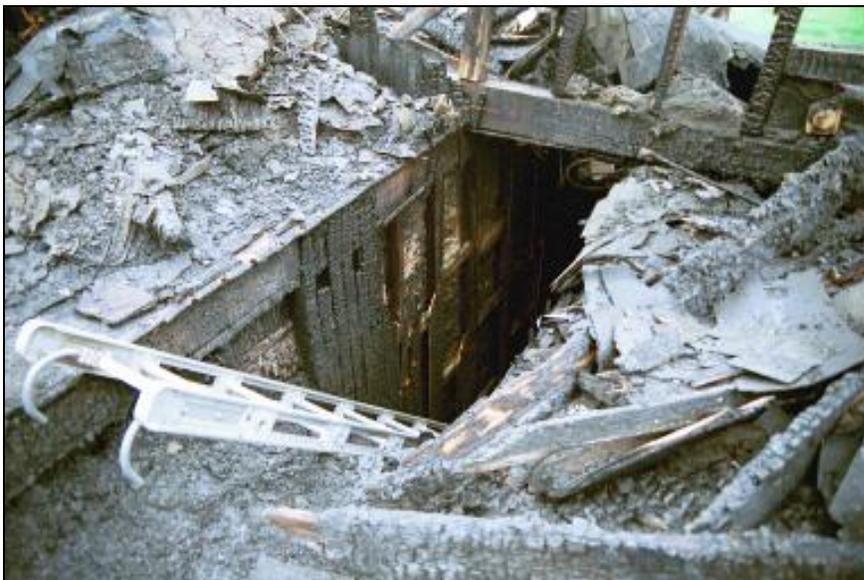
The attic space suffered heavy fire damage and partial collapse. The stair leading from the second floor apartment to the attic was burned away.

Flames entered the attic via the stairs and interior partitions and caused heavy damage to the attic space. The fire eventually burned through the roof structure, causing partial collapse (see Photos 8 and 9).

Photo 8 – View of Stairway Leading to Attic Sleeping area. Fire department Ladder was Inserted for Access to the Attic Because the Wooden Staircase was Burned Away During the Fire. (NFPA)

The attic sleeping area was arranged with a single means of escape, an unenclosed stair that terminated in the owner's apartment. The apartment was a converted guest room on the south portion of the second floor. There was no secondary means of escape from the attic sleeping area. This arrangement did not meet the requirements of the *Life Safety Code*[®].

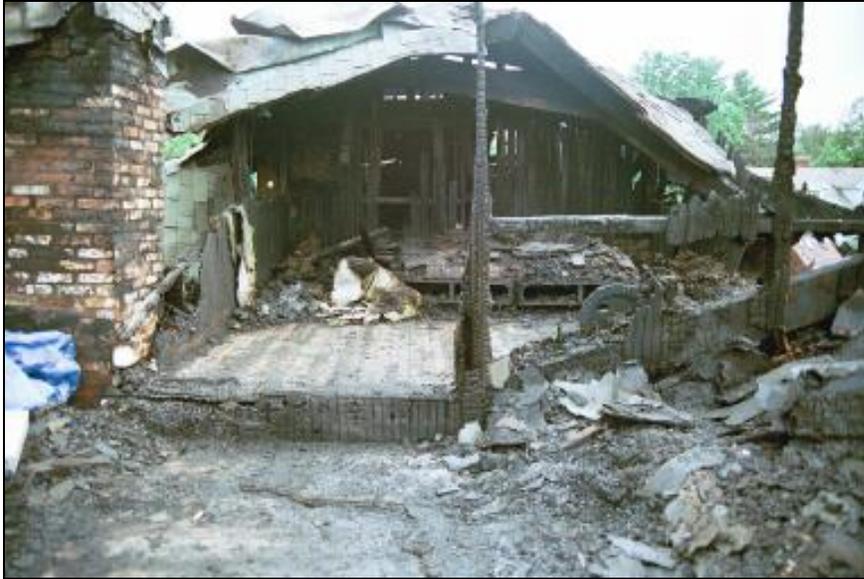
Photo 9 – Attic Sleeping Area. (NFPA)
