# TRACTOR TRAILER EXPLOSION

Benicia, CA  
January 19, 1985

**Summary Investigation Report**

**Highway Accident Involving  
Molten Sulfur  
Benicia, CA  
January 19, 1985**

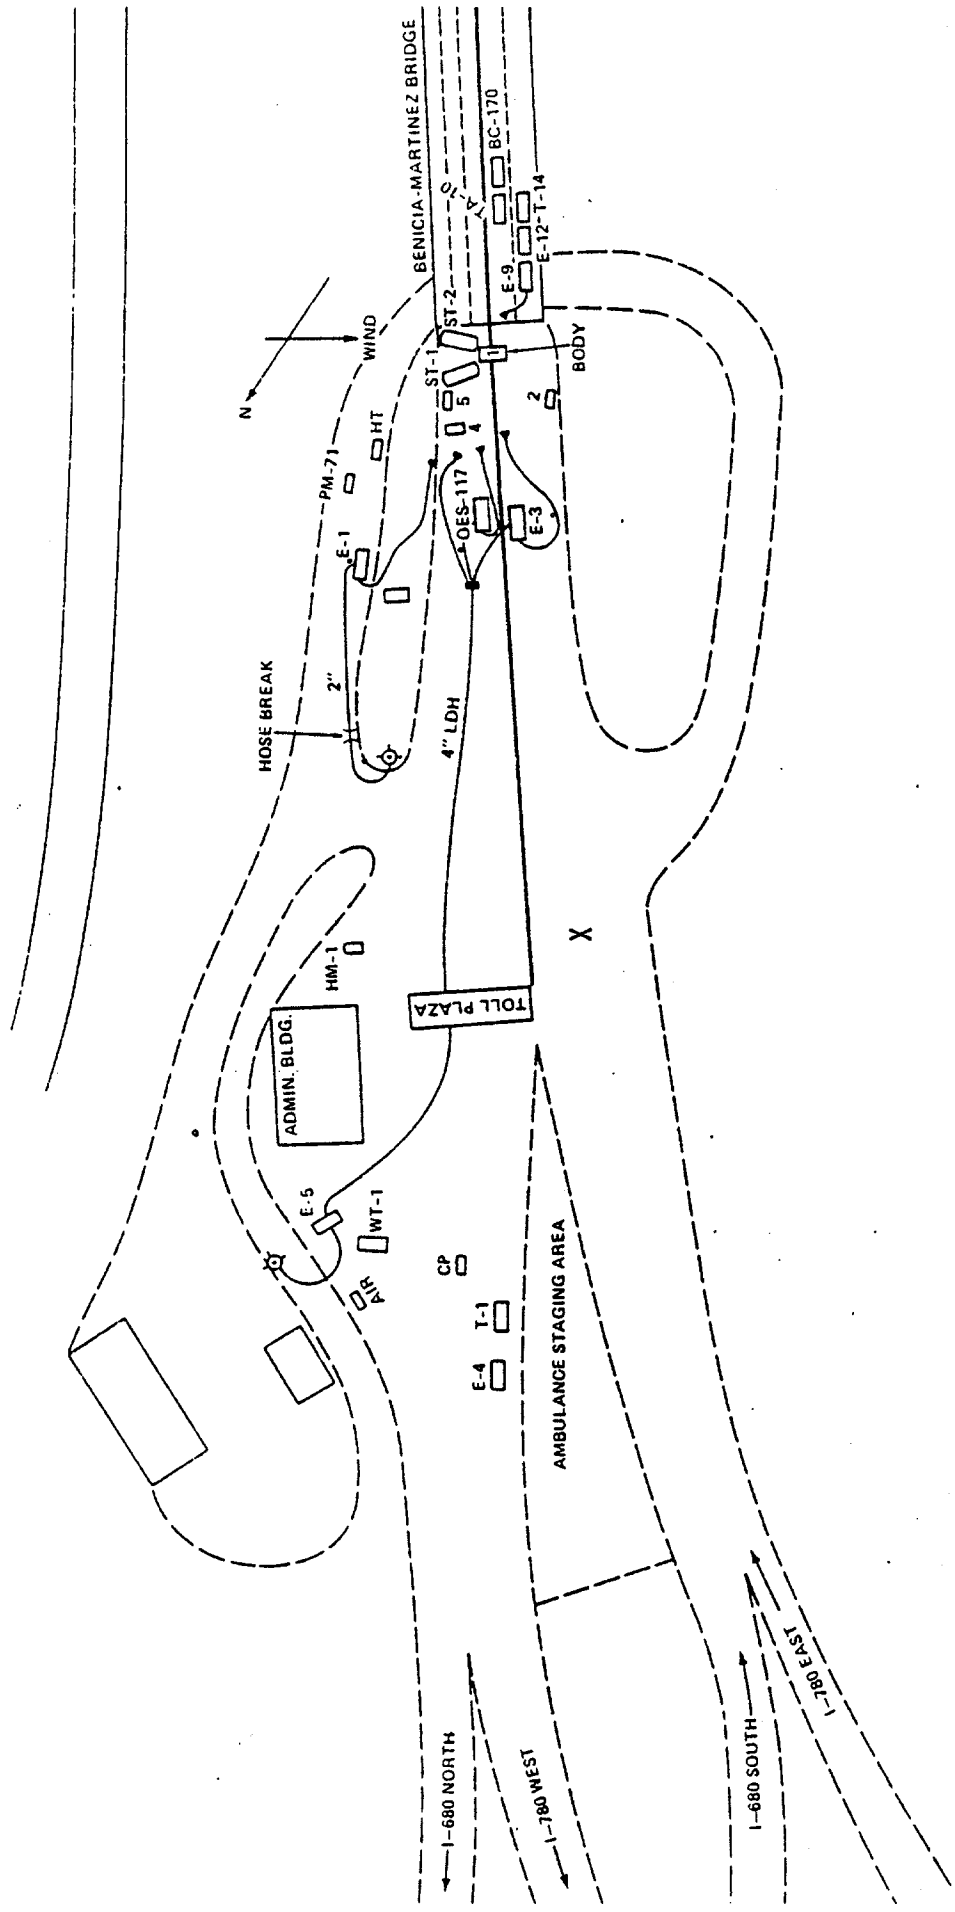
APPENDIX A  
 FIGURE 1

The initial contact between the two vehicles seems to have occurred just south of the toll booths. The Camaro spun out of control and came to rest against the south wall of the bridge. The truck careened along the bridge approach lanes, then struck and vaulted over the center divider into oncoming traffic. Both vehicles travelled up to 250 feet from the point of initial contact. (Point "X" on the Accident Site Diagram, Figure 1.)
