FIRE FIGHTER FATALITY

Biloxi, MS

October 20, 1986

Tragedy Strikes Biloxi

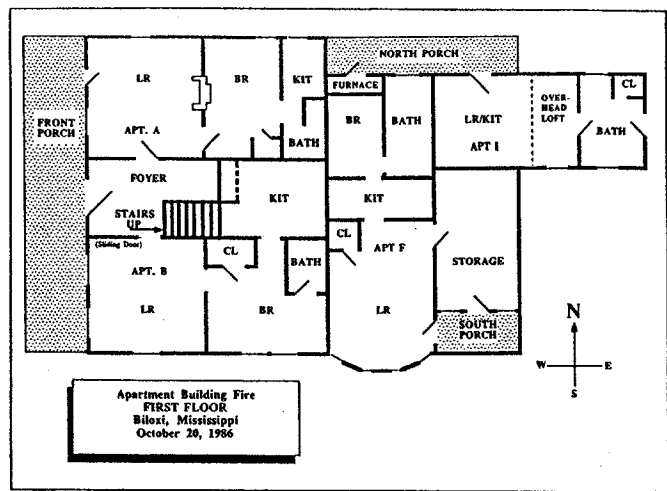
Figure 1

The large, two-story wood frame structure at 506 Reynoir Street originally had been a single family dwelling. It was built around the turn of the century and was converted to an apartment building several years later. There were seven living units in the building—four on the first floor and three

on the second. (See Figures 1 and 2.) Except for apartment I, all units were occupied at the time of the fire. Eight persons occupied the first floor—four in apartment A and two each in apartments B and F. Three persons occupied the second floor—one occupant each in apartments C, D and E.

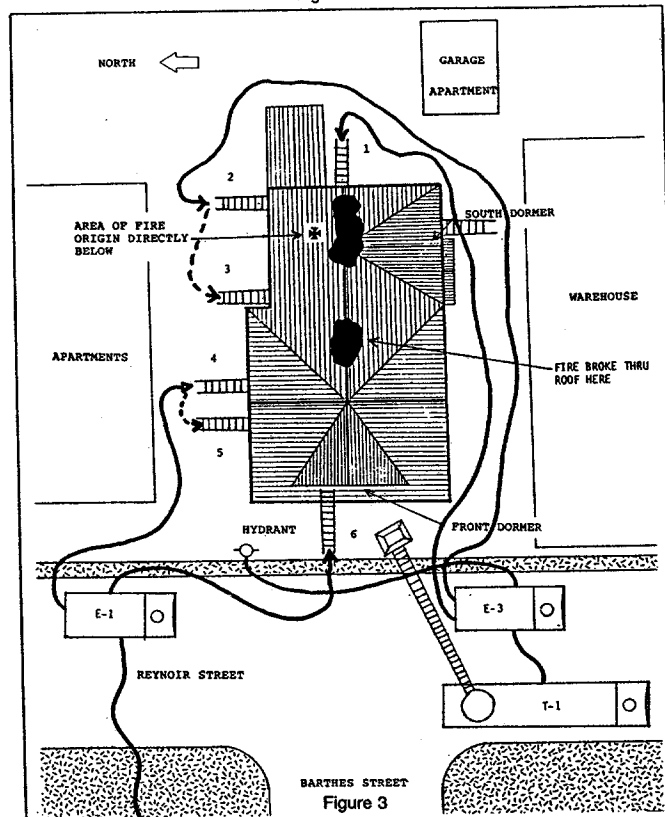
Figure 3

As suppression efforts continued, fire suddenly erupted from the bedroom window of apartment E (see position 5, Figure 3). Fire crews stopped their attack at position 4 and directed streams through the window from the ground. At about this time, Truck 1 began directing its master stream into the front dormer, which also was beginning to burn.

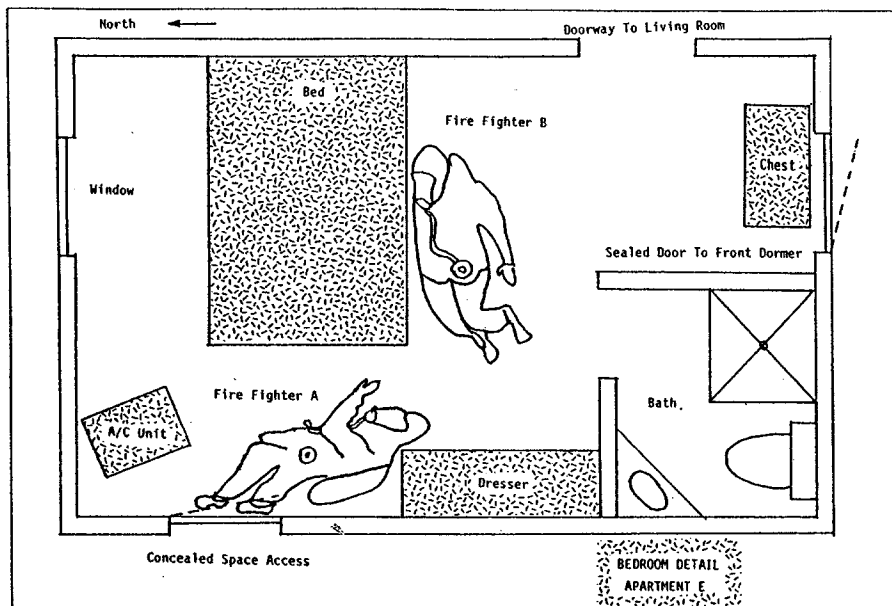
Figure 4

Fire fighter A was found lying on his side on the floor between the dresser and bed (see Figure 4). The SCBA was being worn and the facepiece was tightly sealed on the face. The breathing tube was not connected to the regulator, but was found near the victim's hand. Burned debris was present on top of the body but not beneath it. His helmet was located approximately four feet away, near the bedroom window.
