SUMMARY FIRE INVESTIGATION REPORT

**HOSPITAL FIRE
BROOKLYN, NEW YORK
SEPTEMBER 1, 1993**

**PREPARED BY
MICHAEL S. ISNER
FIRE PROTECTION ENGINEER
NATIONAL FIRE PROTECTION ASSOCIATION**

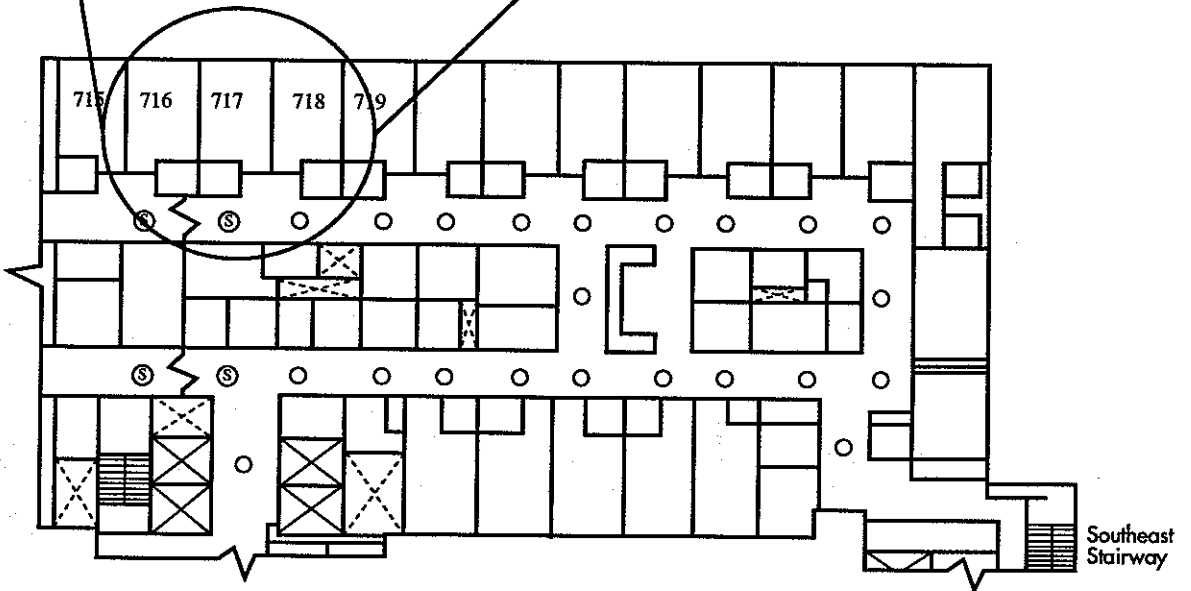
**Fire Area - Maimonides Medical Center
Figure 1**

and in each patient room, one separation wall is in-line with the I-beams (see figure). The other patient room wall is installed between the I-beams. Walls in-line with I-beams extend from the floor slab up to the I-beam's bottom flange. Whereas, walls installed between the I-beams extend up to the underside of the corrugated metal decking, which is perpendicular to the wall.

Three patients died (see figure for victims' location). One patient, reportedly, sustained serious injuries, and many other patients received minor injuries. In addition, 11 fire fighters were treated on the scene for exhaustion.
