CRUISE SHIP FIRE
Port Canaveral, FL
March 9, 1984

Investigation Report

Scandinavian Sea Cruise Ship Fire
Port Canaveral, Florida
March 9, 1984

Tom Timoney
Fire Protection Specialist
Fire Investigations and Applied Research Division
National Fire Protection Association

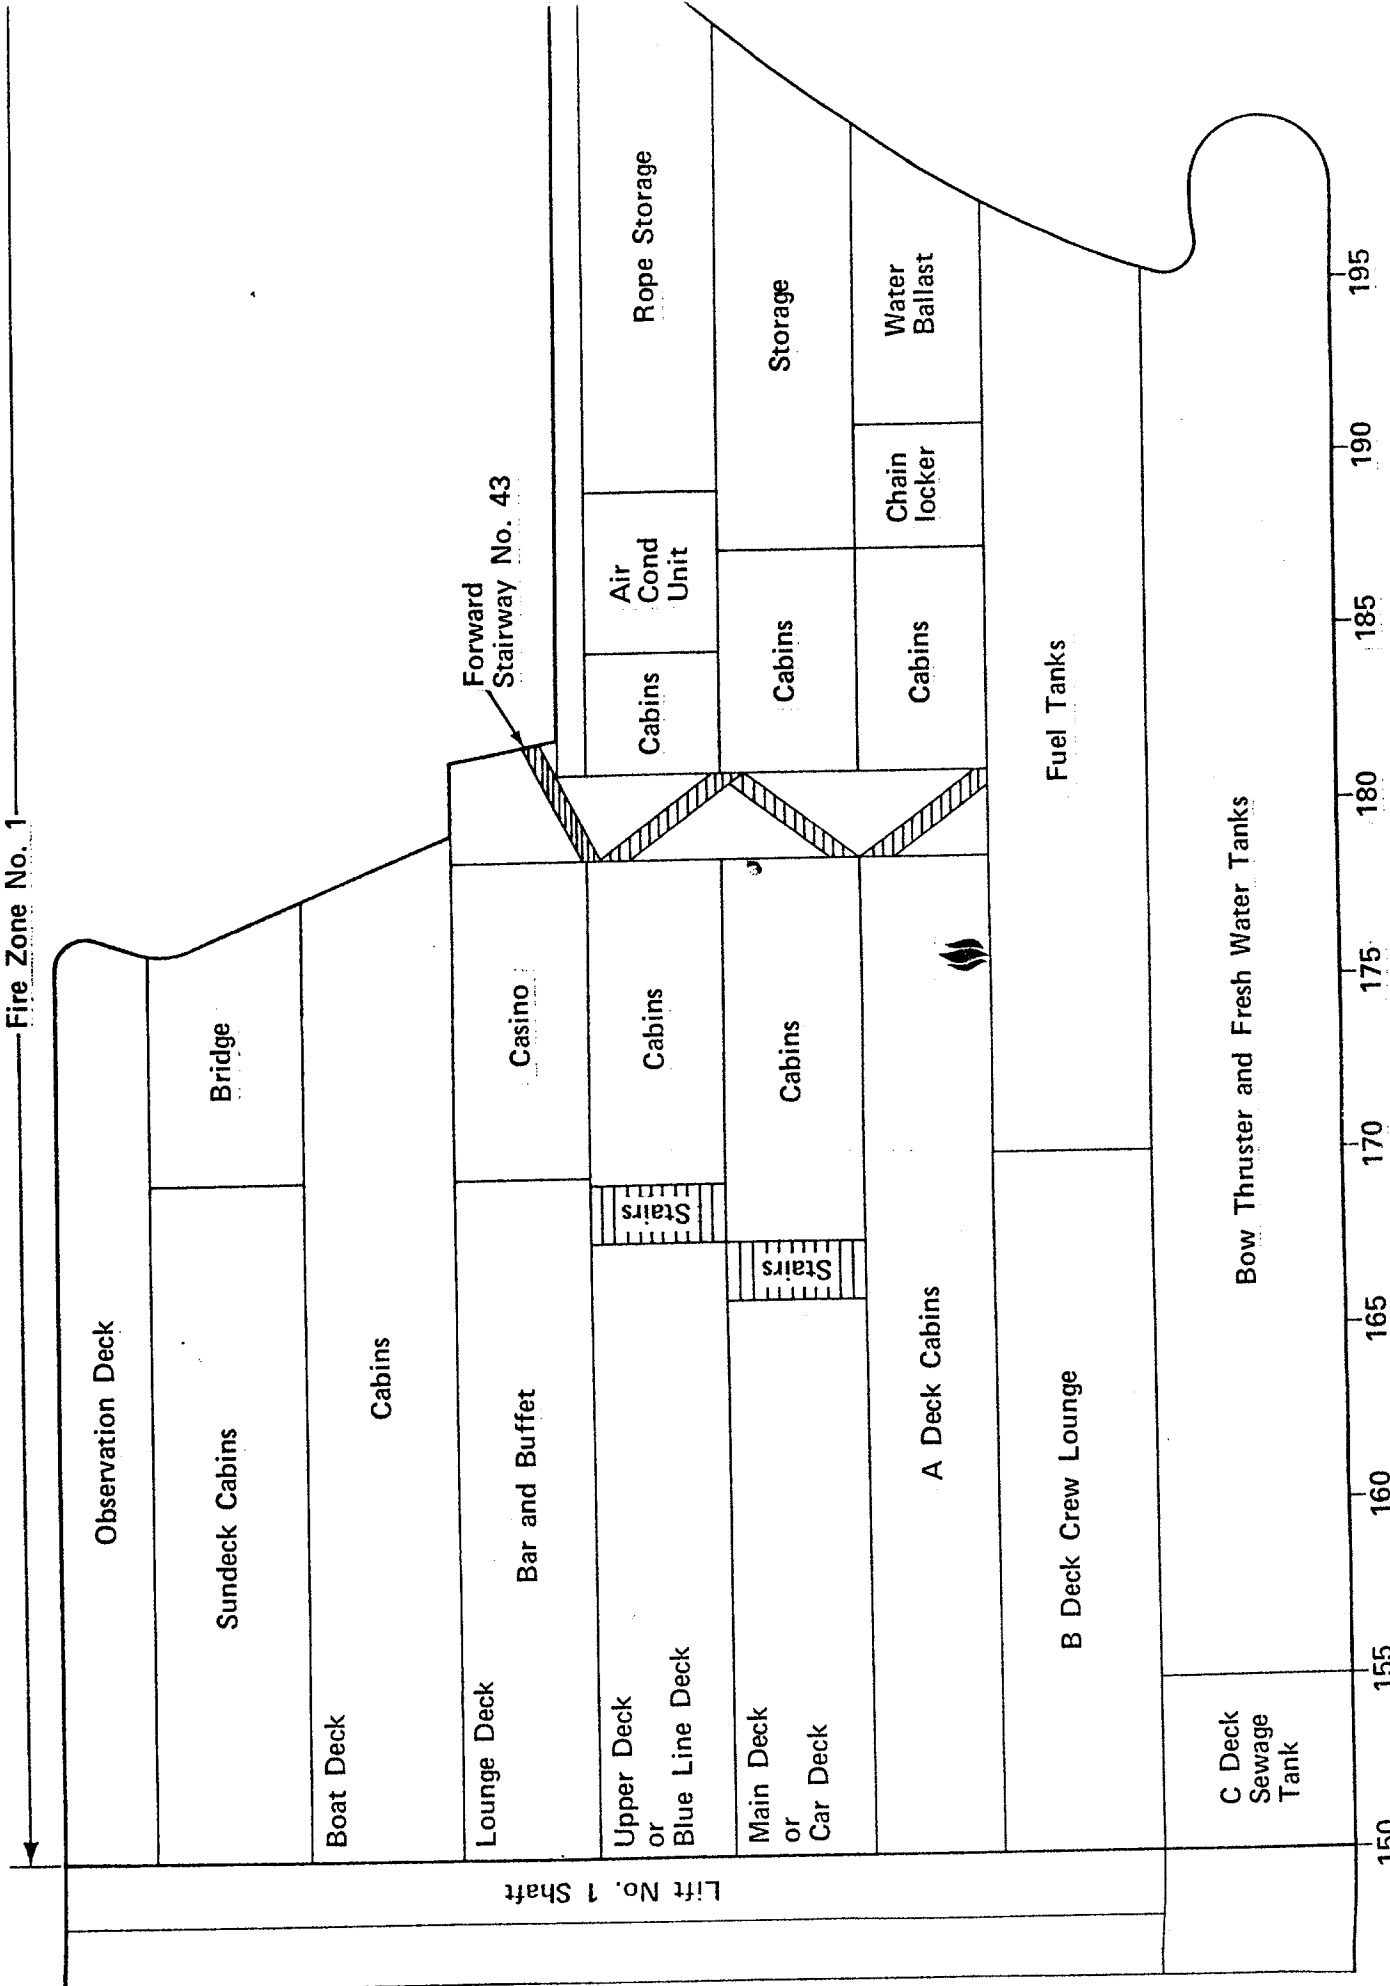
Fig. 2 'A' DECK

At the time of this report, the cause of this fire remained undetermined. The crew member who discovered the fire in cabin 414 described finding a 2-foot circular area of the carpeting burning in the rear of the cabin. He was unable to extinguish the fire with portable hand extinguishers and notified the bridge before retreating from the area to don SCBA.

As the fire in cabin 414 grew from the incipient stage to involve bedding materials, furnishings, and personal articles, full cabin involvement occurred before the fire brigade could attack the fire with 2 1/2-inch handlines. With the door to cabin 414 open, intense heat and smoke quickly built up in the passageway in the A deck area forward of the fire-rated bulkhead at frame 153. The steel envelope created by the ship's hull, bulkheads, and decks not only prevented the rapid dissipation of the built-up heat, but also was a medium of fire spread to the surrounding areas, particularly the upper decks, through heat conduction and through fire rated doors opened during fire fighting operations.

The ship's fire brigade attacked the fire on A deck equipped with SCBA but without full protective clothing. They were able to advance a handline through the fire door in the fire-rated bulkhead at frame 153 and down the passageway to cabin 414. However, before they were able to extinguish the fire, they were driven from the area by intense heat. Because of the intense heat contained in the steel envelope of the A deck, members of the ship's fire brigade could not effectively attack and extinguish the fire in cabin 414, without being equipped with both SCBA and full protective clothing. The fire brigade then withdrew behind the fire-rated bulkhead at frame 153 and sealed openings in the No. 1 MVZ except for the two handlines which ran through the fire door. It was determined this fire door remained partially open,
