## **SUMMARY FIRE INVESTIGATION REPORT**

**PRINTING OFFICE FIRE**

**DENVER, COLORADO**

**SEPTEMBER 28, 1992**

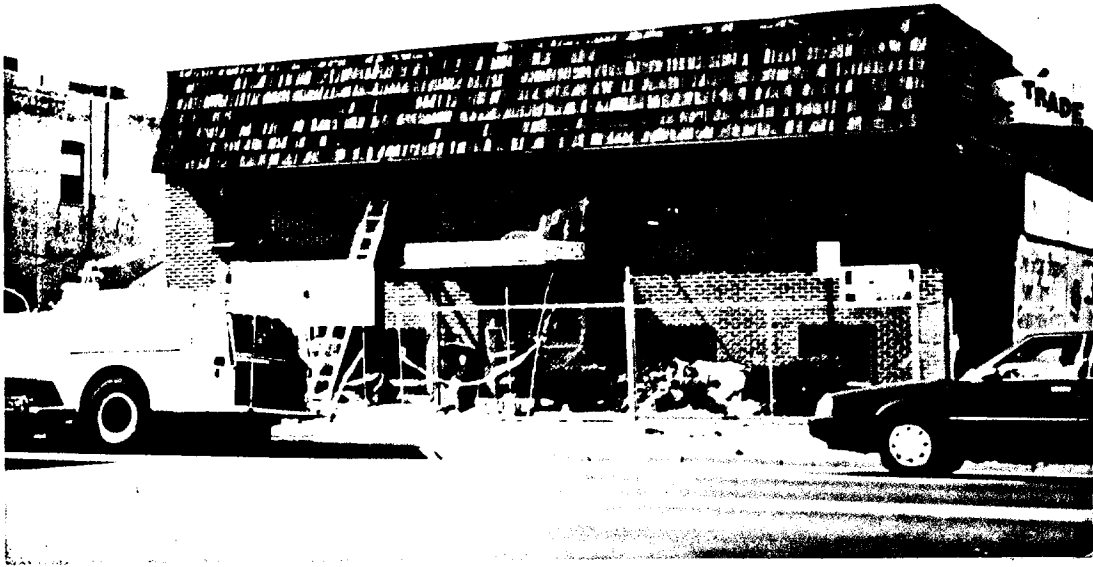
The fire occurred in a two-story, split-entry building that was approximately 48 feet wide and 60 feet long and was being used as the sales offices for three printing businesses. (See Photo 1.) The top floor was 1/2-story above the main entrance and was divided into numerous offices and storage rooms. The first floor was 1/2-story below the main entrance and had additional offices, several production areas, and larger storage areas. There was a minimal amount of flammable solvents in the building so the primary fuels were large quantities of paper stored throughout the building, office furnishings, and office equipment.

**Photo 1. Front of 1625 S. Broadway  
Rescue operations were performed through the  
small second story window next to the ladder.**

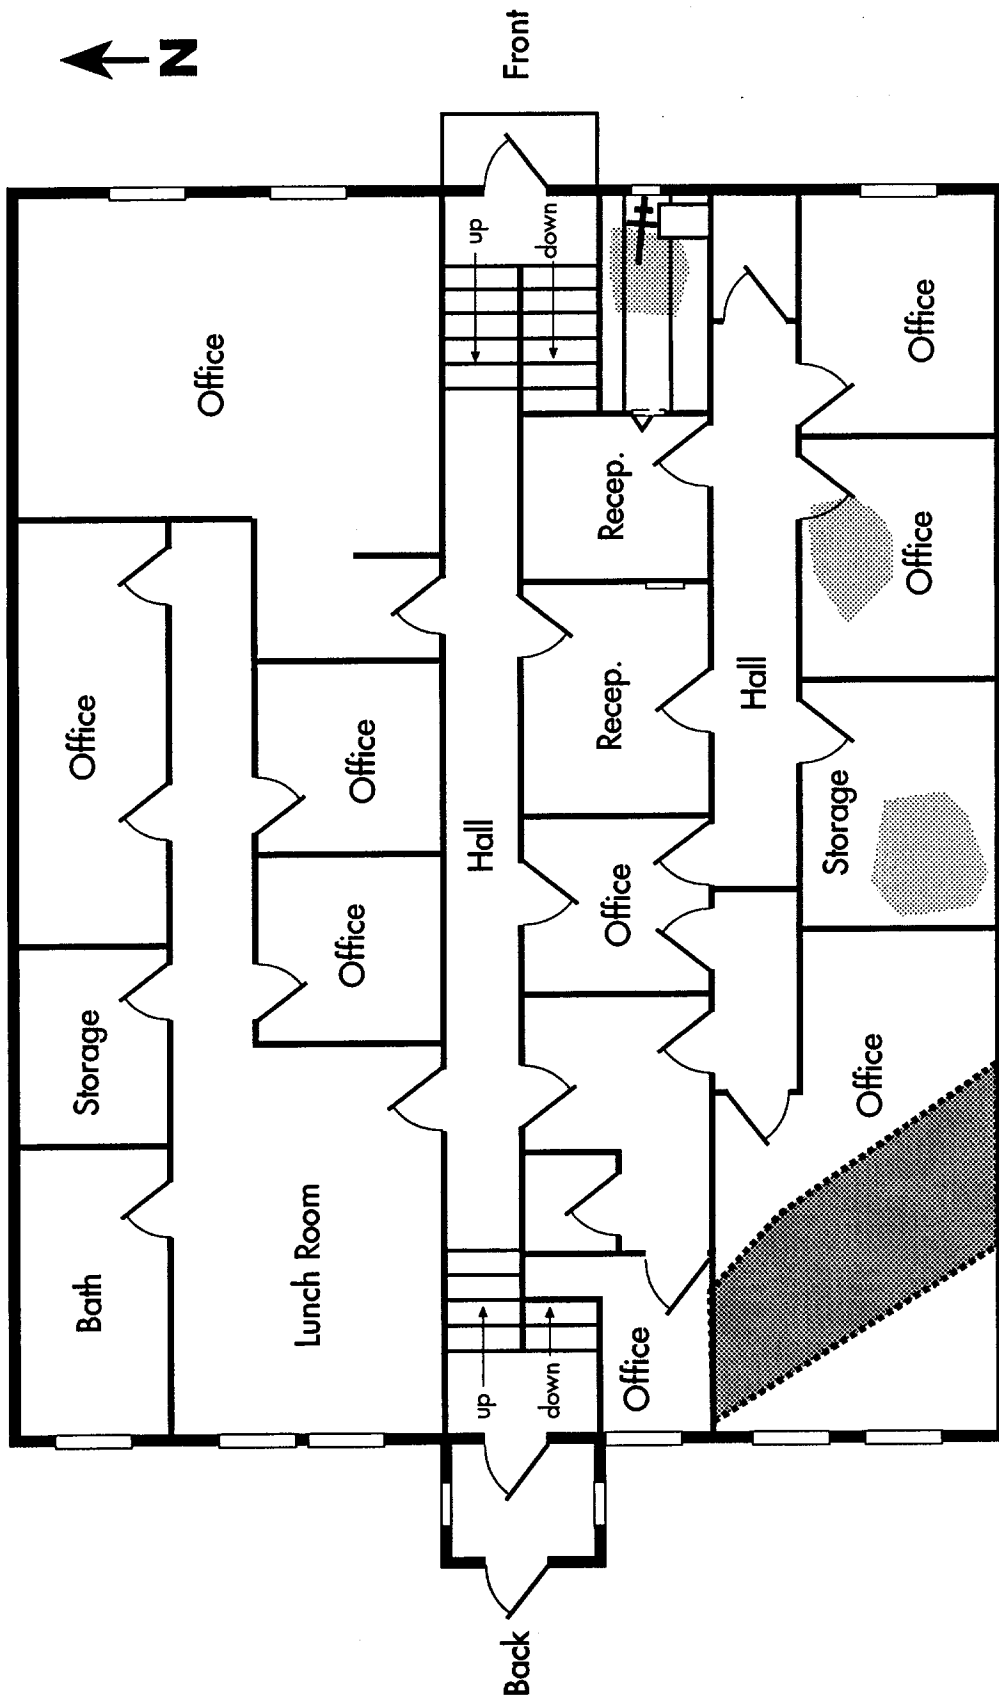
## 1625 South Broadway - 2nd Floor

Their scene examination revealed evidence of a burglary, with forcible entry through a ground floor window. In addition, there was evidence of widespread ransacking of offices, and numerous items of equipment were verified as being missing. Finally, the on-scene work revealed evidence of four separate and (initially) unattached areas of fire origin; three on the first floor and one on the second. (See Figure.) The investigators also believed that a flammable liquid was used in all four locations.
