**RESTAURANT**  
Derby, CT  
December 6, 1985

Summary Investigation Report

Gas Explosion - River Restaurant  
Derby, CT  
6 Fatalities, 18 Injured  
December 6, 1985

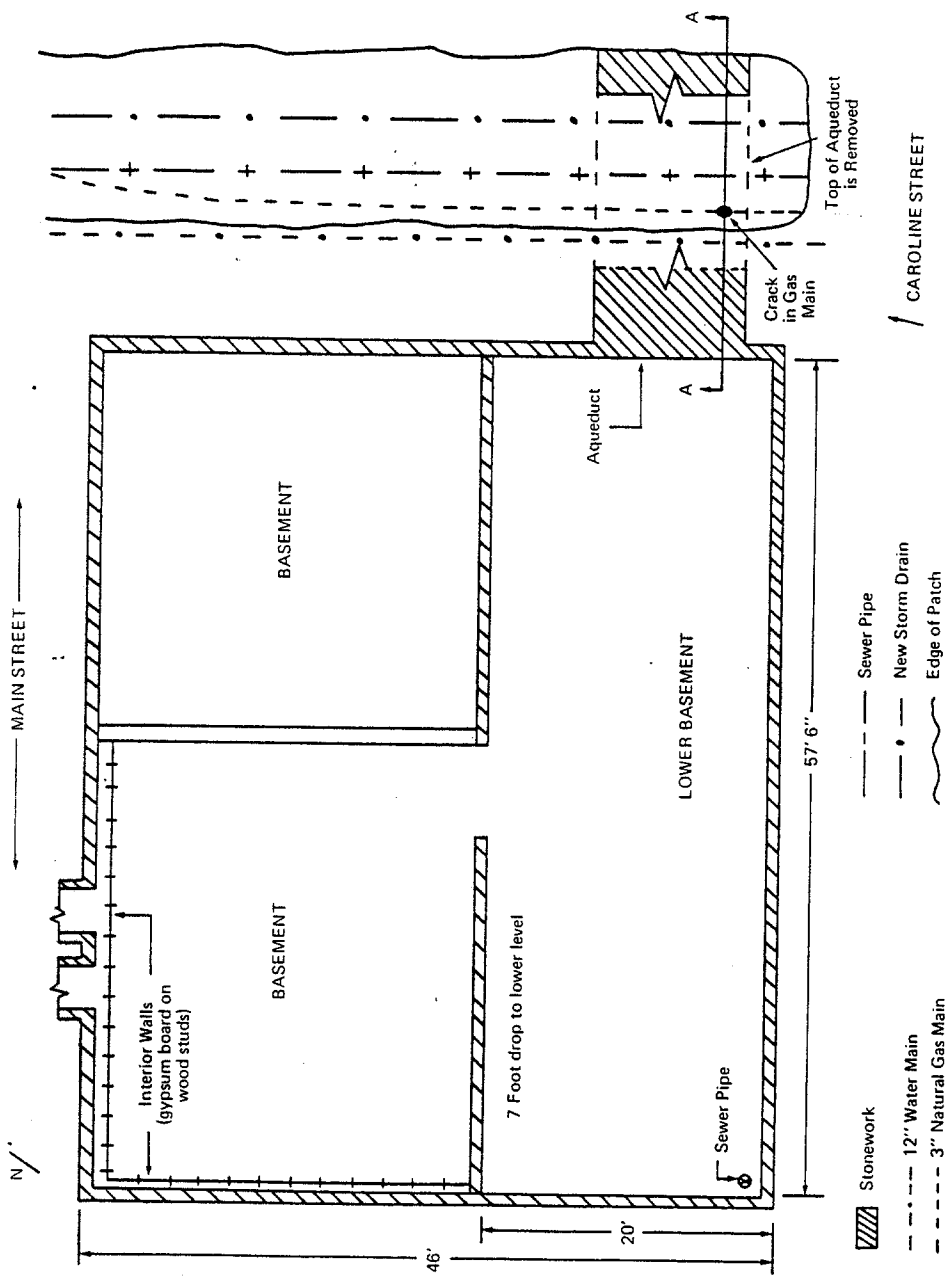
FIGURE 1

The dimensions of the foundation were 57 feet by 46 feet (see Figure 1). Because the building was constructed on a sloping site, it appeared to be a four-story structure in the rear and a three-story structure in the front. The three-story structure had a full basement in addition to the lower basement. Main Street was parallel with the front of the building; Caroline Street was parallel to one side and First Street was parallel with the rear of the building.

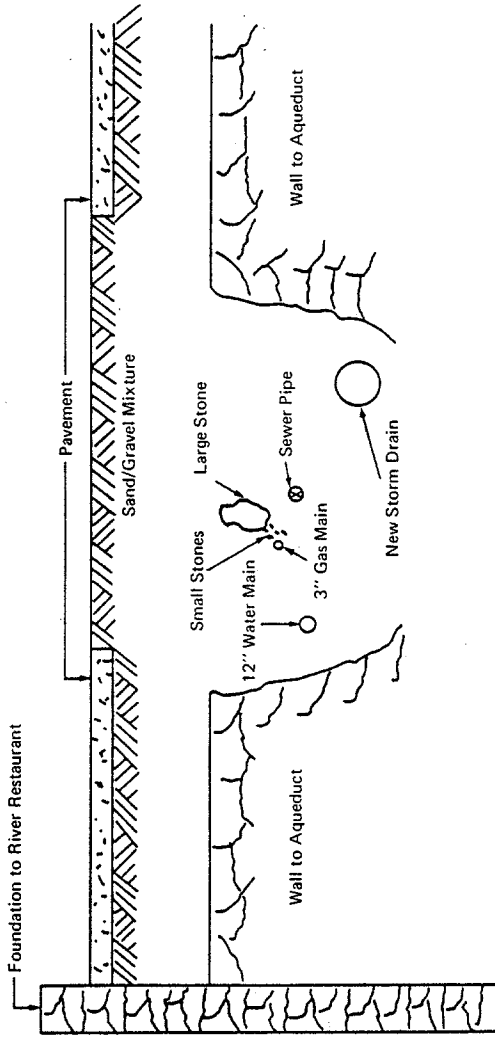
Cross Section at Point of Crack  
Figure 2

A 12-inch water main, a three-inch gas main, a sewer pipe, and a new storm drain were buried under Caroline Street. To facilitate the installation of these pipes, a part of the aqueduct under Caroline Street had been removed and remaining aqueduct was closed off with a stone wall (see Figure 2). The gas main had been in place since 1893 and had a pressure of 1 psi. It was installed about 40 inches below the surface of Caroline Street. Before the work was started, the locations of the pipes were marked on the surface of Caroline Street. These markings indicated that the gas main and the sewer pipe actually crossed one another near the corner of Caroline and Main Streets. The soil in the area of the excavation was a sand/gravel mixture that also contained stones, broken concrete, and asphalt.

The State of Connecticut Department of Public Utility Control determined that "The probable cause of the incident was excavation activities by (the contractor) which caused a cast-iron pipe to crack."<sup>3</sup> Metallurgists from the National Transportation Safety Board (NTSB) examined a cracked section of the gas main suspected as the origin of the natural gas leak. Their tests revealed that the crack, which extended around the entire pipe circumference, was the result of a force overload. A large stone was found within inches of the pipe near the point of force application. In addition, several smaller stones were found between the large stone and the gas main (see Figure 2). These smaller stones were identified as a path through which forces from the rock could be transferred to the gas main. The investigation could not be determined whether the force transmitted by the large stone was a result of it being dropped during backfill operations, whether the stone was in place from other construction work and tamping operations generated the force, or whether the force was generated through other means.

The natural gas escaped through the resulting crack, seeped through the soil, and then entered the basement through the stacked stone walls of the

aqueduct. Considering the size and type of crack in the gas main, the diameter of the gas main, pressure within the main, the estimated volume of the basement and lower basement, and other factors, state fire investigators concluded that the Lower Explosive Limit (LEL) could have been reached in two minutes if the leak was in open air, all the gas entered the building, and all the gas remained in the basement area. They also indicated that this time has to be adjusted upward to account for the affects of the unquantified variables; such as those previously mentioned. Based on these variables and information obtained in the investigation, the State of Connecticut Report indicated that the leak did not exist 6 1/2 hours before the explosion.<sup>4</sup>
