HAUNTED CASTLE AMUSEMENT FACILITY FIRE

Jackson Township, NJ

May 11, 1984

Investigation Report

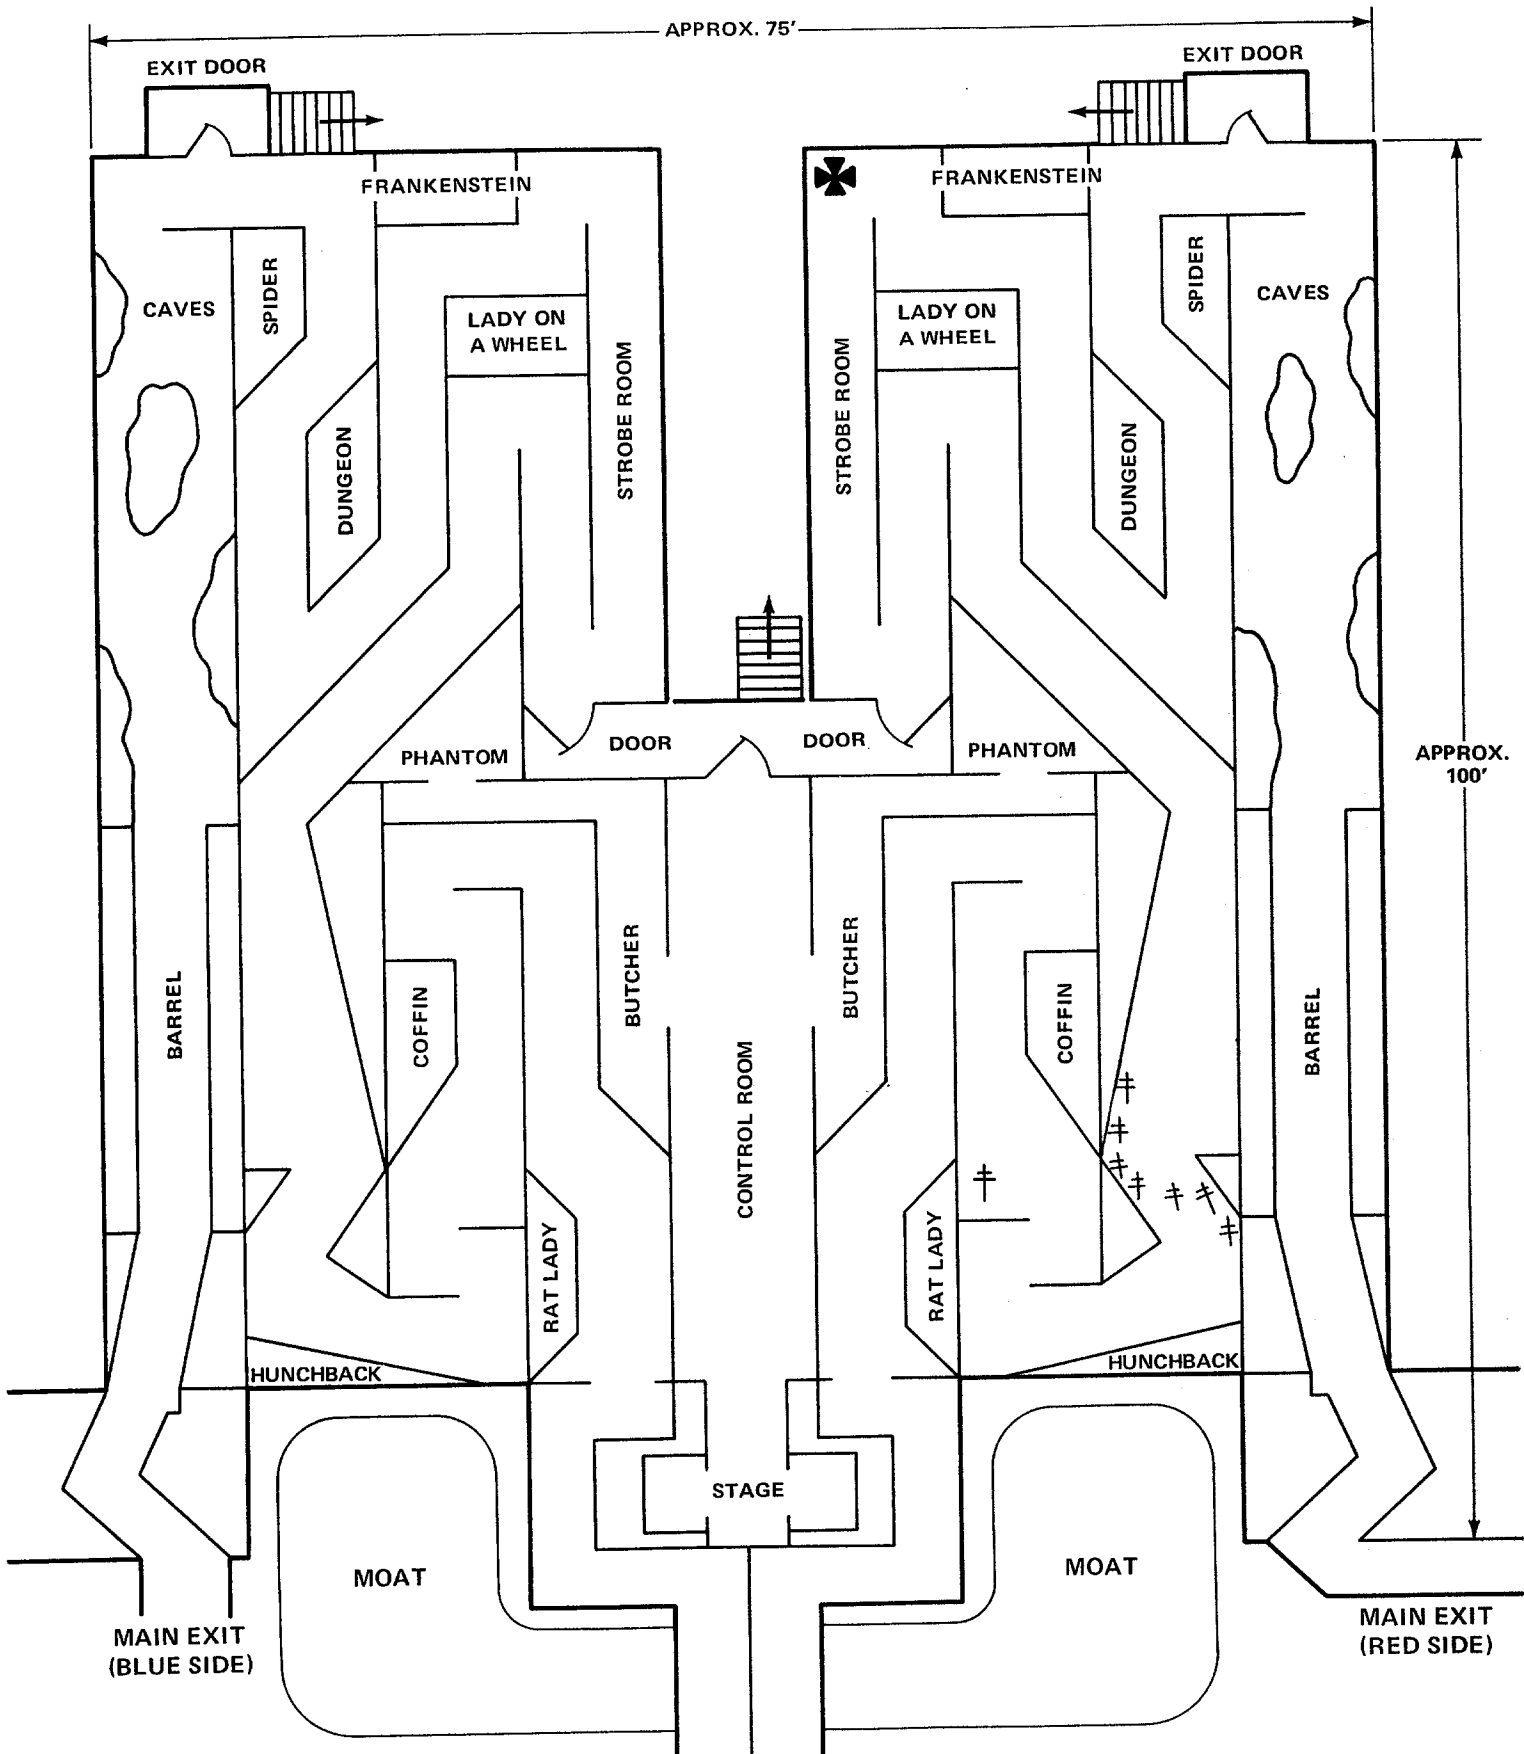
FIGURE 1

According to the Ocean County Coroners office, eight young adults, who ranged in age from 15 to 19, died as a result of smoke inhalation and carbon monoxide poisoning. Seven of the victims were found in the corridor near the hunchback display and the eighth victim was found in the vicinity of the coffin display (See Figure 1).

Investigators from the Ocean County Prosecutors Office, the Ocean County Fire Marshal's office and the New Jersey State Police determined the cause of the fire to be the accidental ignition of polyurethane foam padding on the wall of the strobe room.

Once ignited, the wall mounted polyurethane foam pad burned rapidly in the vertical plane in the corner of the trailer. Fire spread down the strobe room corridor further fueled by the plywood construction of the ceiling, floor and walls. Once the fire had spread through the corridor, it extended past the phantom of the opera area and to other portions of the Haunted Castle.

Two of the nine visitors were able to retreat as far as the coffin display when they were overcome by smoke and collapsed. A Great Adventure employee was able to rescue one of these two visitors. The other seven victims were found in a corridor near the hunchback display.

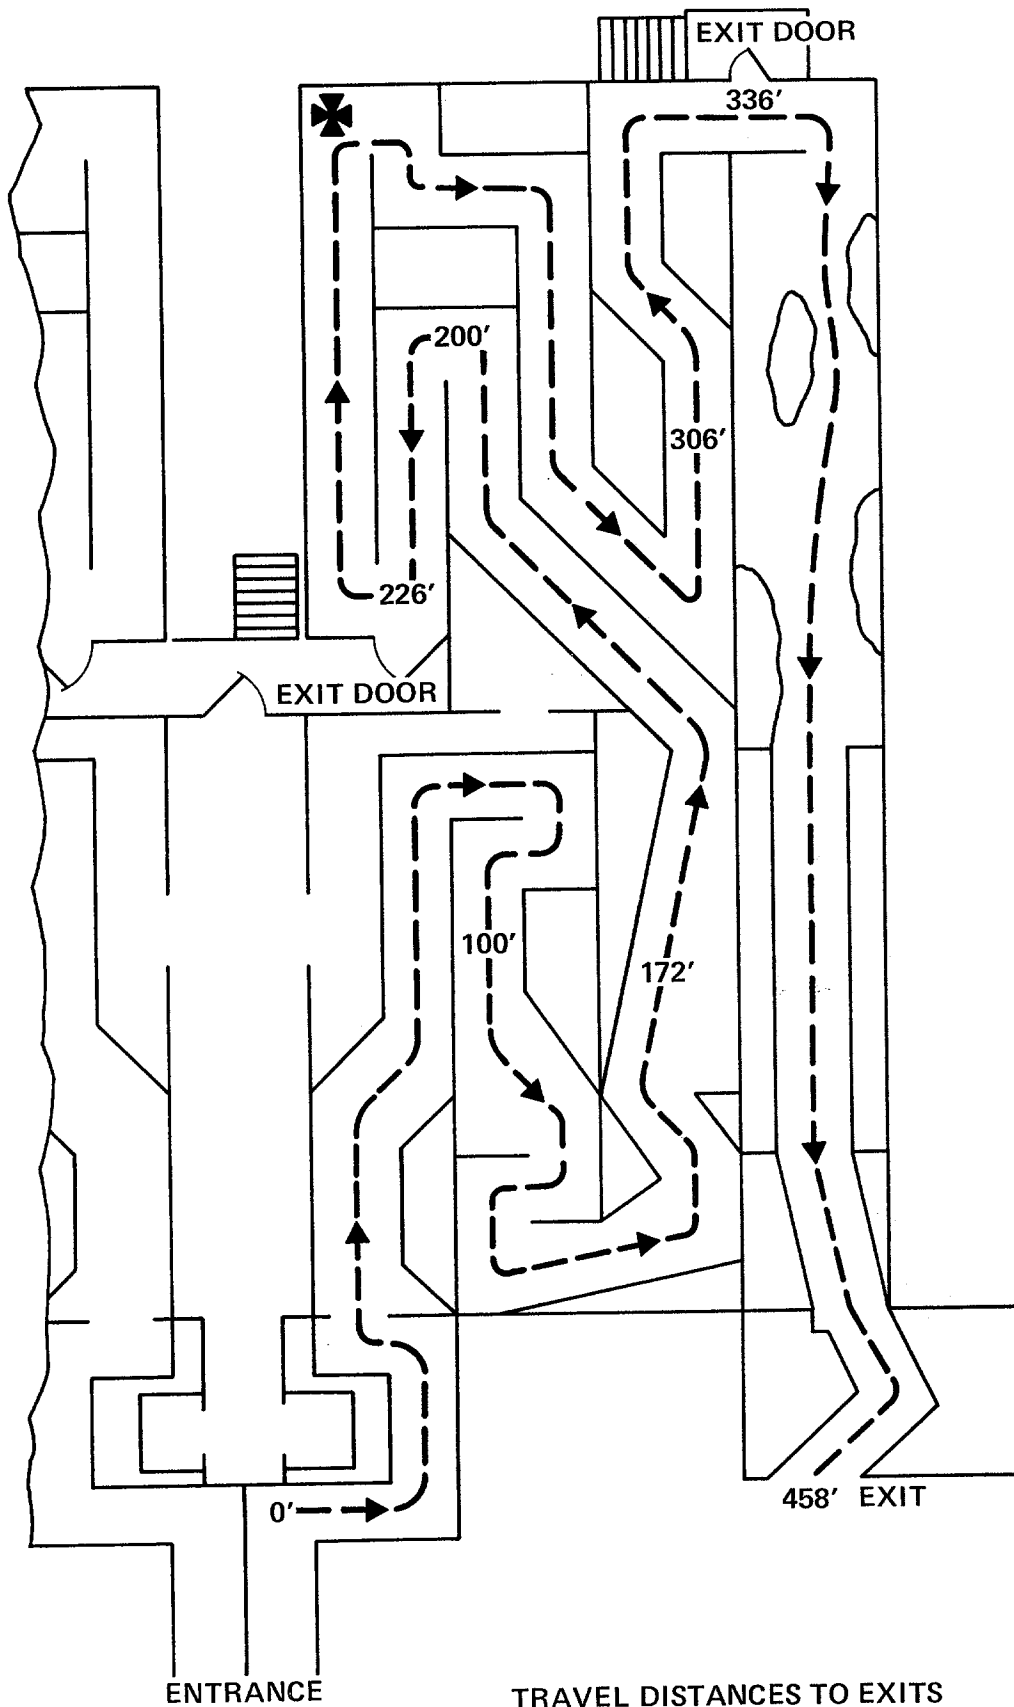
FIGURE 2

Upon entering the darkened, convoluted passageways, a visitor would first encounter a rat lady, a butcher, and then a coffin display (See Figures 1 and 2). The butcher display was designed to be manned by an employee who entered the display through a passageway connected to the control room. The interior walls of the display area consisted of 2-inch by 3-inch wood studs on which 1/2-inch plywood sheets, painted black, had been nailed. Some of the displays were protected from visitor damage by plexiglass windows, metal grates, and bars.
