**FURNITURE MANUFACTURING FACILITY  
DUST EXPLOSION**

Lenoir, NC

# **FIRE INVESTIGATION REPORT**

Prepared by  
**Edward Comeau**  
National Fire Protection Association

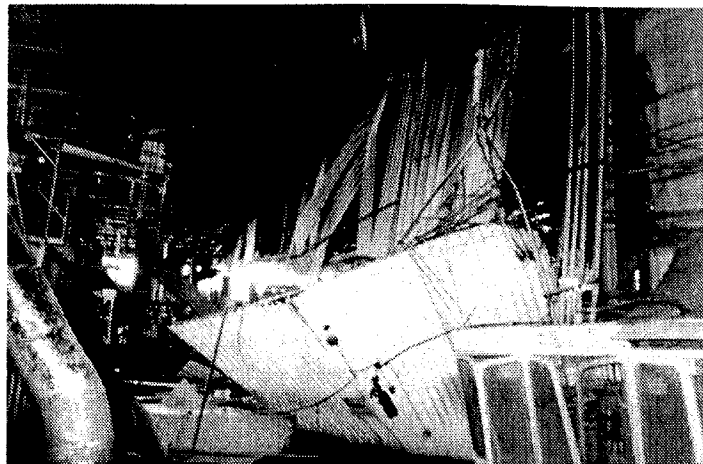
Blast damage. The right side of the lightweight metal panels housed the maintenance area which abutted the milling and drying area.

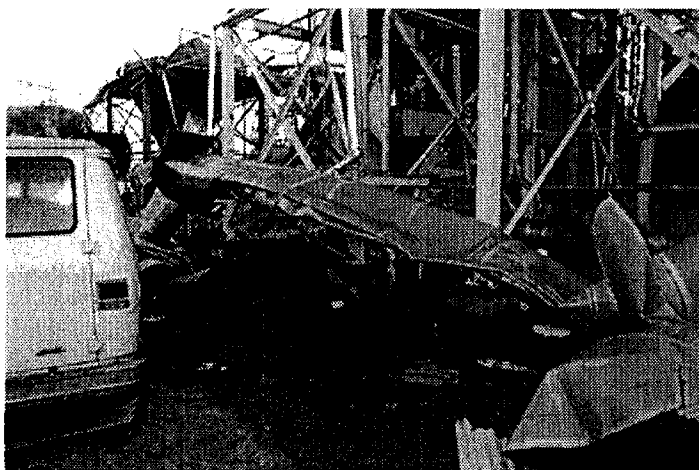
Picture of the damage to some of the ductwork on the south-east side of the building.

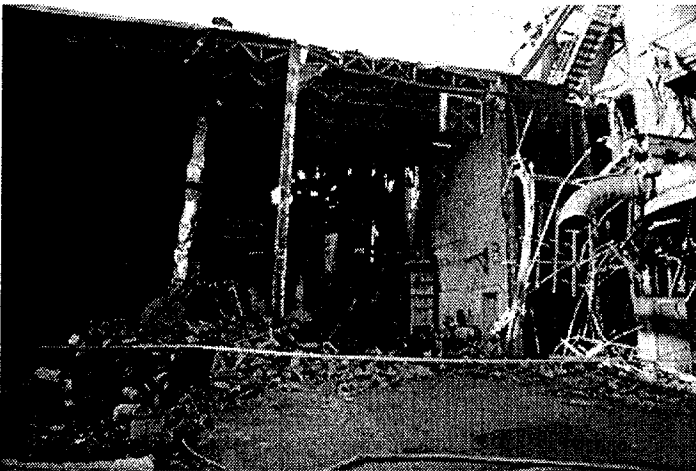
One employee was standing in a door facing the thermal oil transfer unit room when she saw a fireball emerge from the opening. She was close enough that she received burns to her hands as she covered her head.

The view of the thermal oil transfer room from the doorway of the press line where one of the employees was standing at the time of the incident. She reported seeing a fireball emerge from the open door to the thermal oil transfer room. The masonry block wall in the right of the photo separated the room from the milling and drying area. The support column just left of the center of the photograph was where another wall was located prior to the explosion. The debris from this wall was blown to the left.

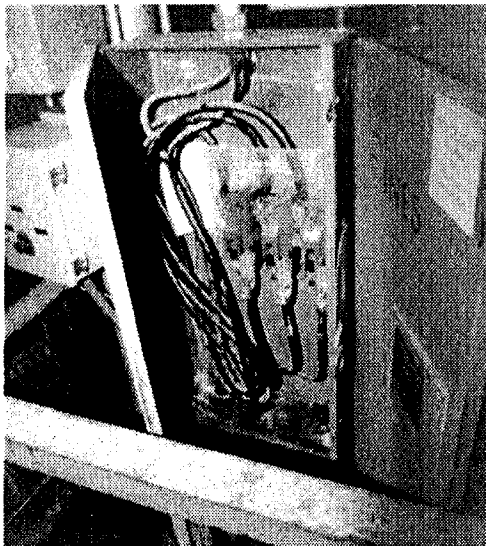
The electrical wiring observed in this facility employed general wiring methods. This allowed for the accumulation of dust within electrical enclosures and created the potential for ignition sources related to arcing from within these enclosures.

There were large amounts of dust on the equipment and on the structural support members. Depths of approximately 4 inches were observed in undamaged and damaged locations. Some electrical switch gear boxes had wood dust of approximately 2 inches in depth within them. No one was able to provide a housekeeping schedule for dust control and, according to interviews, there were no regularly scheduled housekeeping operations.

**Electrical Wiring.** The method of wiring employed throughout the area of the plant that was inspected could be classified as a general wiring method. Rigid conduit was used, but the enclosures were not dust-tight. Accumulations of up to 2 inches were observed in the bottom of some enclosures. If dust was placed into suspension as the result of an explosion, the potential for further ignition and explosion would exist.

Photo of dust accumulation in the bottom of an electrical control panel.

There were a number of potential electrical ignition sources throughout the facility. General wiring methods were employed, which did not provide the required level of protection in this type of facility. In addition, several electrical control panels were observed to have an accumulation of dust within them, which created a potential for ignition within these enclosures if the dust were to be placed into suspension. Use of the proper classification of electrical wiring would have helped to reduce the potential ignition sources.

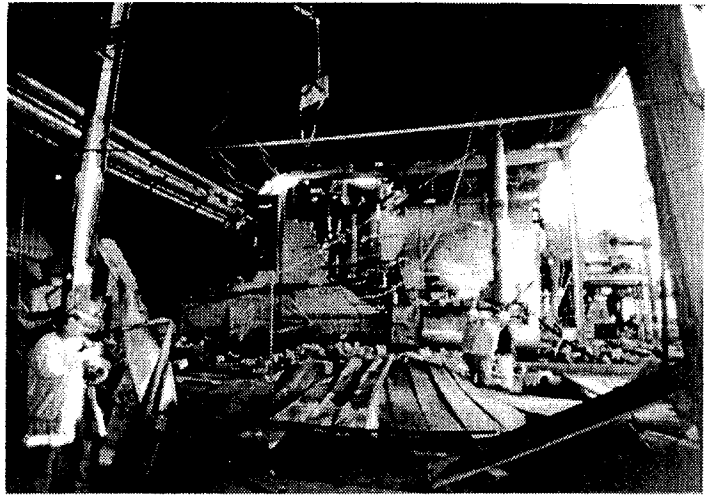
**Explosion Venting.** NFPA could not ascertain if explosion venting was incorporated into any of the building design. However, with the exception of the dust house, all of the building components that did release as a result of the explosions landed in congested or occupied areas. Furthermore, major structural components were damaged in the explosion, resulting in significant roof collapse in some areas of the plant.

In the foreground are the lightweight metal panels that were blown off of the structural members in the press line area. In the background is the thermal oil transfer unit room. The masonry block wall was blown in the viewing direction.
