**FONTANA HOTEL**

Miami Beach, FL

April 6, 1990

**HOTEL FIRE  
MIAMI BEACH, FLORIDA  
APRIL 6, 1990**

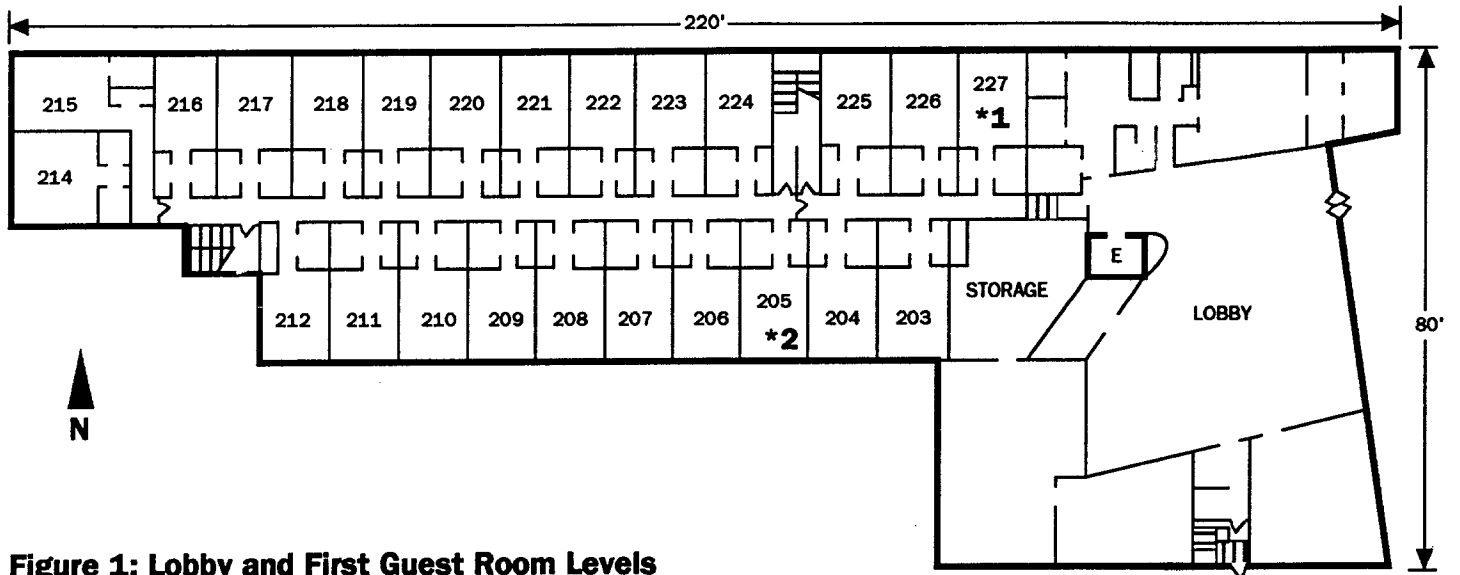
**Figure 1: Lobby and First Guest Room Levels**

The hotel was a three-story L-shaped structure measuring 220 ft by 80 ft at the greatest dimension. (See Figure 1.) The first floor contained the lobby and lounge, three office areas, a storage room, a terrace, an unused kitchen, and 24 guest rooms. The first floor guest rooms were located one-half story above the lobby level with a door separating the guest area from the lobby. The second and third floors each contained 38 guest rooms plus a storage room. Each guest room was approximately 12 ft by 15 ft with a bathroom and closet. Many of the rooms contained electrical hot plates or microwave ovens and small refrigerators in addition to the normal furnishings of a hotel room. Guest rooms appeared to be well maintained.

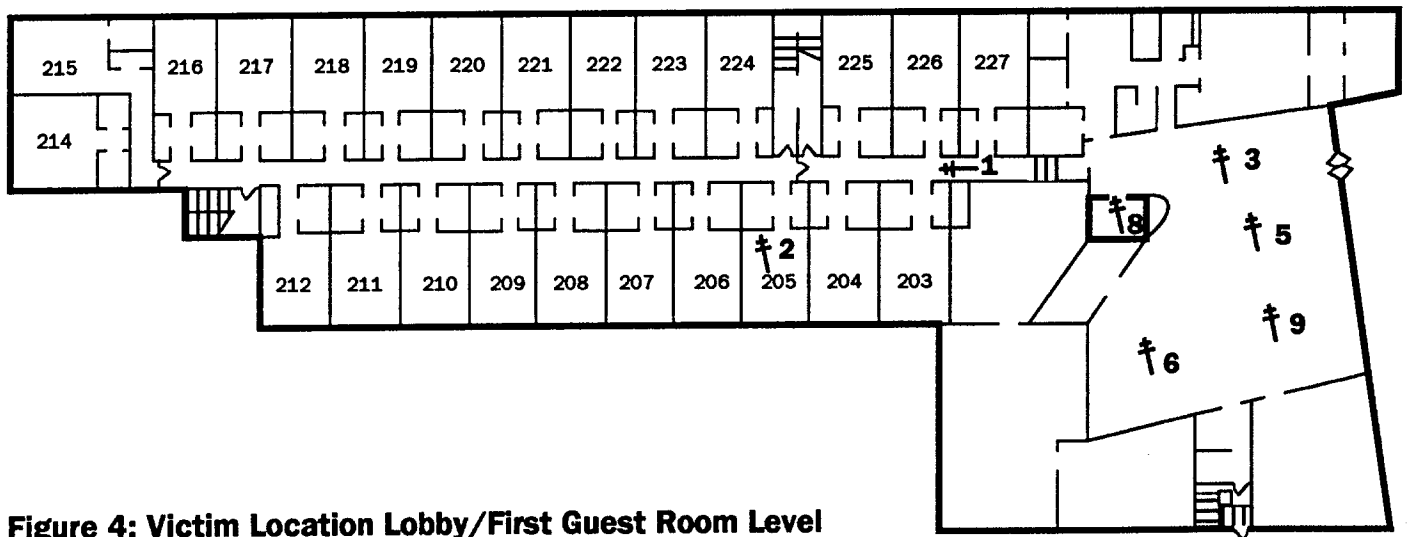
**Figure 4: Victim Location Lobby/First Guest Room Level**

Nine hotel guests died in this incident. (See Figures 4-6.) One victim was found in the ground level corridor, and another victim, an 88-year-old female, was found in Room 205 which was west of the fire wall. A third victim was found in the elevator, and a fourth body was found near the southeastern stairwell. Four more victims were found in the rubble of the upper two floors which had collapsed and fallen into the lobby area. Three days after the fire was extinguished, the last victim was found. It appeared that this person may have died in the third level guest room corridor before the structural collapse occurred.

*NOTE: Victims were found after the structural collapse; therefore this diagram may not show the level on which the victim(s) was (were) located before the collapse occurred.*
