**PLYWOOD MANUFACTURING PLANT**

Nacogdoches, TX

April 16, 1984

Investigation Report

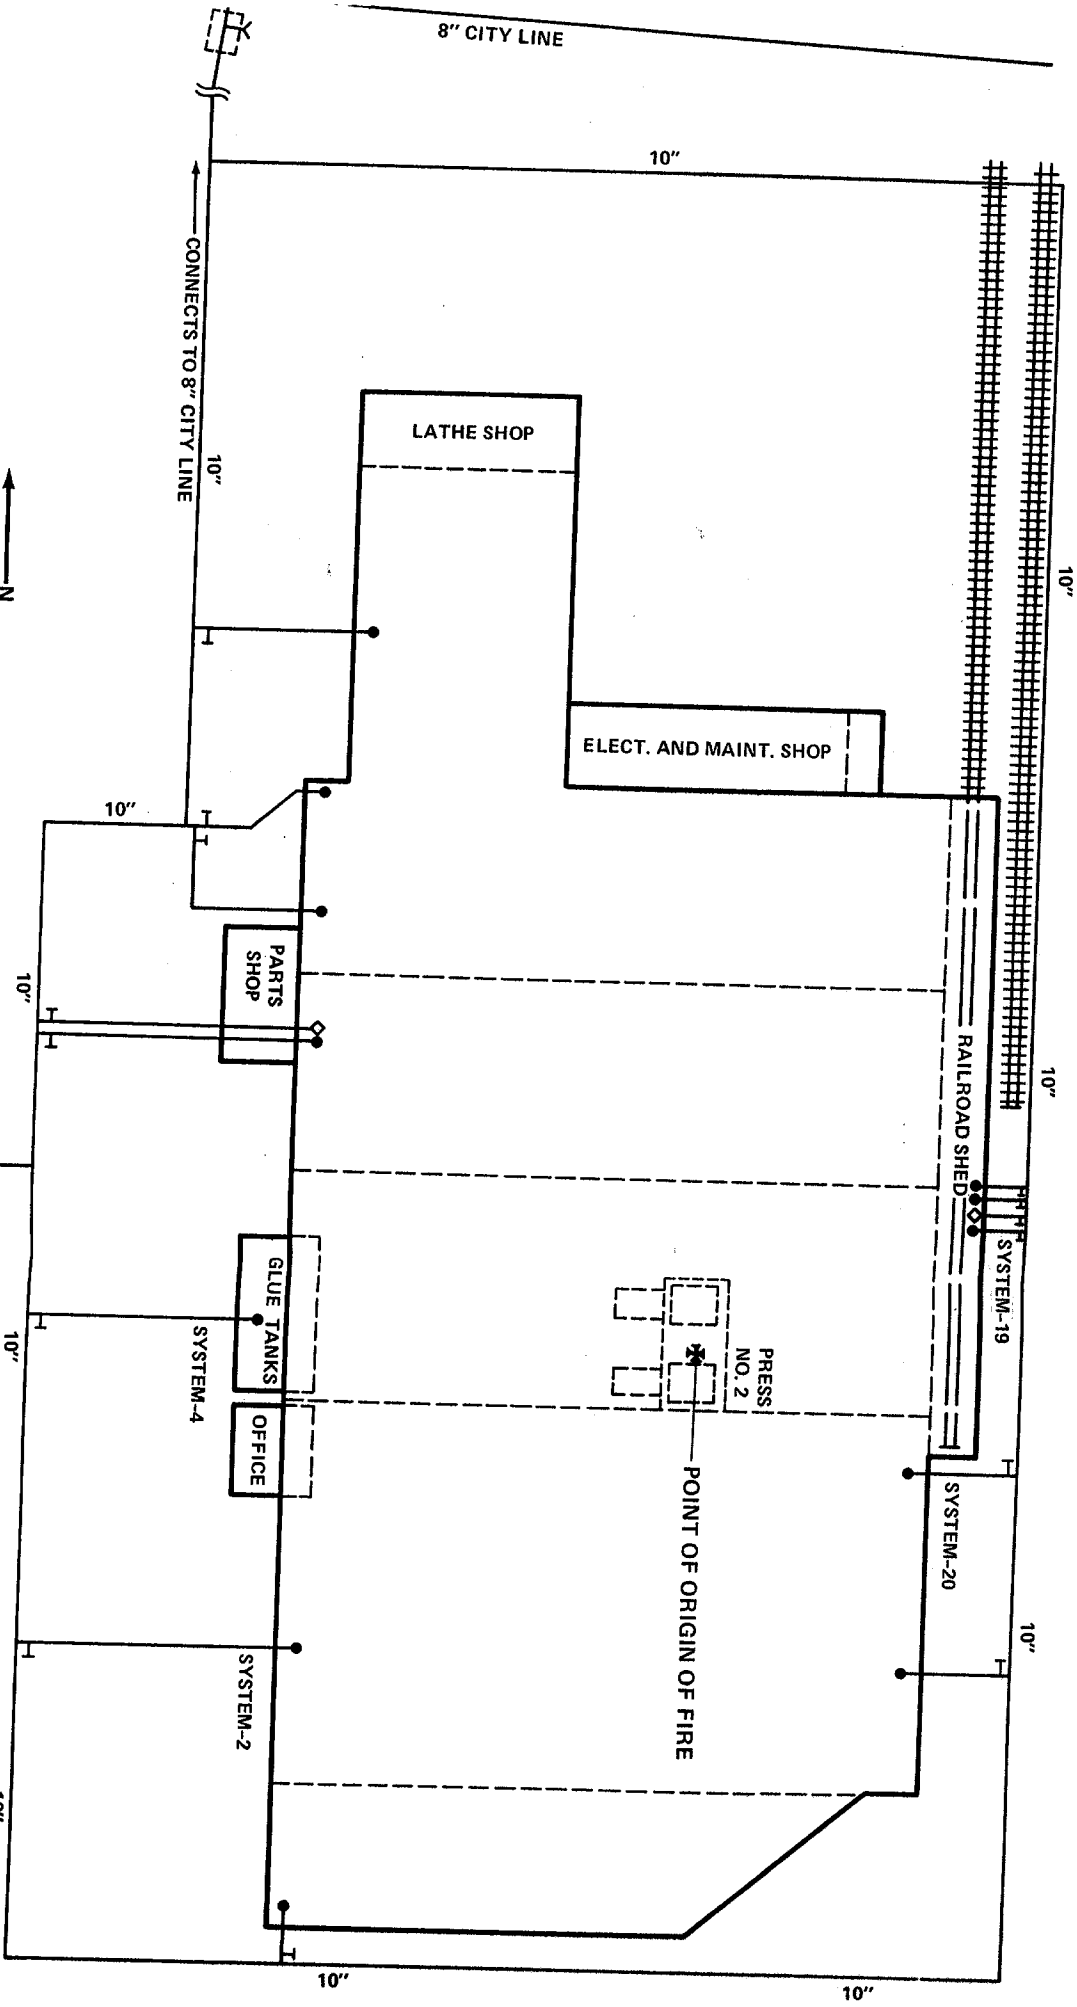
INTERNATIONAL PAPER COMPANY'S NACOGDOCHES, TEXAS PLYWOOD MANUFACTURING PLANT.

The plywood manufacturing building had three undivided sections. The manufacturing section of the plant had approximate dimensions of 330 feet by 520 feet. Attached to the north end of the manufacturing section was a 110-foot by 200-foot "green end section." In 1979, a 213 to 303-foot by 75-foot addition was added to the south end of the manufacturing section. The three sections combined to create a single undivided area of approximately 236,000 square feet (see diagram #1).

There was a 23-foot deep, 2040-square foot draft hood around the two hot presses utilized in the plywood bonding operation (see diagram #1). The draft hood was designed to collect the heat, steam, and vapors generated by the hot presses and assist the two roof-mounted exhaust fans located above the presses. The hood and the hot presses below accumulated deposits of oil, pitch, glue, and wood dust. These accumulations were reported to be at least 1/4 inch deep on the steel catwalks and in the press area.

At approximately 1200 hours on April 16, 1984, workmen initiated operations to replace a motor on hot press #2 (see diagram #1). Before repair work on a broken bracket began, the workmen shut down the hot press, removed all the plywood in the press, and shut down both roof-mounted fans in the 2040-square foot draft hood. Before arc welding operations were begun to repair the broken bracket for an interlock switch, positioned approximately 15 feet above the floor level, a fire watch was established and the area was wet down with a small garden-type hose supplied from a 3/4-inch line tied into the plant water system.
