HOTEL FIRE
Orlando, FL
January 28, 1984

Fire Investigation Report

Howard Johnson's Hotel
Orlando, Florida
January 28, 1984

Revised August 8, 1984

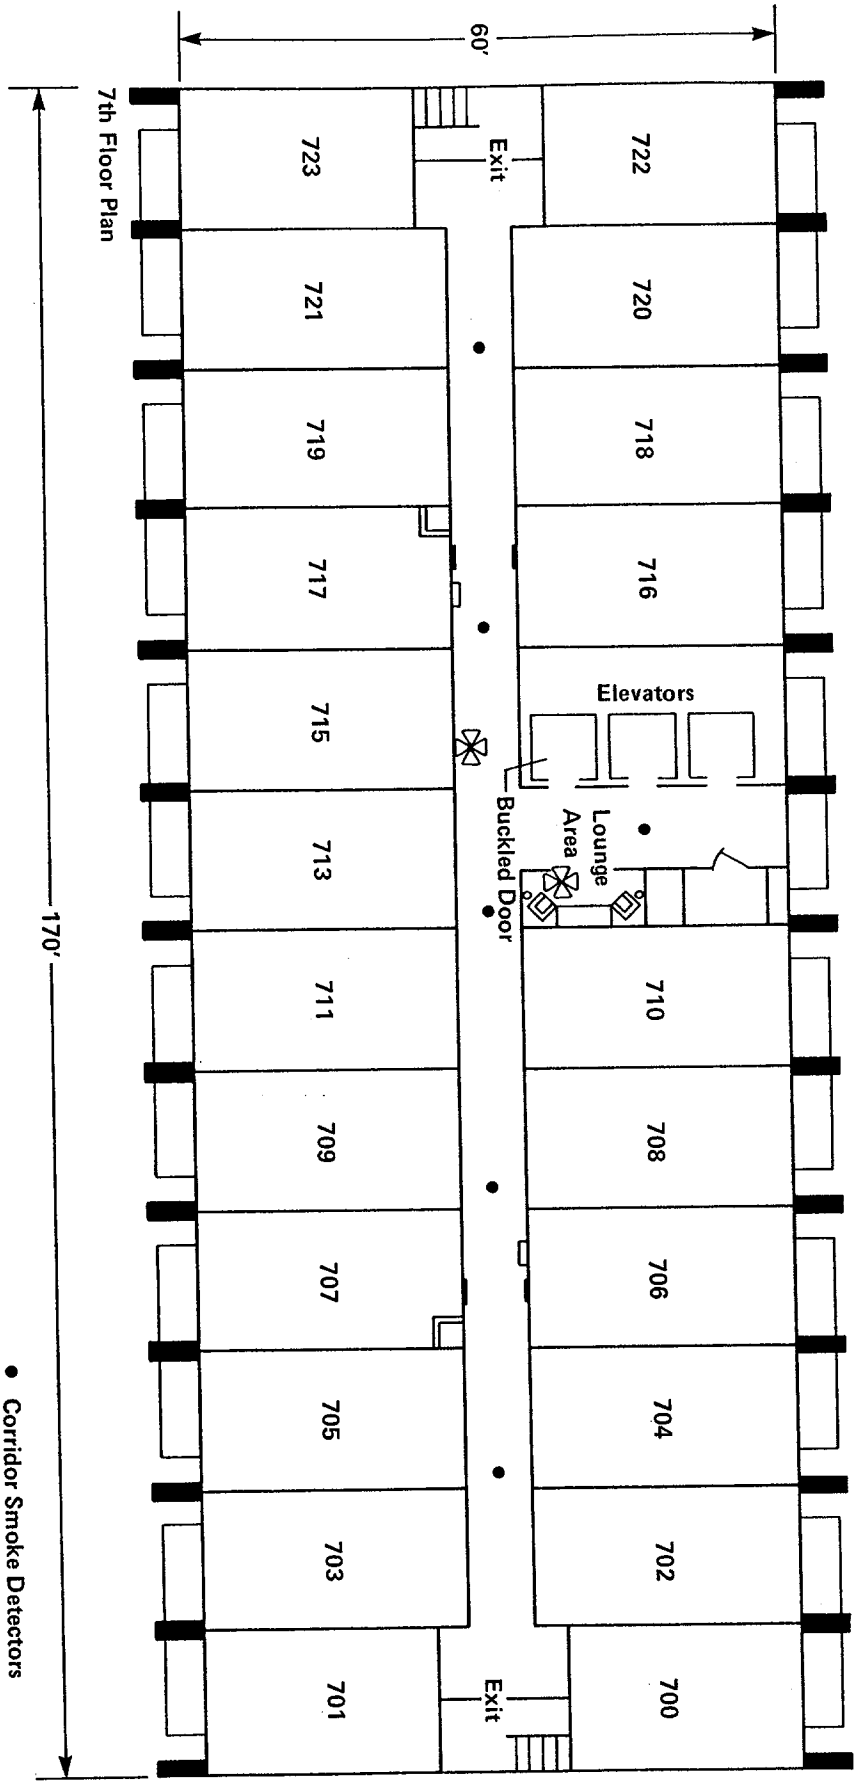
7th Floor Plan

The ground floor contained the hotel reception desk, a lounge, and an attached 1-story restaurant building. The second floor featured a night club and two convention halls. Floors 3 through 13 were configured with 22 guest rooms opening onto a 1-hour fire-rated east/west exit access corridor. (See Figure 1.) The 14th floor had a combination of guest suites and conference rooms.

Two 8 inch by 10 inch steel raceways containing electrical cables ran vertically from the ground floor through the 14th floor supplying electrical power to floors 2 thru 14. These vertical raceways were enclosed with non-fire rated construction and located approximately 31 feet to the east and 19 feet to the west of the intersection of the elevator access corridor and

Fire damage on the floor of fire origin (7th floor) included furnishings in the lounge area, corridor carpeting, vinyl wallcovering, ceiling materials, and heat damage to several solid core-wood guest room doors. While the area of fire involvement was limited to a portion of the furnished lounge, heat generated from this fire was severe enough to buckle one of the adjacent elevator shaft doors, and migrate 19 feet west, igniting electrical cable insulation in the unprotected vertical raceway.
