HOTEL FIRE
Paterson, NJ
October 18, 1984

NATIONAL FIRE PROTECTION ASSOCIATION

Investigation Report
Alexander Hamilton Hotel Fire
Paterson, New Jersey
October 18, 1984

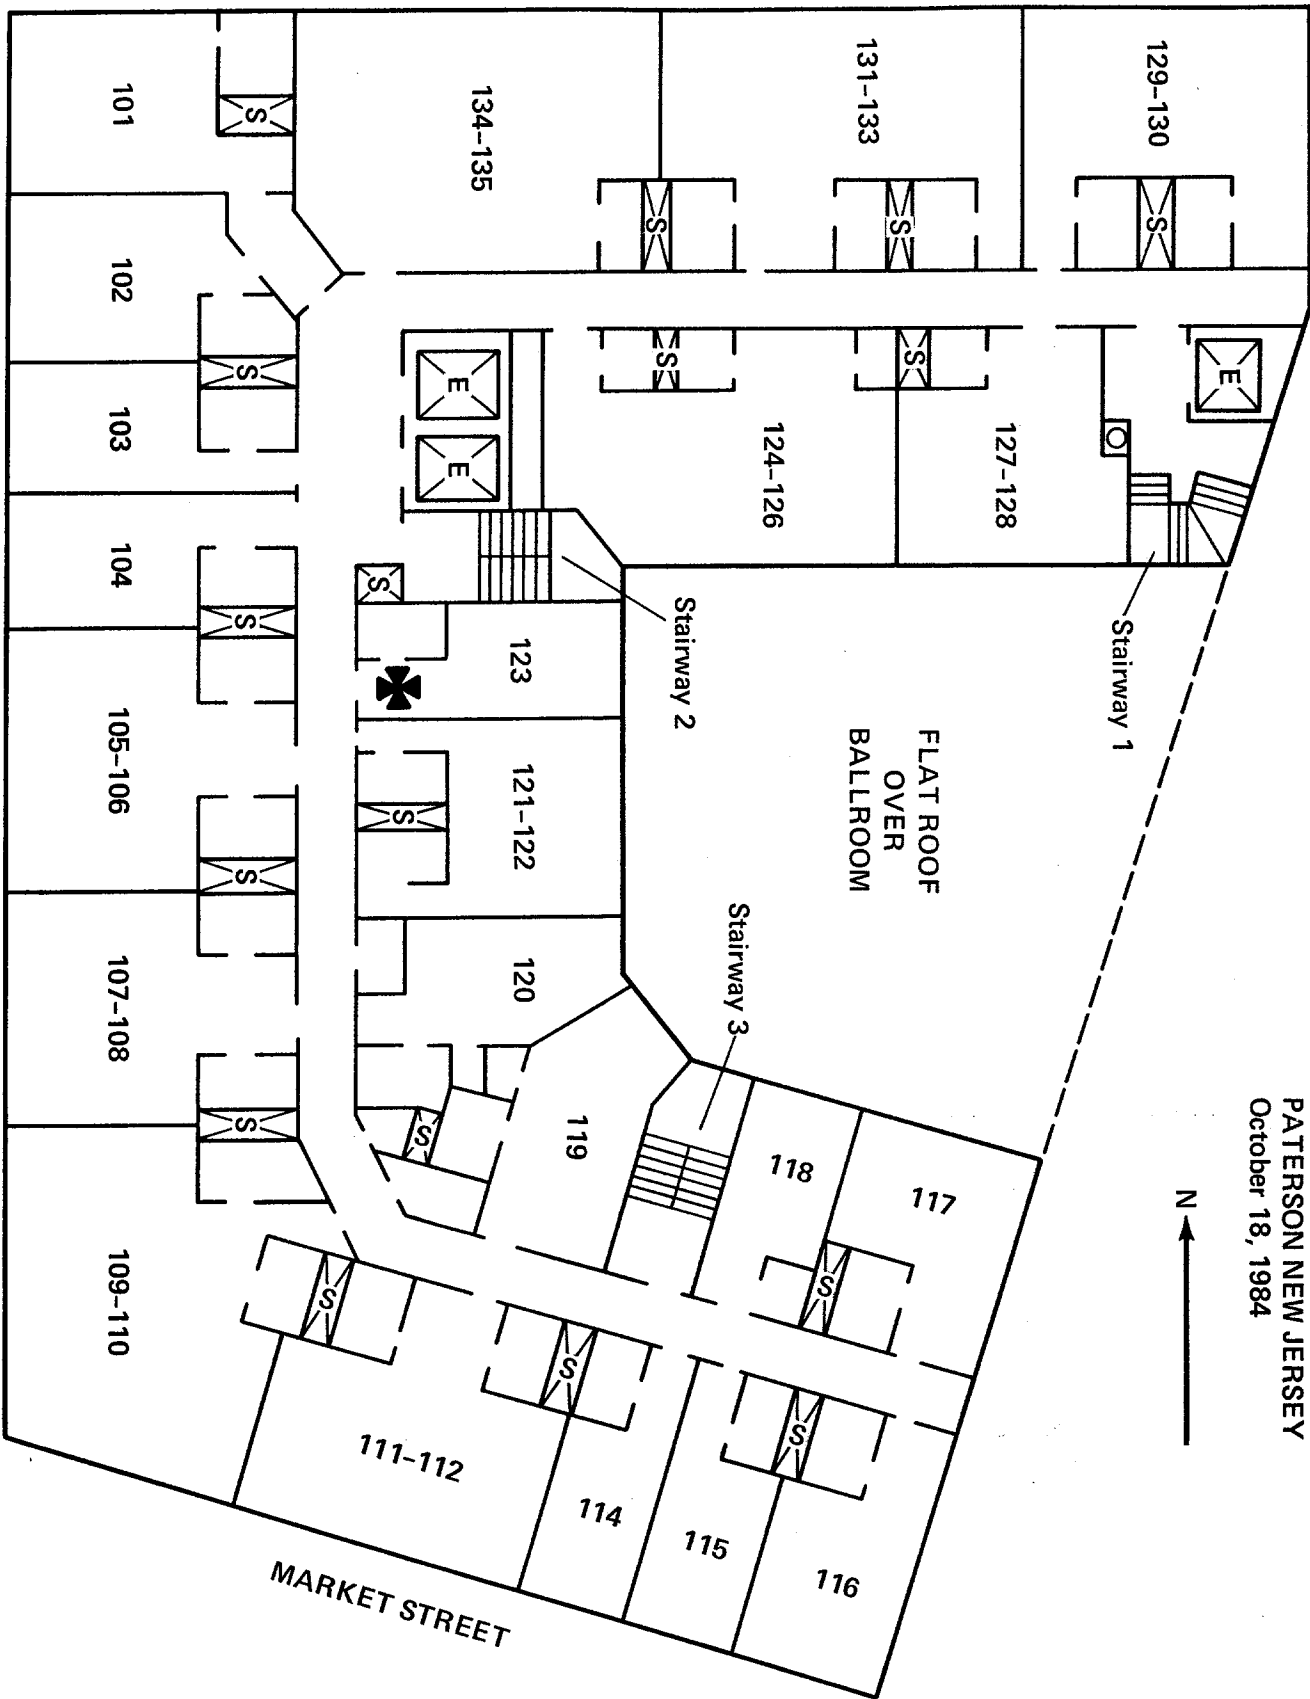
ALEXANDER HAMILION HOTEL
PATERSON NEW JERSEY
October 18, 1984

This incendiary fire, which originated on the third floor (first guest floor) was probably in one of the worst locations since the renovation work described earlier had added considerable fire loading to the corridor. The other guest floors had plaster walls and ceilings in the corridor.

The hotel used 55-gallon steel drums for the collection of rubbish. A drum was located in the stairways at each floor level. These drums were often used to block open stairway doors as the corridors were dimly lit. On the night of the fire, the central stairway, (No. 2) which was adjacent to the room of origin, had the door blocked open by a drum. Also the door to stairway No. 1 did not close.

As the fire developed on the third floor, it extended into a number of rooms. This allowed smoke to penetrate the bathroom ventilation shafts. The smoke then spread into other rooms on upper floors from these shafts and also banked down from the plenum into the other shafts and from there into bathrooms.
