SUPERMARKET FIRE PHOENIX, ARIZONA

MARCH 14, 2001

FIRE INVESTIGATIONS

1 Fire Fighter Fatality

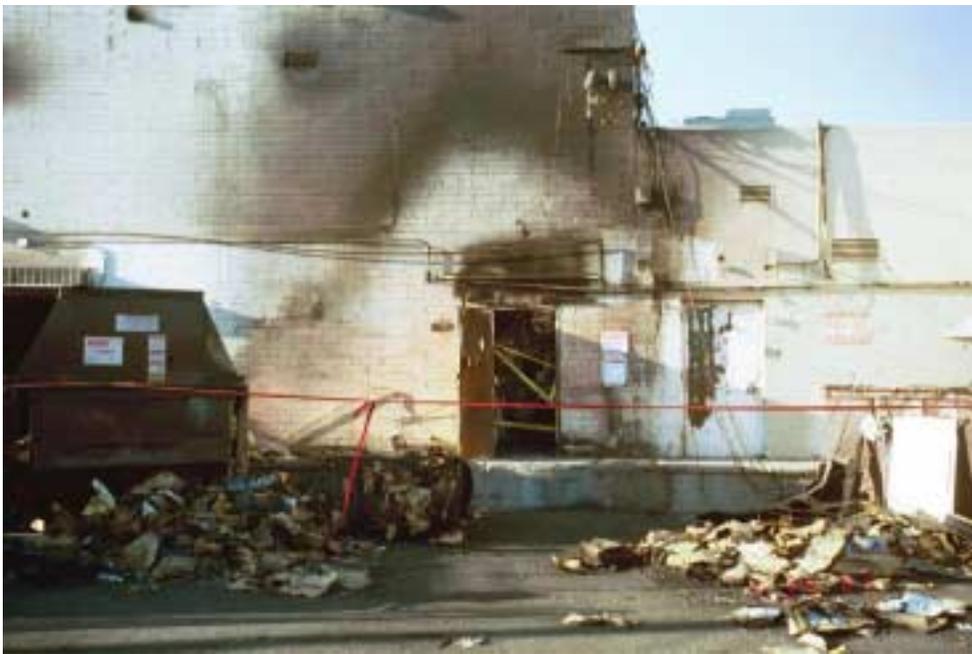
Photo No. 1 – Loading Dock of Supermarket near Point of Origin (NFPA)

The Fire Investigations Unit of the Phoenix Fire Department has determined that this fire began in the discarded cardboard and other debris outside the southwest corner of the supermarket. The cause of the fire has not been determined as of this writing.

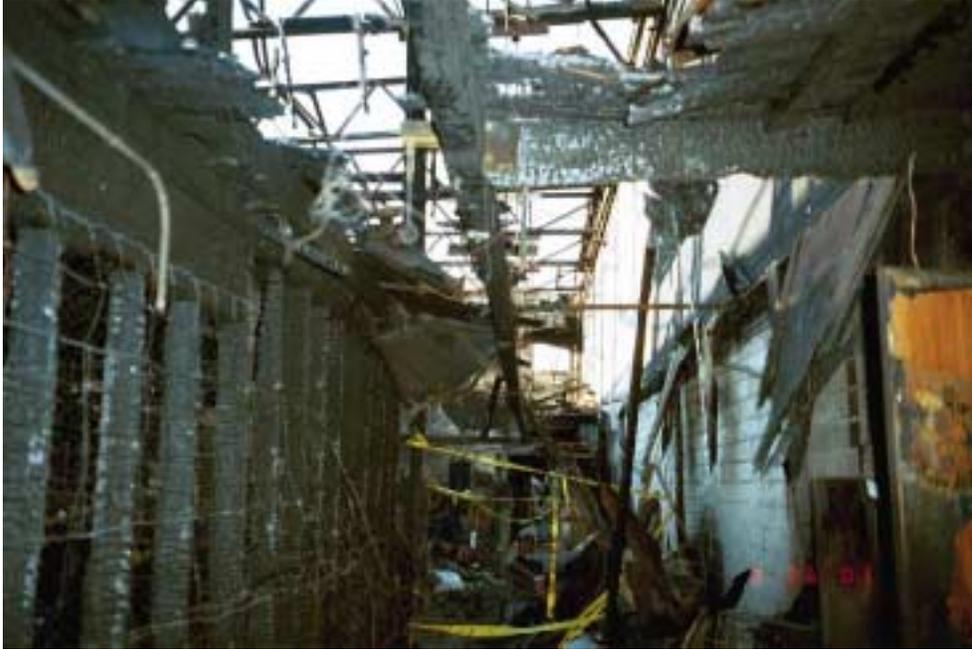
Photo No. 2 – View of Stock Room from Loading Dock looking North (NFPA)

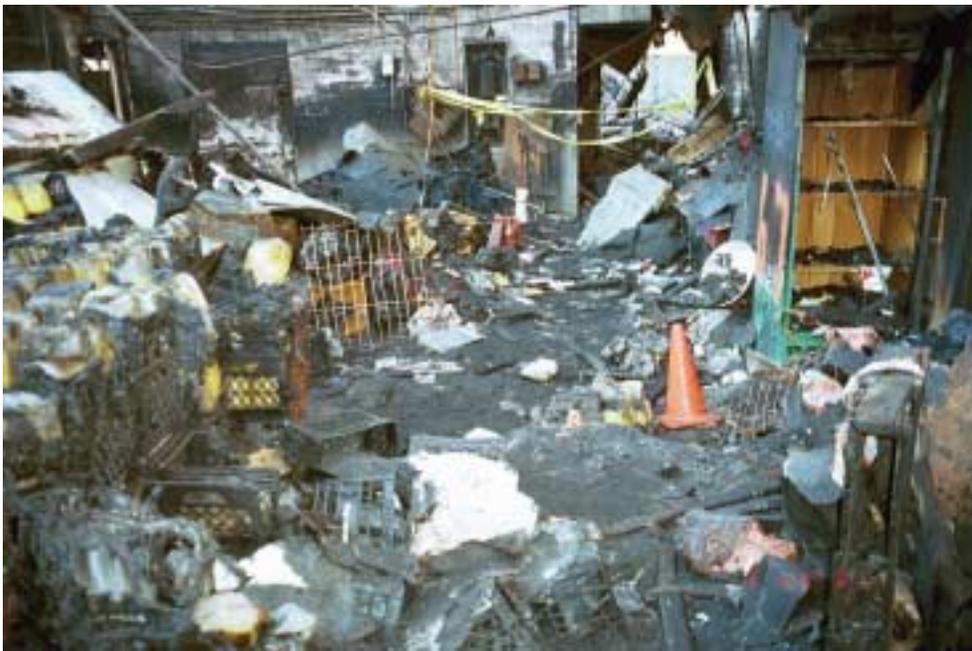
Photo No. 3 – Photo showing debris in stock room that fire fighters encountered while attempting to fight the fire and locate and remove the downed fire fighter (NFPA)

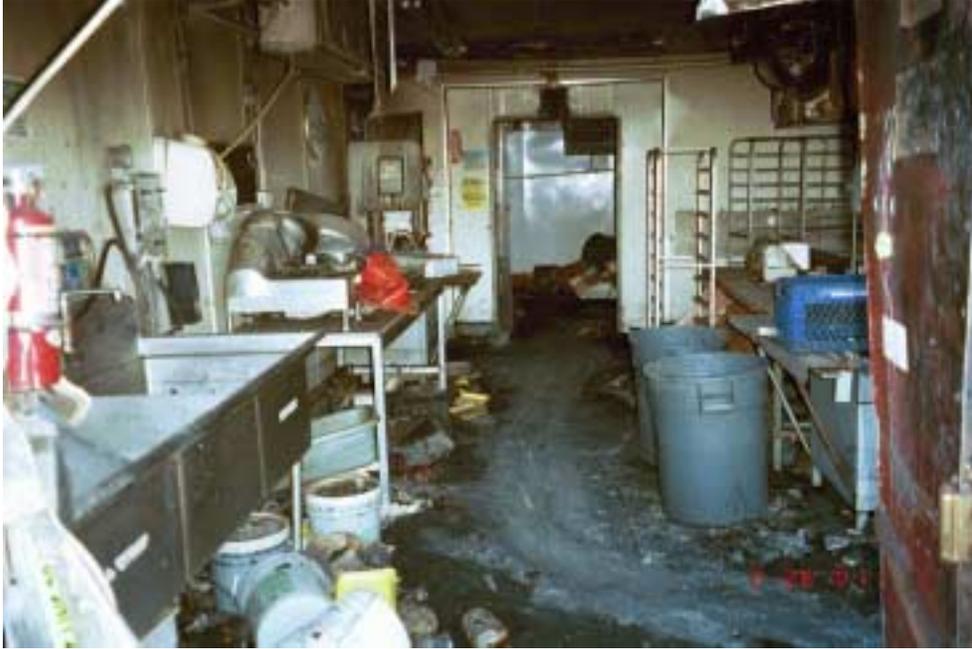
Photo No. 4 – View of meat preparation area looking south into the meat freezer. The downed fire fighter was located in this room when located by the R3 fire fighter. The R3 fire fighter was located in the meat freezer when located later by the E25 Captain. (NFPA)

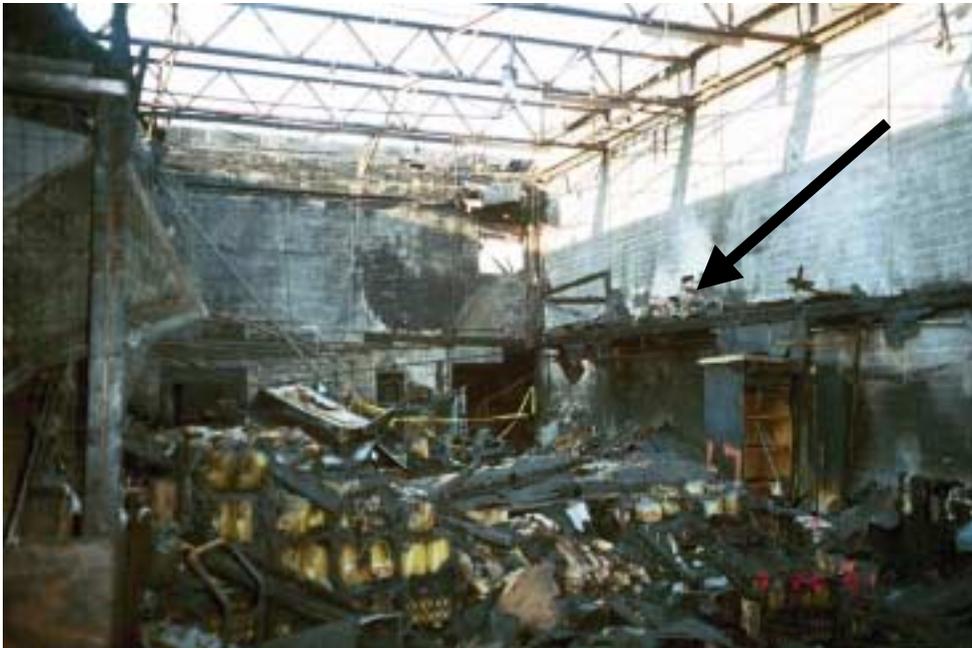
Photo No. 5 – Stock Room in southwest corner of supermarket as seen from overhead door Note: Remaining portions of the partial mezzanine are indicated by arrow (NFPA)

The danger posed by not knowing the extent to which a fire is burning within a building in which fire fighters will be operating has been demonstrated numerous times in the past, often with tragic circumstances. In this case, a partial mezzanine in the stock room prevented fire fighters from seeing the extent of the fire spread over their heads in that area. Information from other sources (such as units operating on the roof and elsewhere within the building) eventually led incident commanders to believe that the fire was spreading rapidly northward and beyond the stock room area, causing the order to "go defensive" and to battle the fire from defensive position outside the building.

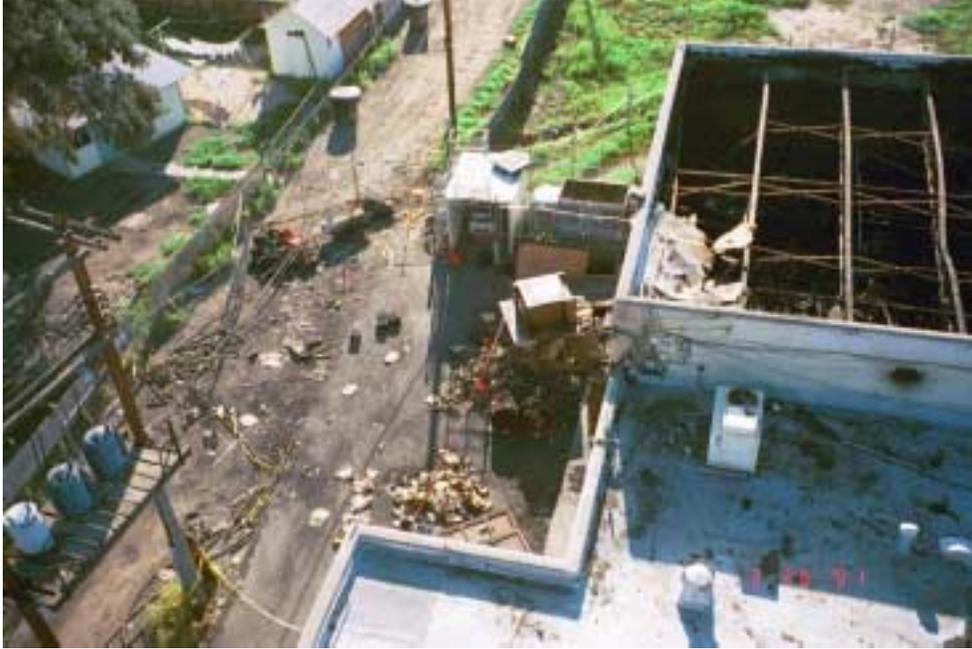
Photo No. 6 – Aerial view of loading dock area showing the pole mounted electrical transformers. (NFPA)

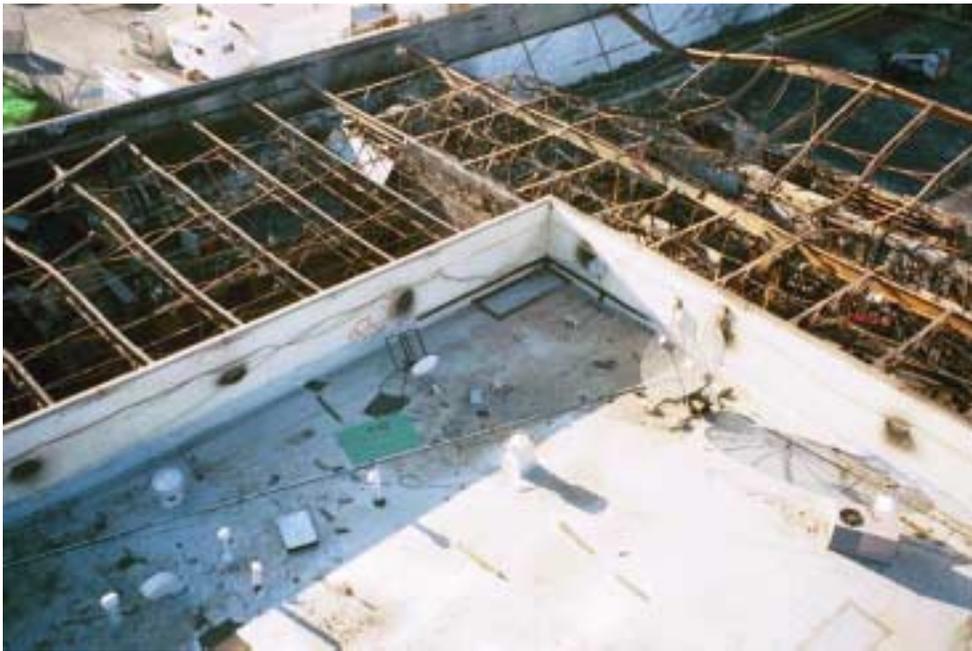
Photo No. 7 – Aerial View of Southwest portion of the supermarket showing the wall separating the stock room from the sales floor and the meat preparation room (NFPA)
