**AUTOMOTIVE SERVICE STATION  
GAS EXPLOSION**

Portland, ME  
May 23, 1986

Fire Investigation Report

Gasoline Tank Explosion  
Portland, Maine  
May 23, 1986

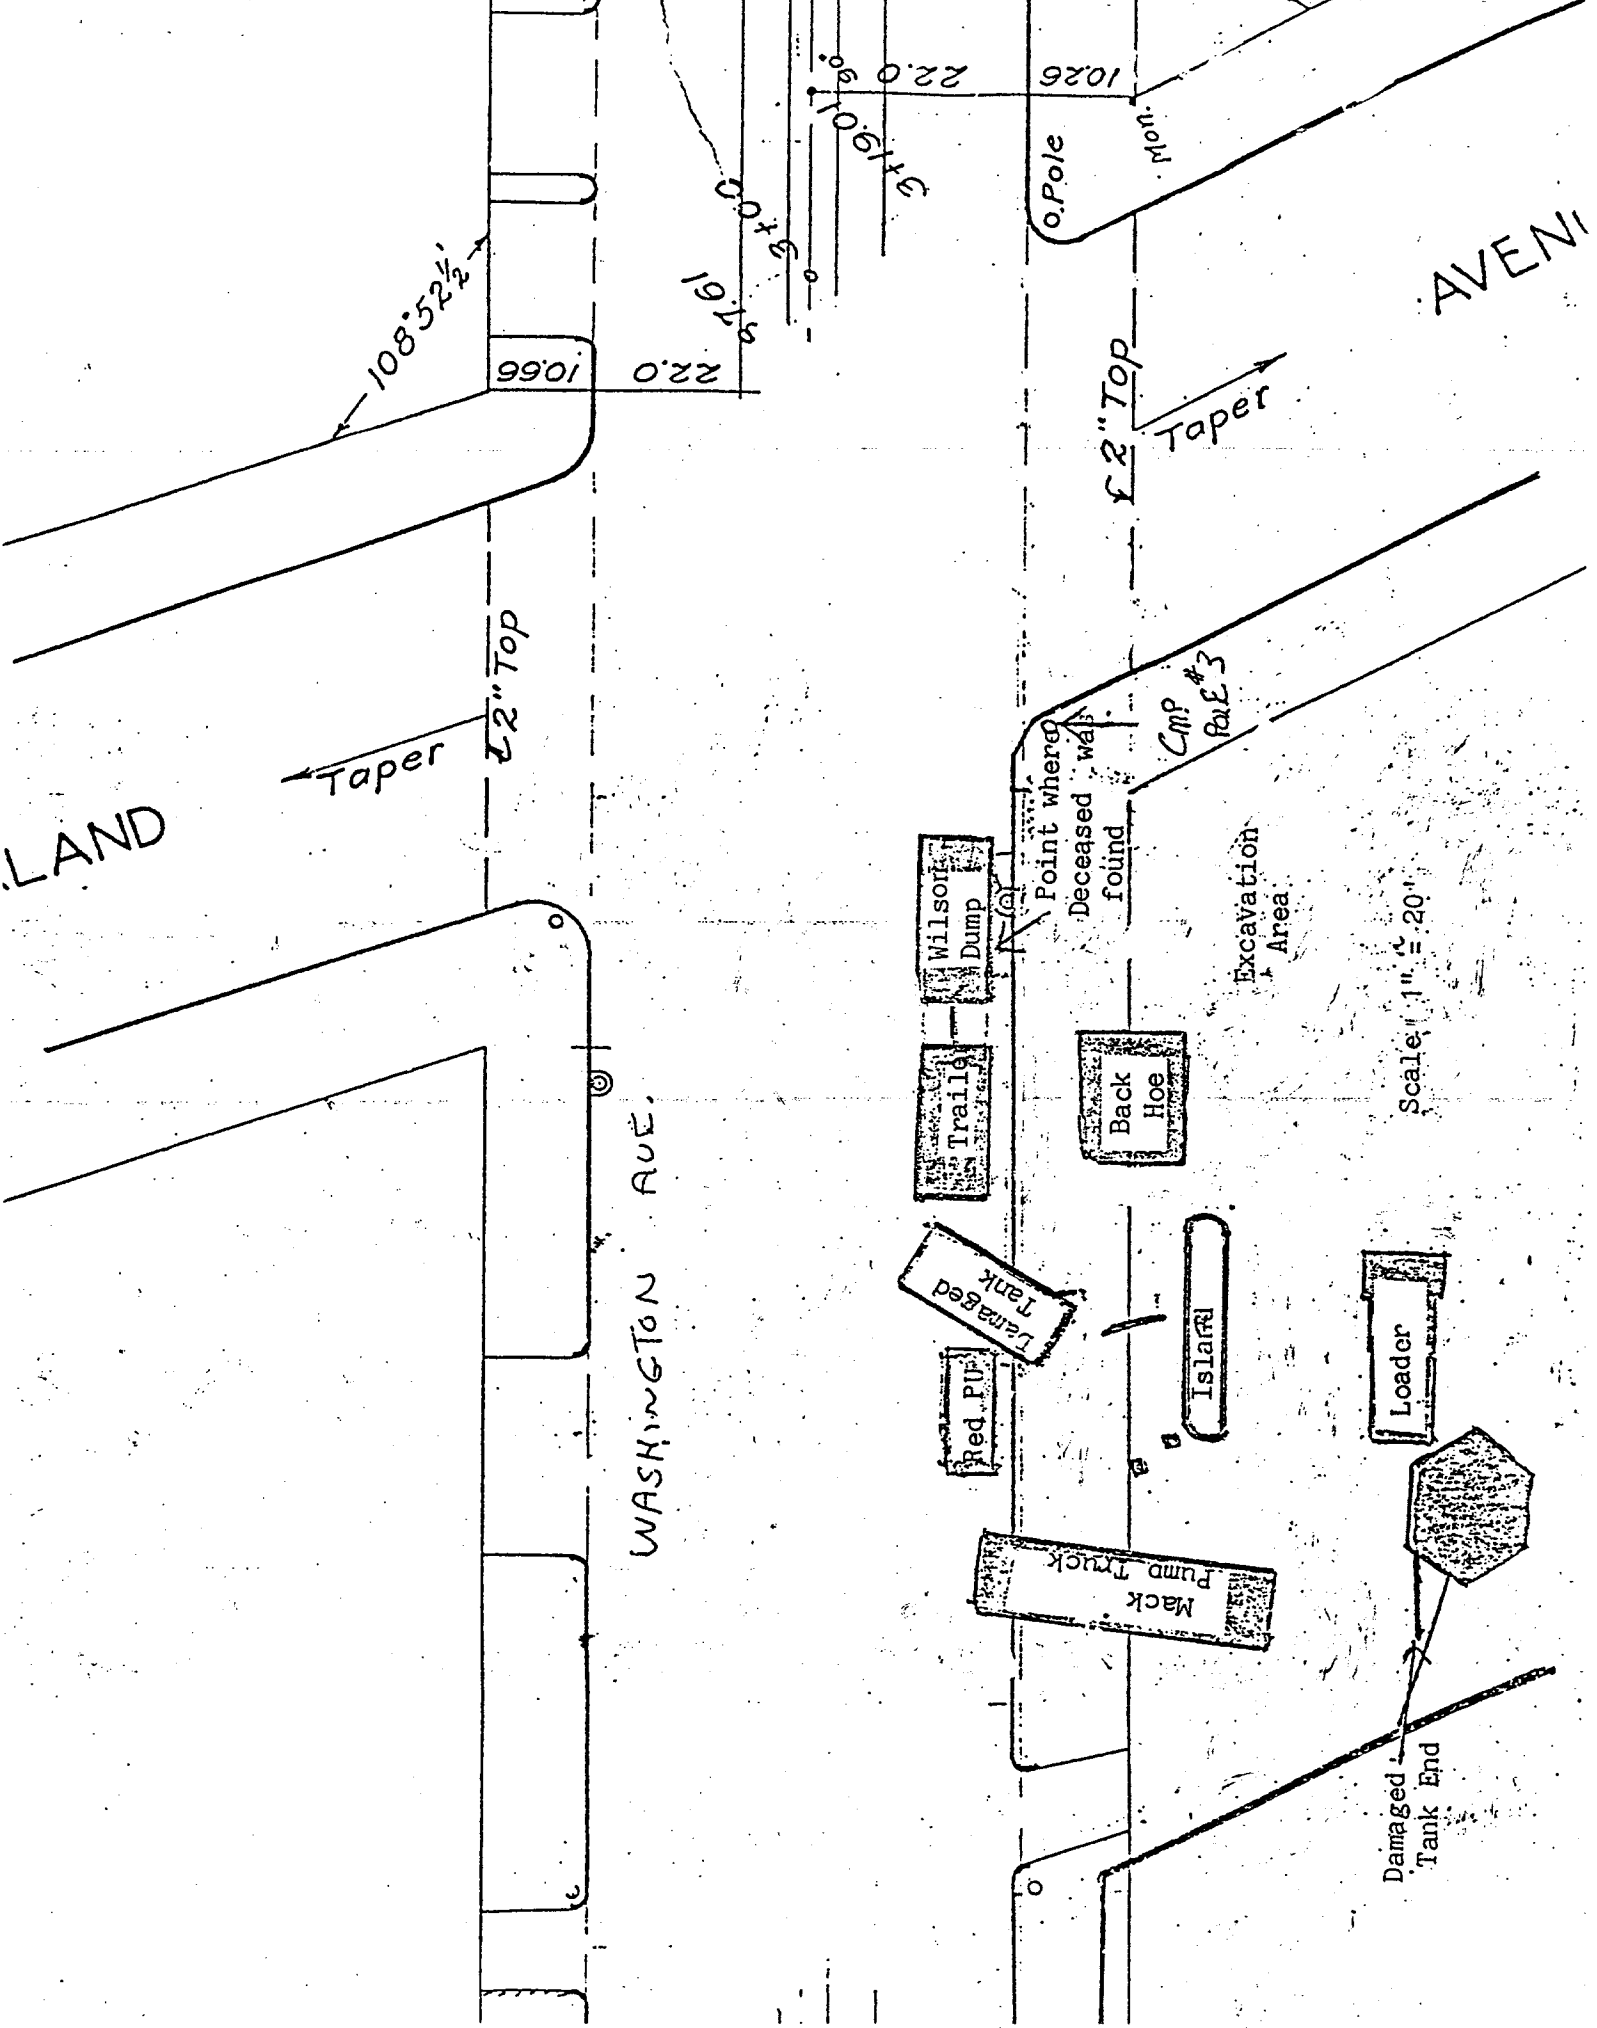
Point where Deceased was found

Damaged Tank

Damaged Tank End
