CHURCH FIRE

St. Louis, MO

April 28, 1994

SUMMARY FIRE INVESTIGATION REPORT

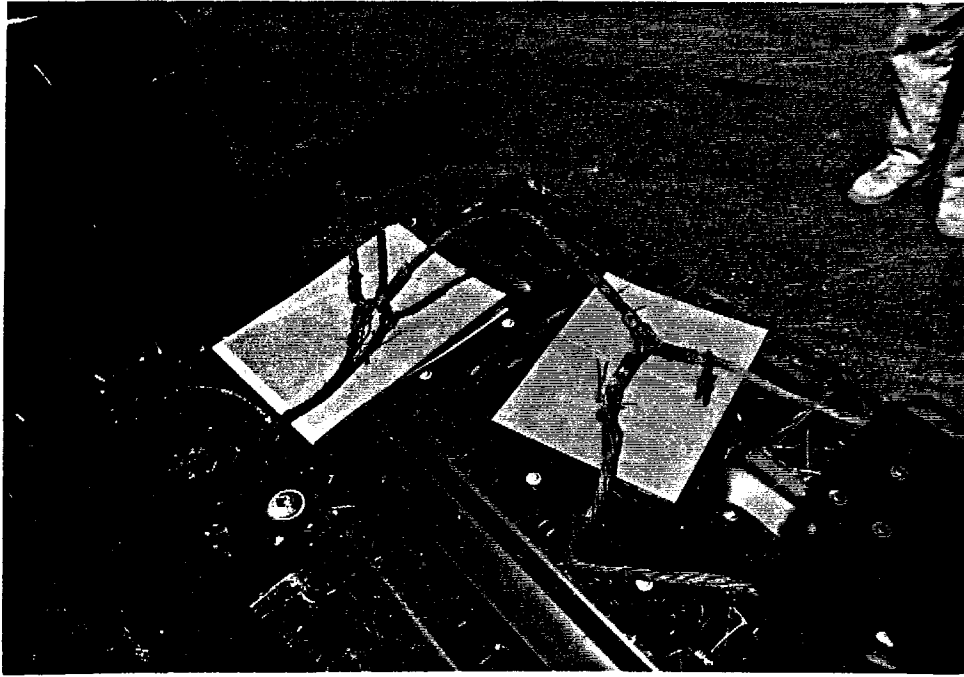
Photo 1

transepts, the cupola prevented the cross-run conductors from running continuously in both the north/south and east/west directions along the ridge. As a result, a braided copper wire, similar to that used for the cross-run conductors, was installed at the base of the cupola, and that conductor looped around the cupola. This looping wire served as a bonding point for the cross-run conductors along the roof ridges and for a braided wire conductor attached to the cross-shaped air terminal on top of the cupola. Damaged conductors, reportedly from the area of the cupola, were recovered, examined, and measured. The cable was found to be 28 strands and 57, 350 circular mills in size.^{1, 2} All bonds to the looped wire were made by wrapping one cable around the other rather than by using splicing devices designed for that purpose. (See Photo 1)

Wrapped wire splice on conductor from cupola area.

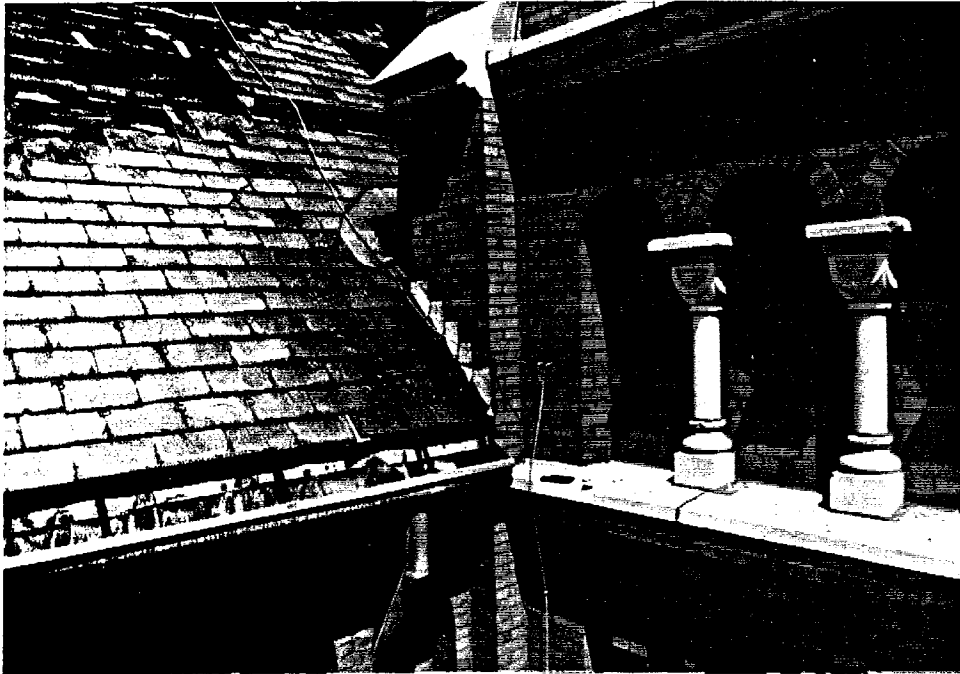
Photo 2

Five "down conductors" connected the system to earth. One down conductor was installed on each steeple, and the installation on each steeple was similar. Each down conductor was bonded to the cross-shaped air terminal on top of the steeple and ran down the exterior of the steeple's roof. Like the cross conductors on the main roof, down conductors were secured to the steeple's roof by bolts. A braided copper wire was spliced to both the steeple's down conductor and to the cross conductor on the ridge of the roof in order to bond the conductors. (See Photo 2) Again the splices were made by wrapping one cable around the other rather than by using splicing devices. Fasteners and bolts securely held each down conductor to the exterior of the steeple's masonry walls, and each down conductor was bonded to the copper gutter by a bolt and metal clamp. A clamp and bolt bonded each down conductor to a grounding cable that was set into the concrete sidewalk.

Down conductor installation near east steeple and main roof.

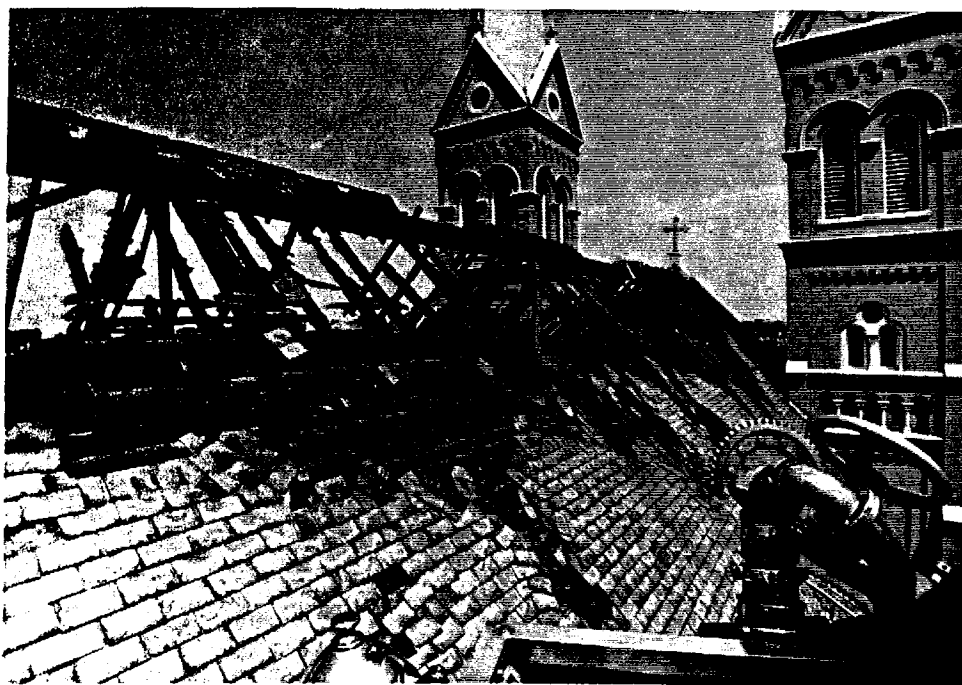
Photo 3

The roof covering the church was heavily damaged by the fire. (See Photos 3 & 4) The vast majority of the combustible materials in the roof assembly were completely consumed by the fire, leaving in place only steel structural members and copper conductors for the lightning protection system.

Roof damage looking toward the north end of the church.

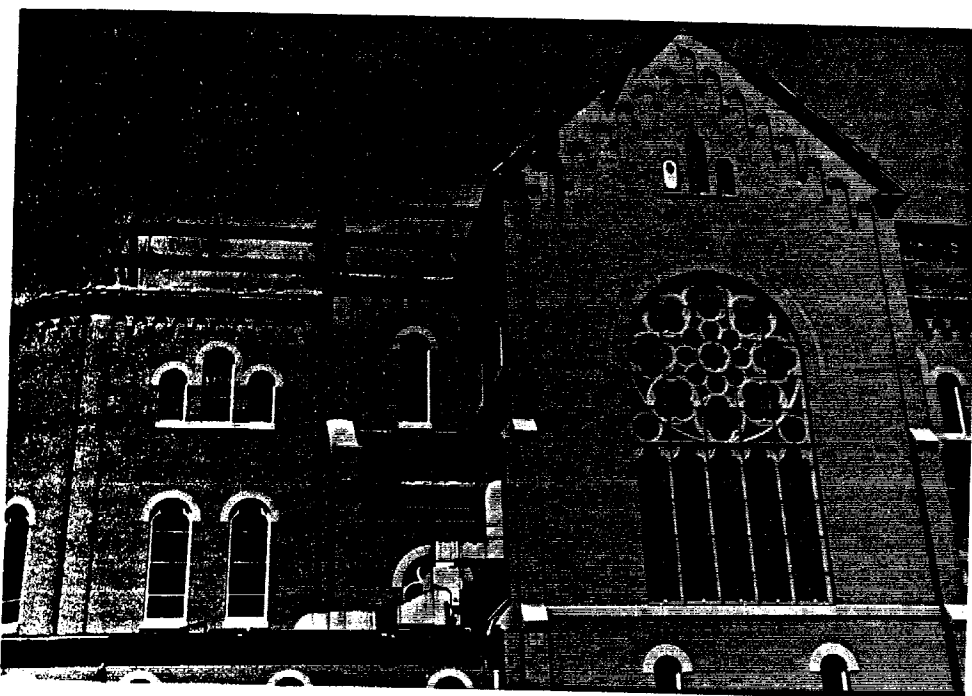
Photo 4

Roof damage at the south end of the church.
