TRACTOR TRAILER/GAS EXPLOSION

Woodruff, Utah
October 16, 1986

Fire Investigation Report

BLEVE - LP-Gas Storage Tank

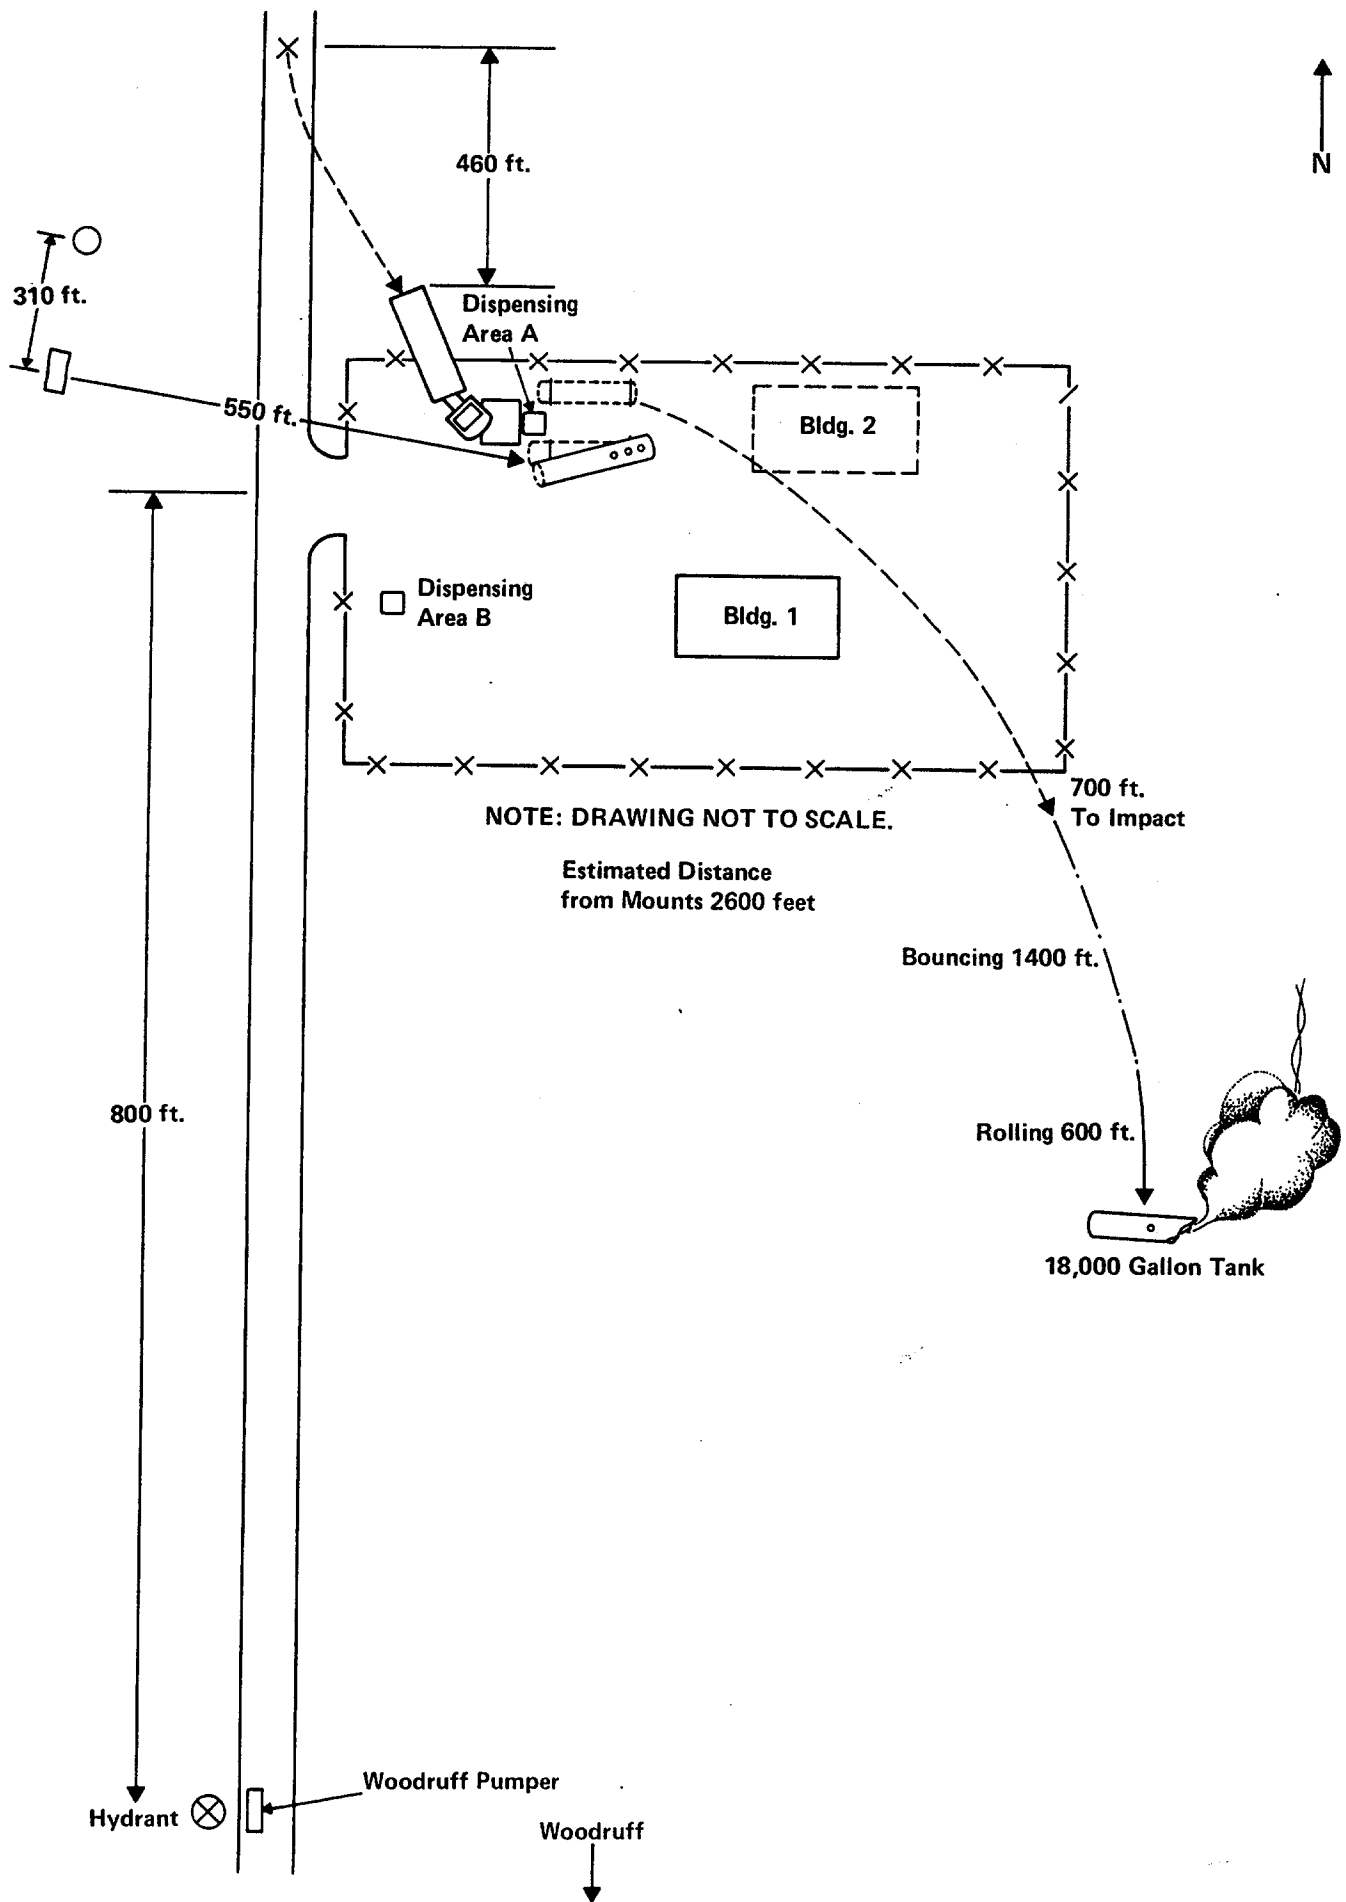
FIGURE 1

westerly direction and landed about 500 feet away from their original position (see Figure 1). The tear that separated the smaller 90-inch section from the rest of the container occurred in the base metal about two inches from a welded seam. The third piece, which was approximately 40 feet long, rocketed in an easterly direction and struck an LP-gas delivery truck inside Building #2 (see Figure 1) knocking it out of the building. This impact changed the tank's direction of travel and the tank hit the ground for the first time about 700 feet from its original mountings. The tank then bounced for about 1,400 feet and rolled another 600 feet. It finally came to rest about 2,600 feet away from its original mountings.

In addition to the damage to the large LP-gas tanks, the garage building (Building #2, Figure 1) collapsed and burned. All the vehicles (including the Woodruff FD Tanker) and contents were destroyed. The office building (Building #1, Figure 1) was heavily damaged by flying debris. Wreckage from

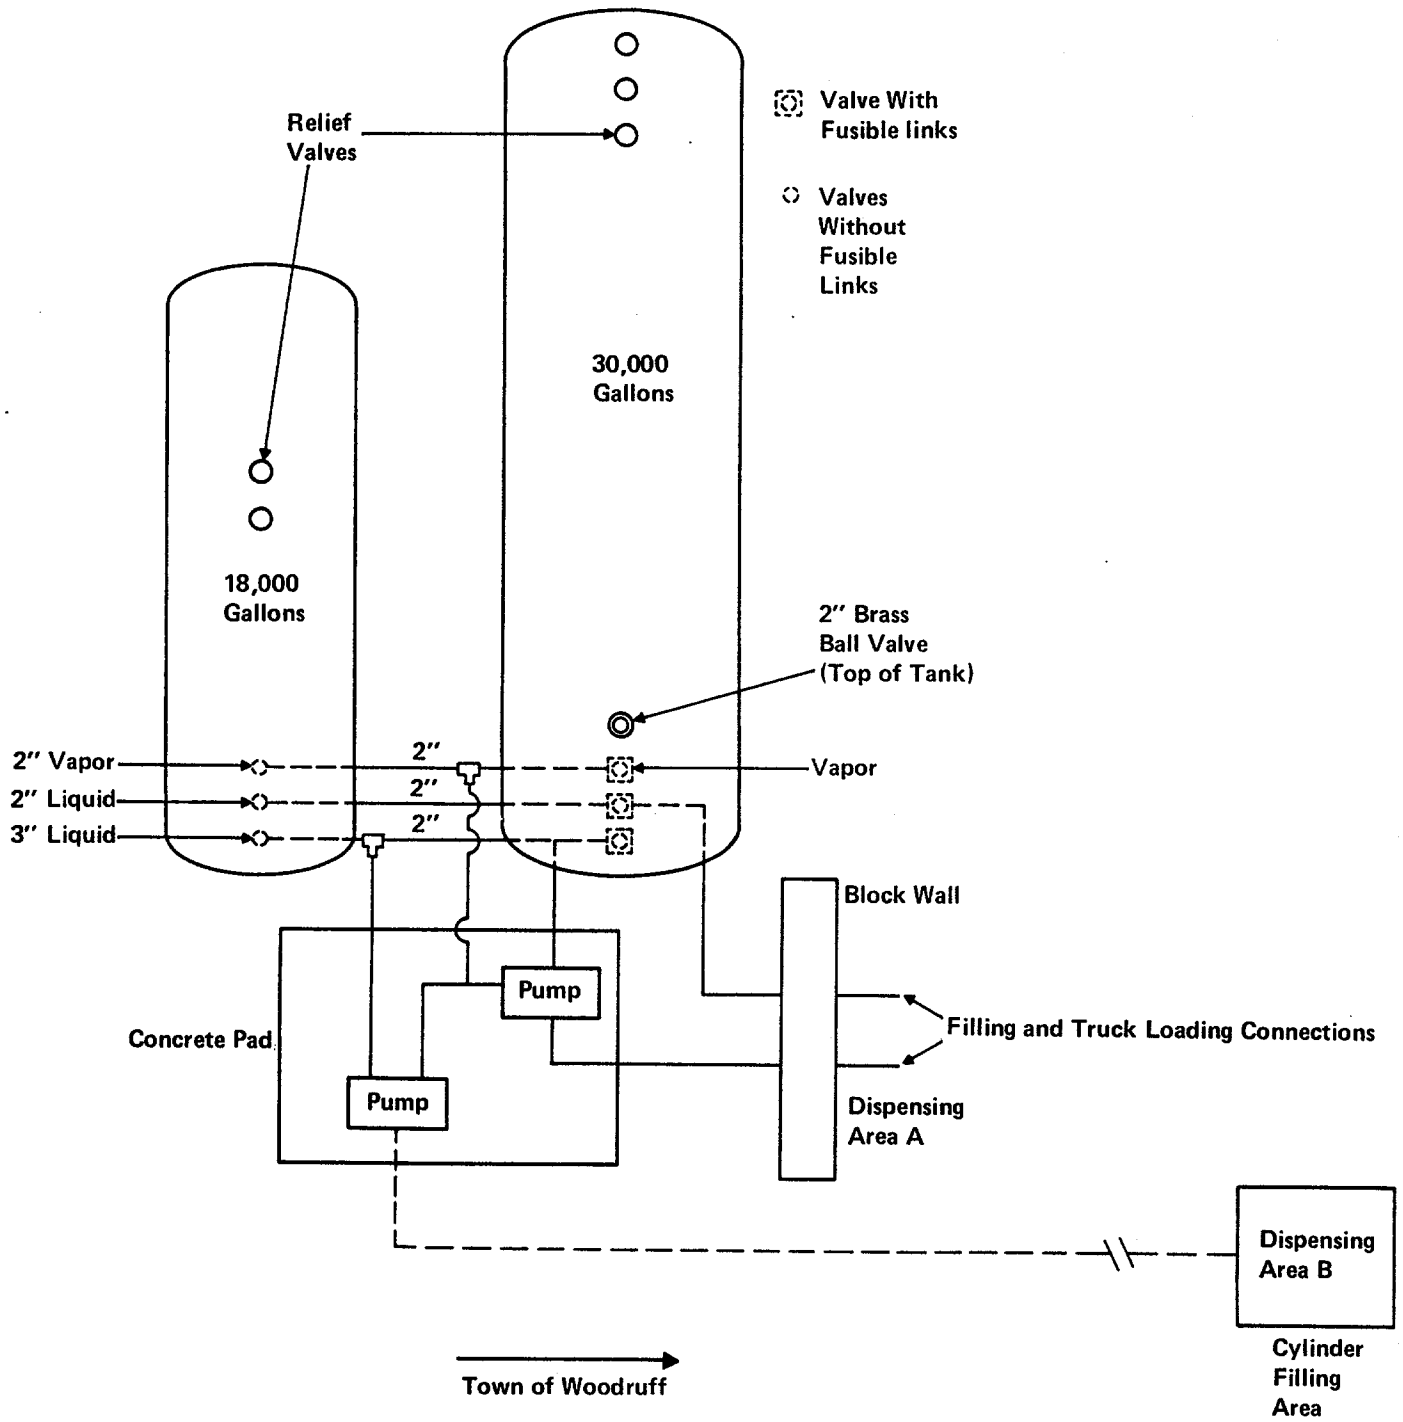
FIGURE 2
SIMPLIFIED PIPING DIAGRAM

Figure 2 shows the arrangement of the storage tanks, piping, and liquid transfer pumps prior to the accident. The smaller tank had a capacity of 18,000-gallons, the larger tank had a 30,000-gallon capacity, and both containers were considered to be full^{1,2}.

Both tanks had a 3-inch liquid line, a 2-inch liquid line, and a 2-inch vapor line, all of which were attached to the bottom of the tanks at the west end. Each of the six openings in the tank had "excess flow" protection. In addition, the three valves on the bottom of the largest tank had emergency valves activated by fusible links; however, none of these valves were arranged for manual remote operation.

Two electric-powered pumps were in the piping system. One pump moved the product to and from Area A (see Figures 1 & 2) during dispensing and tank filling operations. The second pump move product to Area B, which was used for product dispensing only. At the time of the accident, there was no dispensing or filling occurring, so the system was shut down.
