THE KISS NIGHTCLUB FIRE

This article updates my original fire report for the *Boate Kiss* tragedy, published in the Journal's [Spanish](#) and [Portuguese](#) editions in June 2013.

BY JAIME A. MONCADA, P.E.

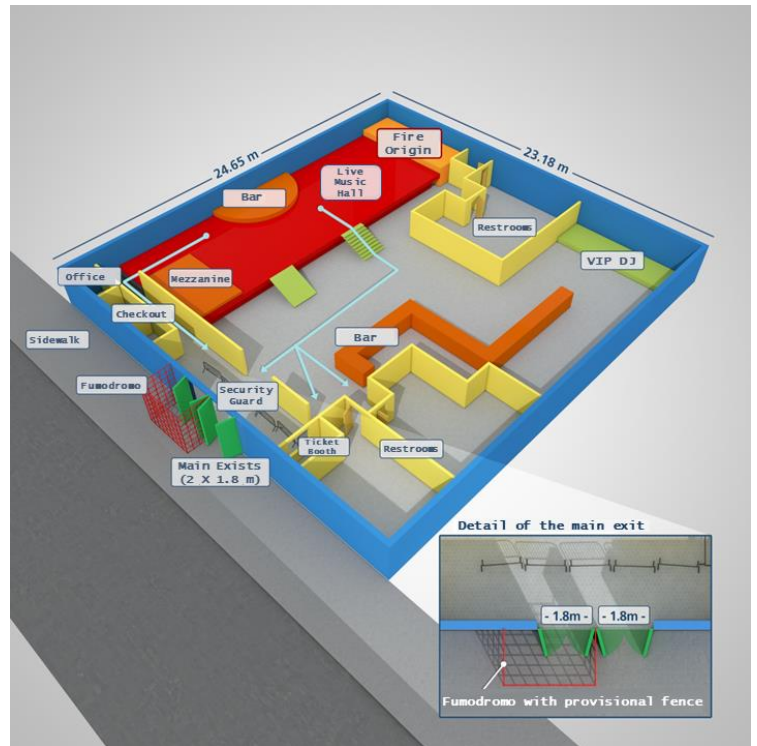
The building lot was a rectangle with a depth of 26.65 m (87½ ft) and a width of 23.18 m (76 ft), with a gross constructed area of 618 m² (6,649 ft²). In March 2010, after extensive renovation, the *Boate Kiss* had its inaugural opening. According to the construction documents approved by the municipality, the structure had brick exterior walls, a gabled metal roof, false ceilings of cardboard plaster, interior walls of plastered masonry covered with wood panels, and a ceramic floor.

The *boate* was only protected by fire extinguishers. There were no automatic sprinklers, hose cabinets, smoke detection and alarm systems, illuminated exit signs, or emergency lighting.

According to police reports, in late 2011, expanded polyurethane foam was installed to solve sound reverberation issues inside the nightclub. This foam was installed on the ceiling of the stage and on the walls of the checkout booths. According to police investigations, the polyurethane foam had not been treated with fire retardants.

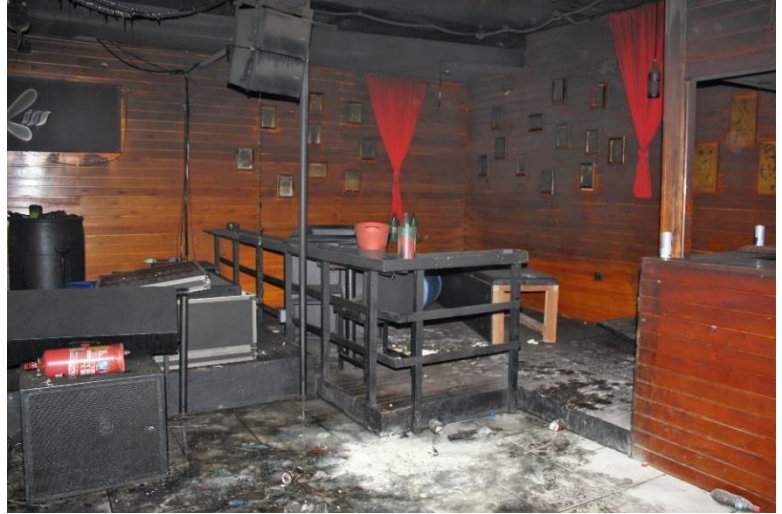
Another striking fact about this incident is the short duration of the actual fire, even though the building interior had combustible finishes and could have potentially undergone flashover. Pictures taken after the fire, around the VIP DJ area, just 15 m from the point of fire origin, show only smoke damage. Very likely this was a fuel rich fire, with not enough oxygen to support extended combustion outside the point of fire origin. The building appeared very airtight, with no windows, and only the front exit doors opened to the outside. Basically, the fire ran out of oxygen sufficient to cause the rest of the *Boate*'s combustible contents to ignite.
