Carpet Store Fire Investigation
Branford, Connecticut
November 28, 1996

SUMMARY

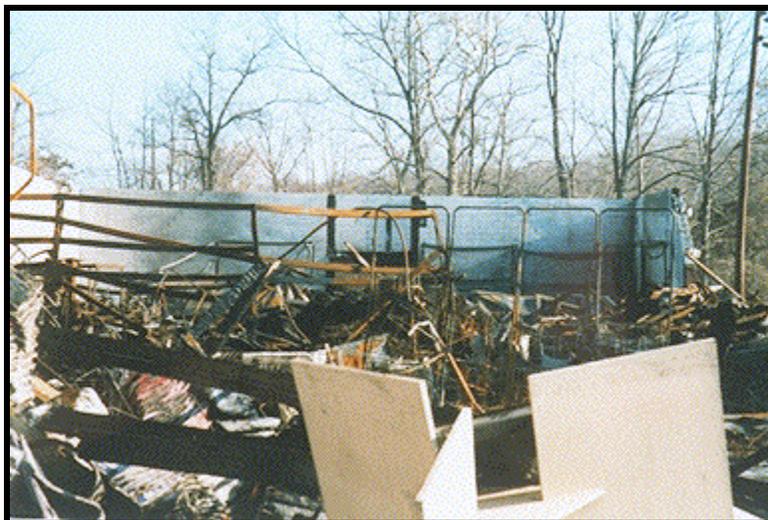
The building was 60 ft (18.3 m) wide and 120 ft (36.5 m) long. It had wood-frame exterior bearing walls in one section and masonry block exterior bearing walls in all other areas. Lightweight wood trusses carried the store's roof over a clear span of 60 ft (18.3 m). The building did not have any fire detection or suppression systems.
