**Aircraft Loading Walkways – Literature and
Information Review**

Joshua D. Swann
Joseph L. Scheffey
Hughes Associates

Fire Protection Research Foundation
© May 2014

Keywords: aircraft loading walkways, aircraft boarding bridges, glass boarding bridges

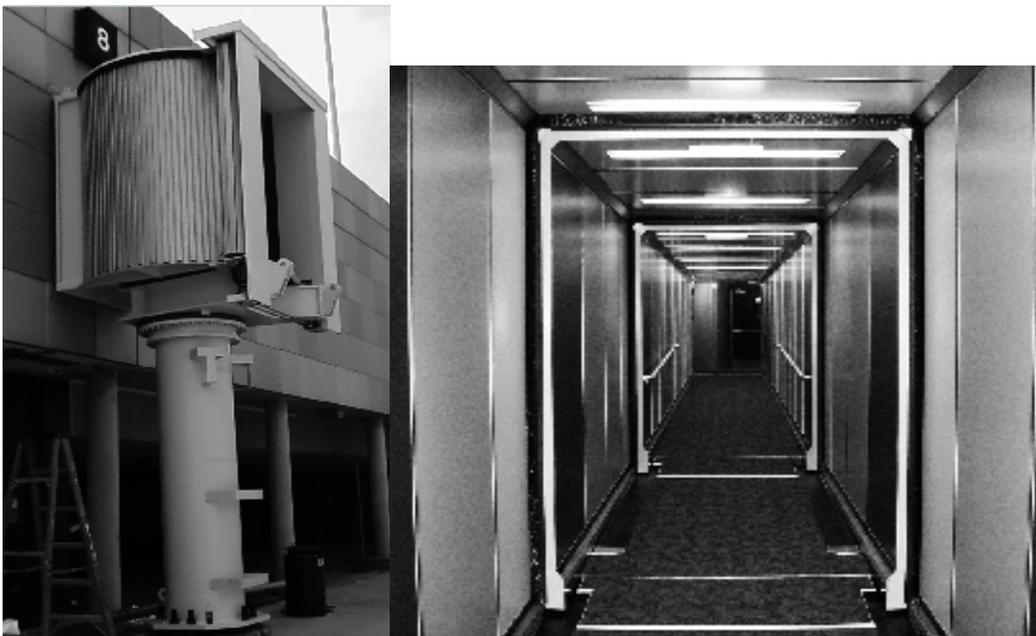
A representative, mobile walkway of steel design is described by ThyssenKrupp [ThyssenKrupp, 2012b]. A rotunda, supported by a column, is shown in Figure 1. This is the primary support for the loading walkway. It is often attached directly adjacent to the terminal entrance and is constructed from steel. The telescoping tunnel consists of the exterior sides, roof, and floor panels. Each component is manufactured from galvanealed steel panels attached to a framework of steel angle and tubing. Strength is derived from formed sheet metal ribs. The minimum internal clear width of the loading walkway is 58 inches. An internal view of the telescoping tunnel is depicted in Figure 2. Other steel walkways may be fixed with only the cab/canopy being movable.

Figures 1 and 2—Telescoping Boarding Bridge [ThyssenKrupp, 2012a]

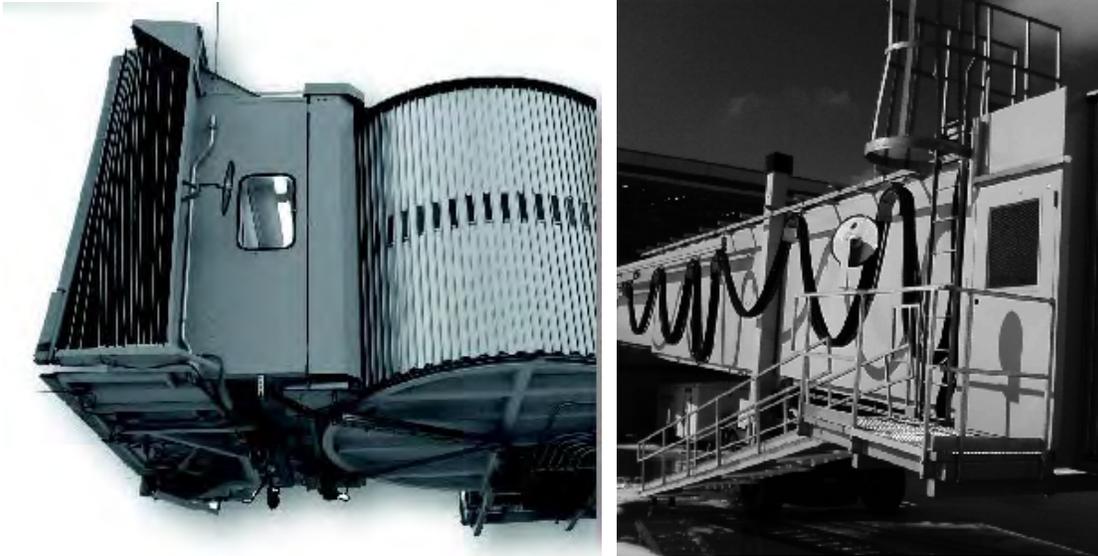
The aircraft cab is the portion of the loading walkway that connects to the aircraft. It consists of a bumper that is able to extend and retract in order to ensure a weather-tight fit to the fuselage. It is constructed with laminated safety glass windows in order to assist operation in less than desirable weather conditions. The windows are small and located to allow the loading walkway operator to properly align the loading walkway prior to any passengers or crew members boarding or deplaning the aircraft. The cab is shown in Figure 3. The service access includes a stair leading to the ramp which accommodates the loading walkway operator. This includes a safety wire glass window, and service door. This is shown in Figure 4. All surfaces, internal and external, have a painted finish [ThyssenKrupp, 2012b].

Figures 3 and 4—Walkway cab and service access [ThyssenKrupp, 2012b]

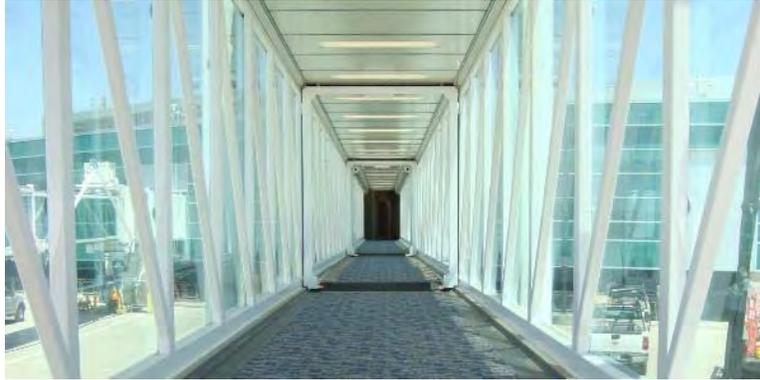
ThyssenKrupp has a glass apron drive loading walkway that is nearly identical to their traditional loading walkway. Only a few differences exist in the construction [ThyssenKrupp, 2012a]. For instance, the roof and floor panels remain the same, being constructed of galvanealed steel panels attached a framework of steel tubing and angle. The walls, however, are constructed of a diagonal steel tube profile frame with side walls consisting of laminated double glass panes. The panes consist of an outer laminated pane (8 mm), an inner colored pane (6 mm), and an intermediate 8 mm air gap. Both panes are of tempered safety glass. As a result of the varied wall construction, the minimum clear internal width of the glass loading walkway is one inch wider (59 inches) than that of the steel loading walkway (58 inches). The key feature and difference between the traditional steel loading walkway and the glass loading walkways is simply in the fact that the walls are constructed using glass panels instead of steel panels. An example of a ThyssenKrupp glass walkway is shown in Figure 5.

Figure 5—Glass Boarding Bridge [ThyssenKrupp, 2012b]

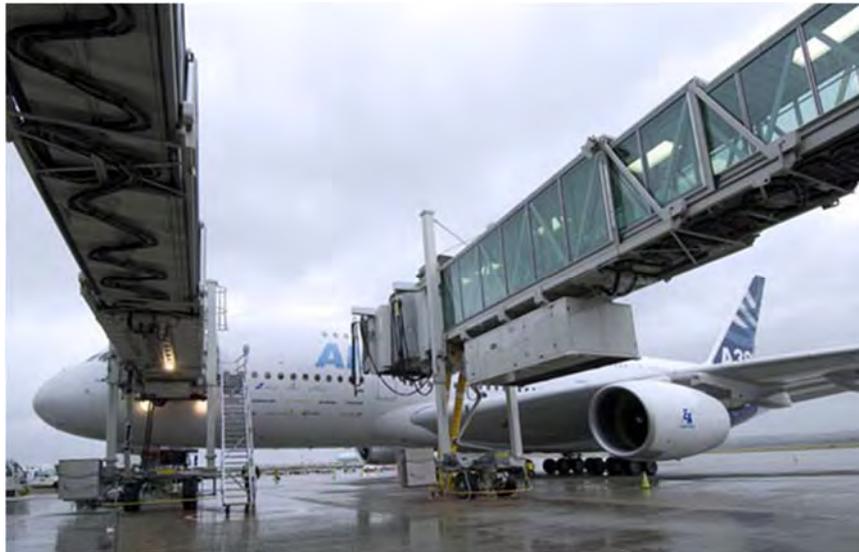
In correspondence to the NFPA 415 Technical Committee, FMC (now JBTAerotech/Jetway®) indicated that they approached the design and construction of their glass loading walkways with the idea that they incorporated as much of the steel loading walkway design as possible [Smith, 2007]. The intent was to meet NFPA 415 requirements. They described in detailed the design of such a glass walkway, using a wall structure consisting of a truss structure that is skinned with glass panels. It is unclear from this correspondence whether the glass structure was ever subjected to a fire test. Figure 6 is an example of a Jetway® walkway.

Figure 6—Jetway® Glass Loading Walkway

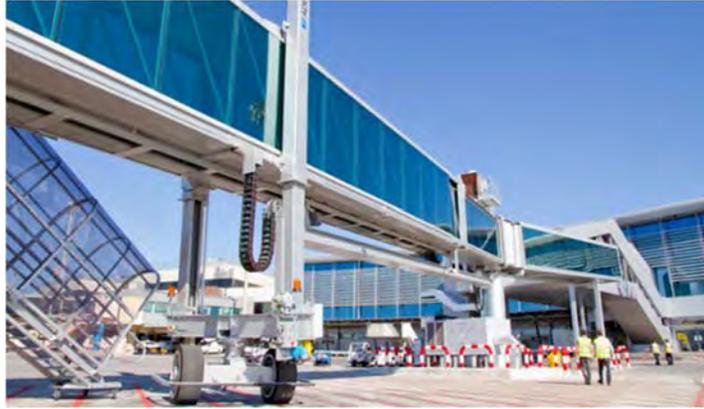
Other glass loading walkways were identified. Another example is shown in Figure 7. It is not clear that other glass walkways have been subjected to fire testing. The manufacturers' specifications were not readily available to indicate whether they were subjected to the NFPA 415 test criteria. Since NFPA 415 is typically applied in the United States, it is unclear that other countries, where glass loading walkways are commonly used, apply similar standards.

Figure 7—Adelte Glass Loading Walkway

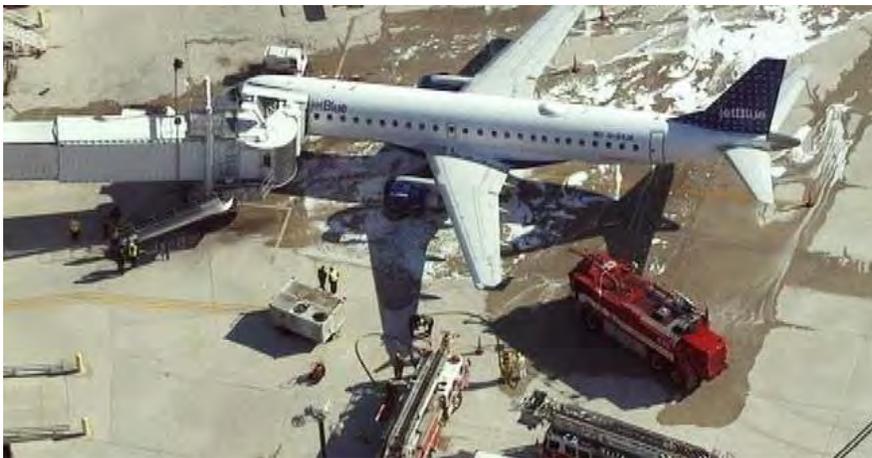
Figure 12—JetBlue Airways Fire, BWI, November 2012
http://media.nbcwashington.com/images/654*368/jet-blue-1.jpg

On November 21, 2012, a small engine fire was reported on JetBlue Airways flight 1329 as it was taxiing to its gate at BWI Thurgood Marshall International Airport. The plane proceeded to taxi to the gate where the fire crews responded and extinguished the fire on the Embraer E190 aircraft. All the passengers and crew members were able to evacuate through the walkway completely unharmed [WBAL TV, 2012]. This is shown in Figure 12.

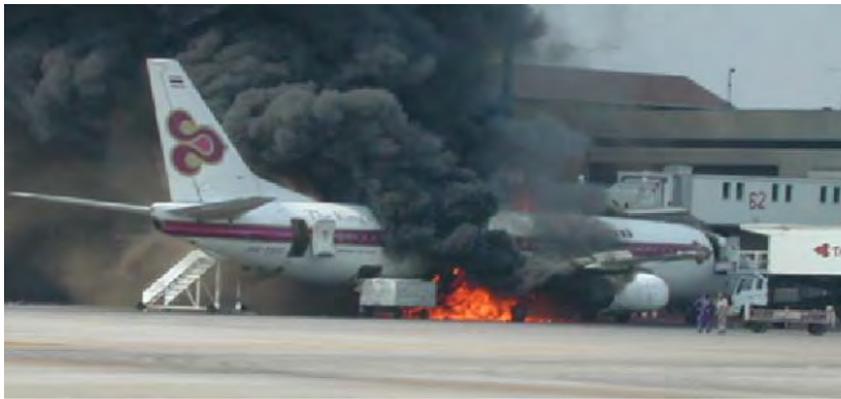
Figure 13—Thai Airways Fire, BKK, March 2001

On March 3, 2001, a Thai B737-400 parked at gate 62 of the Bangkok International Airport (BKK) had an explosion and fire in the wing (Figure 13). The plane was destroyed; nine of the ten occupants survived, but sustained some injuries. Two cabin attendants were near the first two passenger rows and exited via the partially blocked passenger door into the passenger walkway. A third cabin attendant was located above the wings during the explosion and was unable to evacuate the aircraft. The subsequent investigation suggests he was incapacitated during the initial explosion and was unable to exit prior to the resulting fire. Two more cabin attendants were located toward the rear of the aircraft. When the explosion occurred, they exited the aircraft by jumping onto the tarmac below; the door was not armed for the slide deployment at this time (see photo). Several other ground support personnel were in the vicinity of the aircraft at the time of the explosion and sustained minor injuries [Thai Airlines, 2001].

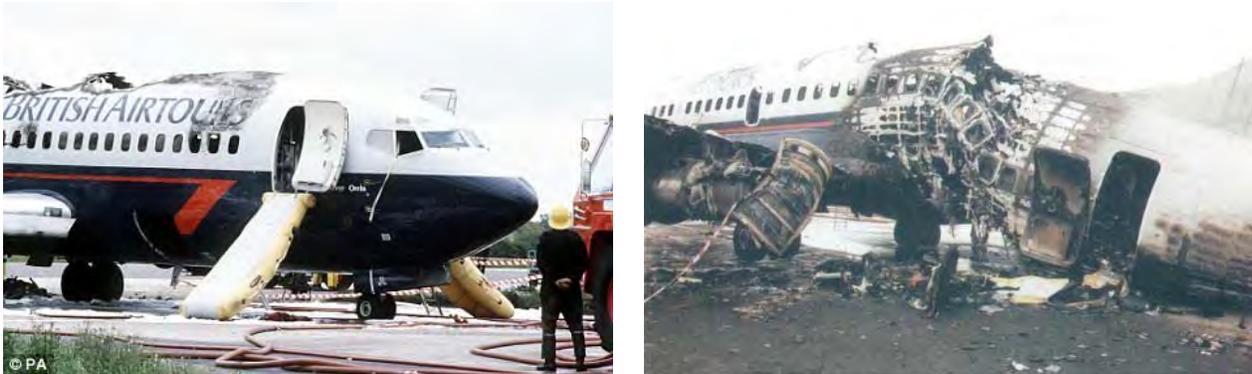
Figures 14 and 15—British Airtours, MAN, August 1985
http://i.idnes.cz/11/11/cl6/VSE3ef239_BritishAirtours28.jpg

British Airtours flight G-BGJL was ready for take-off in the early morning on August 22, 1985 from Manchester International Airport (MAN). As the co-pilot was commanding the aircraft down the runway at 125 knots, a failure occurred in the left engine which caused a leak in the fuel tank. An audible 'thud' was heard by the crew which forced the Boeing 737 to abort take-off. The aircraft was brought to a stop under the assumption that a tire blew out or a bird was ingested in the engine. It was not until the aircraft fuselage began taking on smoke that the crew realized there was a fire involved. The Captain immediately ordered an emergency evacuation from the aircraft on the right hand side. Although prompt action by the crew took place, the fire quickly consumed the fuselage and spread to the inside

of the cabin. Additionally, the airport fire service responded quickly to begin controlling the fire. The slides were successfully deployed, as shown in Figures 14 and 15. This allowed eight-two passengers and crew members to safely evacuate the aircraft. Rapid fire growth resulted in the destruction of the aircraft and the loss of fifty-five persons on board [DOT, 1988].

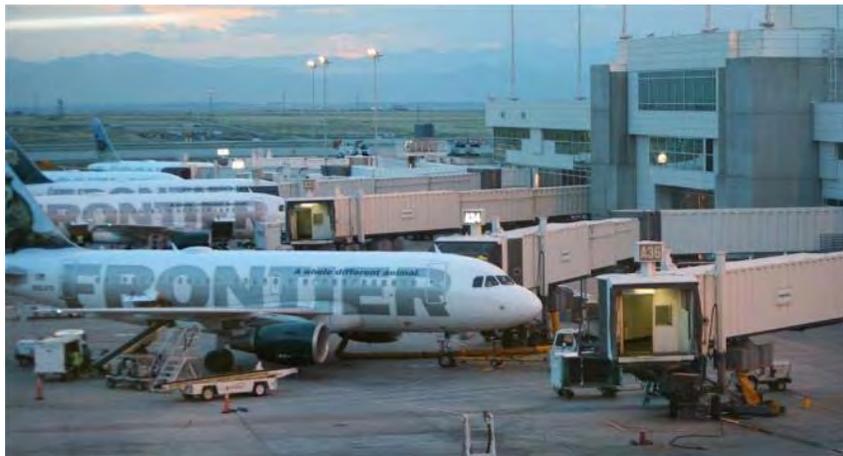
Figure 16—Aircraft Loading Walkway

A normal means of egress is through an aircraft loading walkway (Figure 16). In most airports, aircraft loading walkways are the primary means for passengers and crew members to board and deplane the aircraft. They are particularly important where passengers need to be protected from inclement weather. There are occasions where the size of the airport or aircraft traffic demands other methods of egress (see China Air incident).

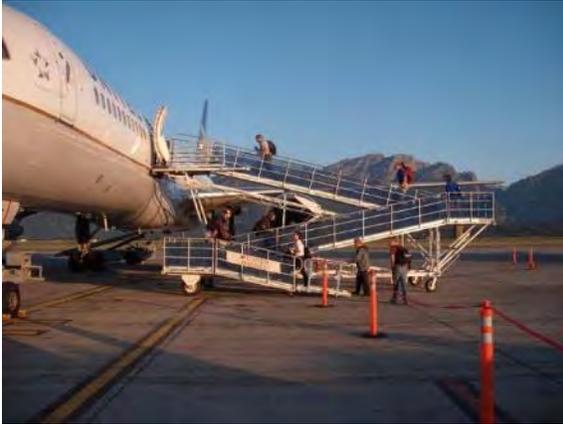
Figure 17—Ramp Loading [Scheffey, 2013a]

An alternative means of egress from a plane is the use of stairs/ramps instead of an enclosed walkway (Figures 17 and 18). Although most operators prefer a loading walkway since it is better from a customer service perspective, there are no requirements for an enclosed walkway versus apron loading ramps or stairs. According to the participating Technical Panel members, if money is available and space permits the use of a loading walkway, it is very rare to choose alternatives. Smaller airlines/airports tend to use stairs simply because of cost restrictions. Small airports often require some stairs to accommodate the flow of traffic. If an airline or airport can afford the loading walkway, it is

uncommon for them to use stairs [Anglin, 2013]. However, they can also be used for larger aircraft as well (Figure 17 is a B757).

The use of apron loading (boarding and deplaning directly from/to the ramp) offers no protection against fires. Aircraft occupants are discharged directly onto the ramp and exposed to any fire situation.

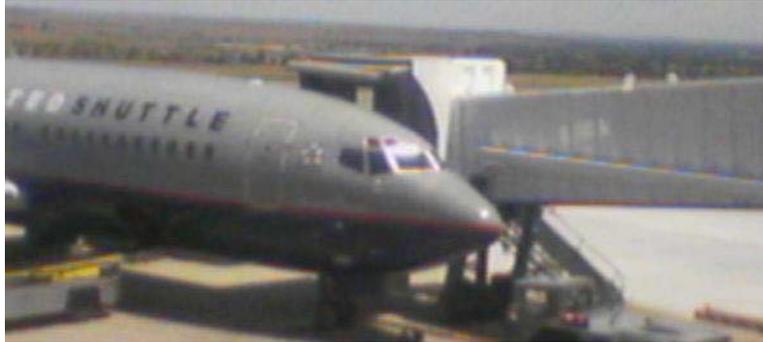
“Several air carriers have stopped using the canopy to seal a loading walkway to a plane in order to save time getting in and out of the gate. However, a canopy won’t be effective during a fire if it isn’t sealed properly” [Walker, 2001]. This scenario is demonstrated in Figure 19. Although weather is not a valid reason to eliminate canopy use, NFPA 415 recognizes that tight fits are not always possible (NFPA 415, Section A.6.2.8).

Figure 19—Gap between Canopy and Aircraft [Scheffey, 2011]

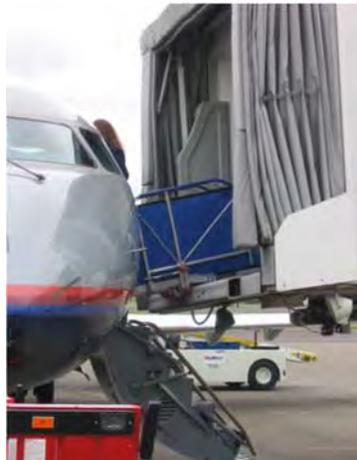
Bridge adapters are often employed when an aircraft parks at a gate not designed for that particular aircraft. Most loading walkways are universal and accommodate many different types of aircraft; however, they cannot incorporate them all. A loading walkway adapter makes it possible for the aircraft to use a loading walkway that is not designed for that specific aircraft. Although this is a very convenient option, the loading walkway adapters typically do not have a tight fit of the canopy to the fuselage. A loose fit or gap will not block potential smoke and flames from entering the loading walkway or aircraft. They may have a significant open gap which ultimately compromises the protected egress path. Figure 20 is an example of a loading walkway adapter that prohibits the proper use of the canopy.

Figure 20—Example loading walkway adapter

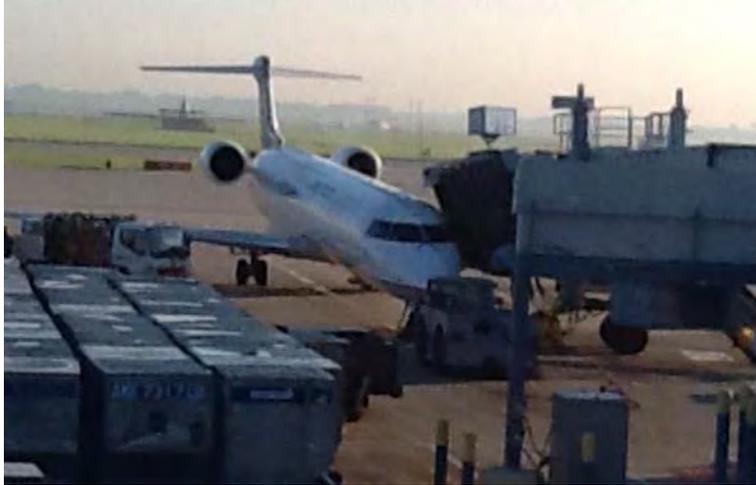
Another situation occurs where the loading walkway integrity is compromised. Aircraft may use a gate/walkway which can mate to the exit door, but canopy does not provide complete protection. This occurs where the walkway used is not designed for that particular aircraft. An example of this is shown in Figure 21.

Figure 21—Aircraft parked at walkway with incomplete canopy mating [Scheffey, 2013b]
