TECHNICAL NOTES

Railing Height, Design, and Criteria Review

September 2019

Report number: FPRF-2019-09

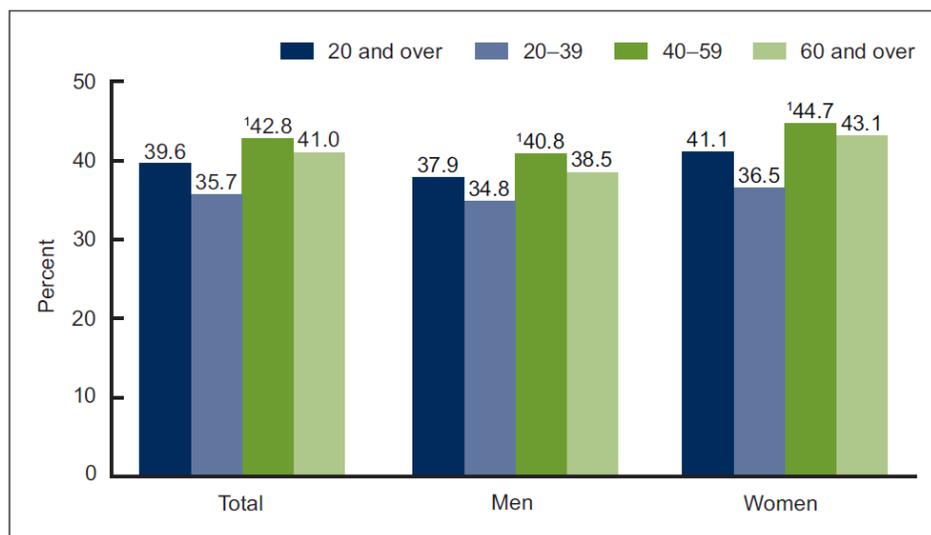
¹Significantly different from those aged 20-39.

NOTES: Estimates for adults aged 20 and over were age adjusted by the direct method to the 2000 U.S. census population using the age groups 20-39, 40-59, and 60 and over. Crude estimates are 39.8% for total, 38.0% for men, and 41.5% for women.

The trend identified in the last 17 years is similar to that observed in the last 50 years (USDHEW 1962, CDC 2018). According to the CDC, both men and women in the United States are roughly an inch taller and 25 pounds heavier than they were in 1960, the study concludes. A measure of obesity has also jumped. BMI, or body mass index (ratio of weight (in kg) to the square of the height (in meters) has increased about 10% among adults from a value of about 25 in 1960 to 28 in 2002. Individuals are classified as being “obese” if their BMI is 30 or greater (CDC, 2019). The proportion of adults who are classified as obese varies with age, as indicated in Figure 1.

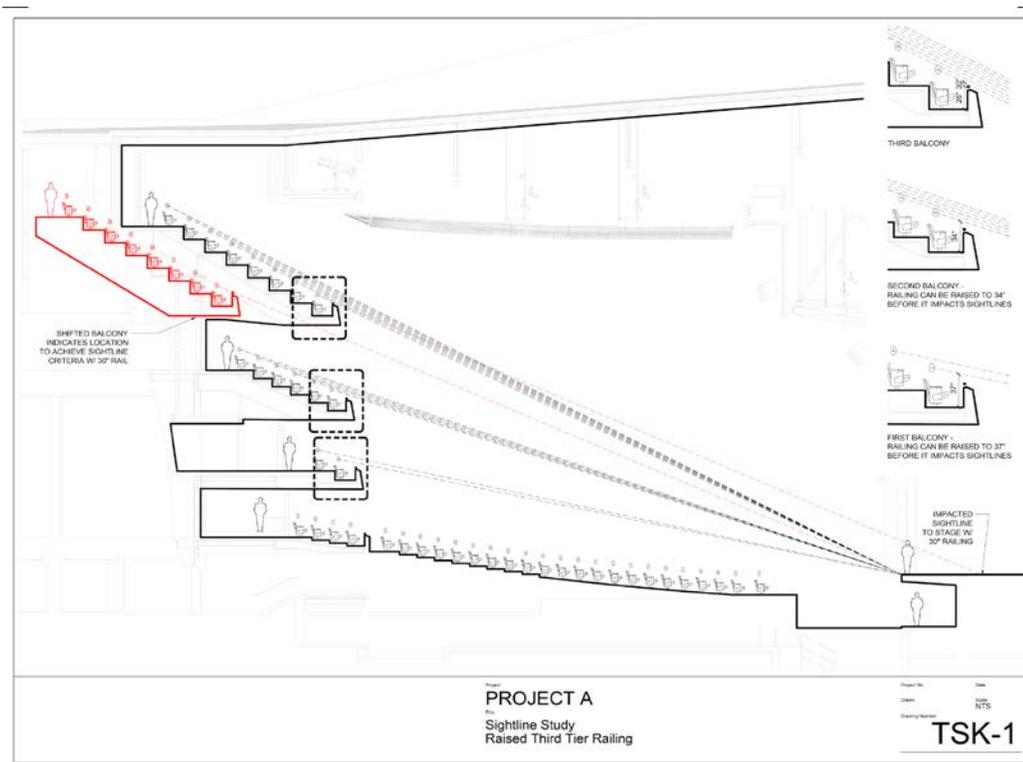
Figure 2. Red lines show the effect of raising the railing in the upper balcony area (Rosenbaum, 2019)

As mentioned previously, some stadiums have raised their railings to at least 2 inches above the NFPA requirement of 42 inches (Larimer, 2016). However, raising the railing guard has the prospect of degrading sightlines for individuals. The American Society of Theatre Consultants performed a study on railing heights in performing art centers (Rosenbaum, 2016). In most cases, the railing height is below the average individual's center of gravity and some individuals may feel vertigo looking over the edge which can lead to a lower sense of security. While there can be a lower sense of security, businesses will have to consider sightlines as a key factor when considering into raising railing heights. In Figure 2, the railing height is shown with sightlines to the performance. The lower balcony can raise the height without significantly impacting the sightline. The upper balconies will be more significantly impacted by an increased railing height at the lower level seating areas. In order to achieve the same sightline as the lower tiers at the same height, the entire balcony will have to move backwards.

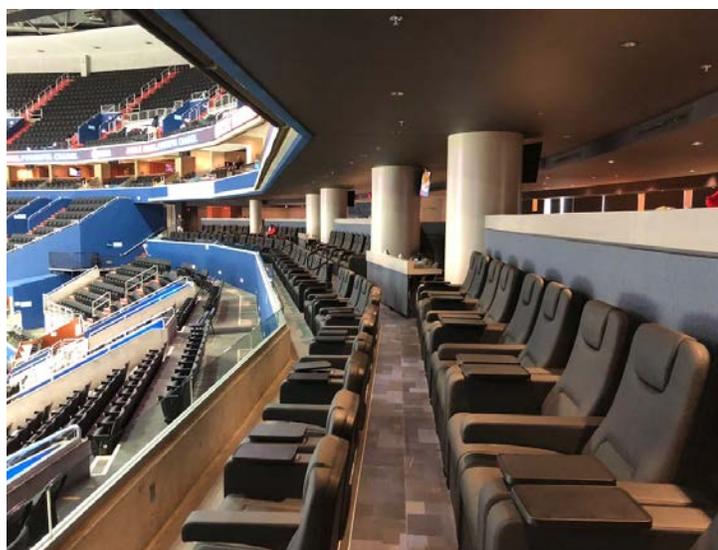
Figure 3. Glazed railing in front of box seating areas at the Capital One Center in Washington, DC (Brown, 2018)

One solution in lieu of opaque railings used in some venues includes a sheet of transparent glazing, such as that illustrated in Figure 3. Transparent glazing can be composed of a polymer composite and be about ½-inch thick and glazing can be any height. In some designs, a thin metal frame may surround the glazing. This eliminates the sight line issues associated with a solid railing and hence would be a significant positive feature. However, having a solid barrier will affect the sound quality received at the aisle of seats adjacent to the glazing. Furthermore, when performances include light displays, reflections off the glazing could detract from the show. Another consideration for glazing involves means for anchoring the glazing, either via slots in the structural component on the edge of the seating area or some bracket.

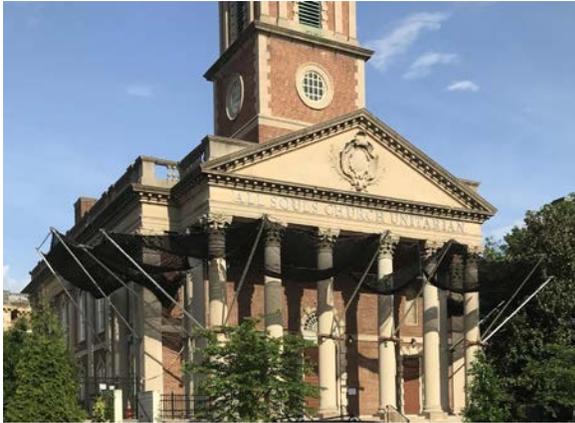
**Figure 4. Safety Net Around Building
(Photo by C. Lee)**

A safety net, much like the construction safety nets depicted in Figures 4 and 5, could be installed around upper decks of stadiums. This would be a second line of protection, there to catch an individual were they to fall over a railing. A safety net could help prevent falls, especially in cases where the falling subject is able to grab and hang from the railing, such as in the incident at Riverfront Stadium in 1981. Such nets can be custom made to meet the exact shape and requirements of a given stadium. Safety nets can be made of any combination of various netting and rope. Depending on the materials used in the net, the shape of the netting itself will be different. To minimize visual obstructions, certain netting patterns can be chosen

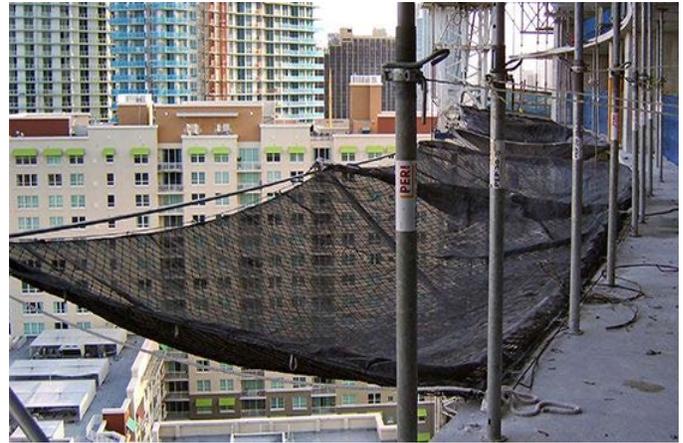
**Figure 5. Safety Net
Construction Site (InCord, 2019)**

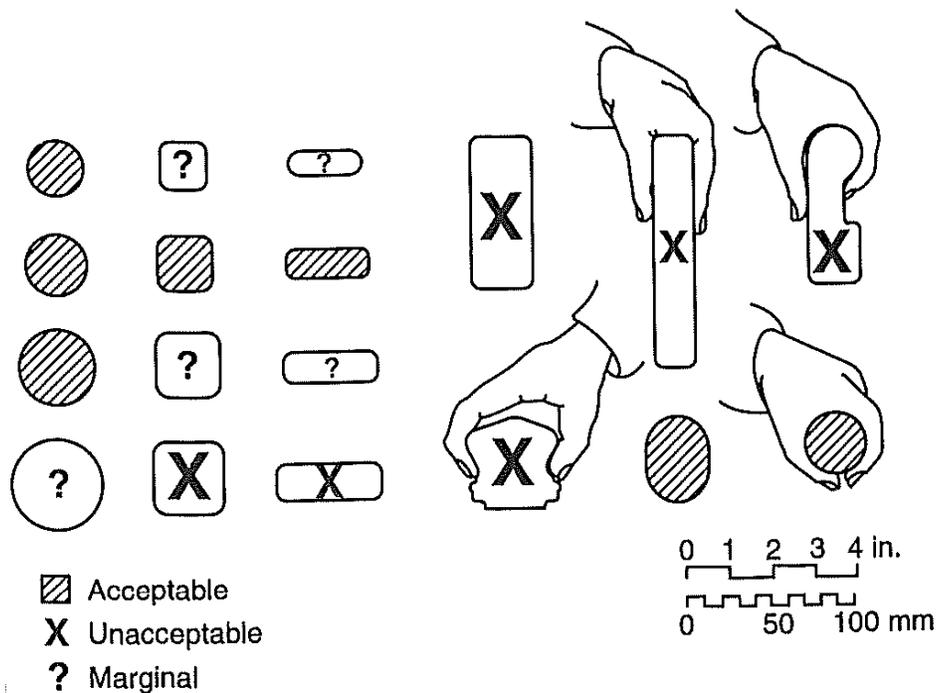
Figure 6. Cross Sections of Railings (NFPA, 2009).

It is worthwhile to consider the cross section of the top of guardrails for safety regulations. A flat cross section would obstruct the view of individuals less than a circular cross section. However, it is important to note that the width of the railings should not be too wide, as it could tempt individuals to sit on the railing or otherwise misuse it. The design of the cross section of the top of the guardrails should also take into account the individual's ability to grasp the handrail (see Figure 6). In at least one case in the review of incidents, an individual fell over the railing at Riverfront Stadium, but was able to grasp the top of the guardrail and pull himself up to safety. Because the guardrail was graspable, he did not sustain a serious injury. Therefore, the top of guardrails should be able to be grasped by individuals to act as an extra emergency safety feature.

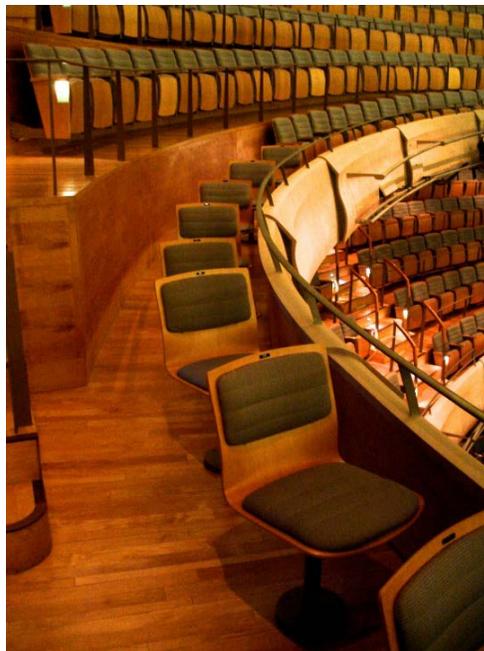
Figure 6. Configuration with Aisle behind Seating (Pauls, 2019)

One final solution could involve positioning the aisle accessway behind a seating area, or providing an increased horizontal surface, such as a table, at the edge of the seating section, such as that depicted in Figure 6. This arrangement could be a potential solution as it would restrict people from falling over the railing by having a separation distance between the aisle accessway and the edge of the seating area. A negative aspect of the arrangement with the swivel chairs illustrated in Figure 6 for facility operators is the additional space required for swivel chairs as compared to fixed seating.

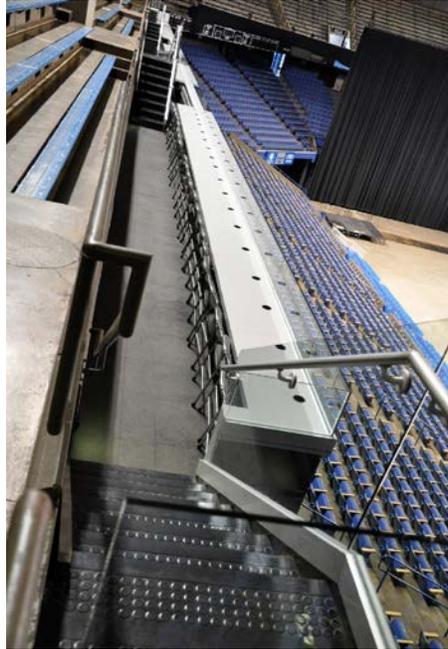
Figure 7. Table between Seating and Glazing (Pauls, 2019)

As an alternative, a table could also be included at the edge of the seating area (in front of the row of seats) (see Figure 7). Two negatives of this solution are concerns about sightlines and potential misuse. For people in the row of seating, sightlines may be restricted unless the railing on top of the table is relatively low. A concern about this solution is the potential of people standing on top of the table and misusing the table, which could lead to a fall over the railing. Also, having a table might decrease profits because it would take spectator room away from the stadium.
